# Glen St. Intersections Pedestrian Study

Memo To: Mr. Aaron Frankenfeld, Director  
Adirondack/Glens Falls Transportation Council (A/GFTC)  
11 South Street, Suite 203  
Glens Falls, NY 12801

Date: 8/27/2021

From: Barton & Loguidice, D.P.C.

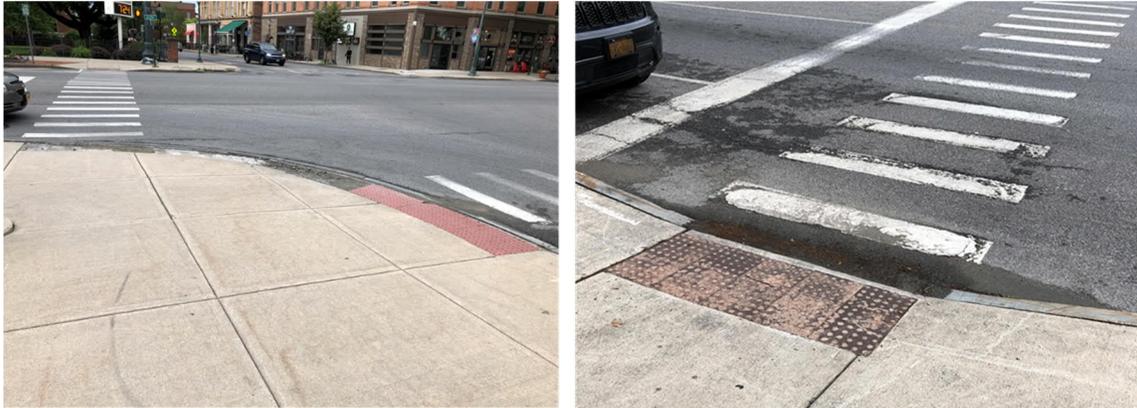
Figure 3.1 – Glen/South/Bay intersection striping and sidewalk ramp condition

1. Pavement striping – Existing striping is faded and not visible in some locations. Please see Figure 3.1 below.
2. Curb ramps – Several of the ramps are showing signs of deterioration with damaged sections of concrete, curb, detectable warning units, and ponding water, as shown in Figure 3.1. Several pedestrians with strollers were witnessed having a difficult time traversing the existing ramps.

3. Re-Striping the pavement would aid in guiding vehicles through the intersection and bring attention to the crosswalks.
  - a. High Visibility Crosswalks should be installed at this intersection to provide improved driver awareness of the pedestrian crossing locations. The crosswalks include the addition of two transverse lines to the perpendicular ladder bars that are on site currently as shown in the figure below. The pavement markings should be Epoxy paint with glass bead for retro-reflectivity or retro-reflective thermoplastic pavement marking tape.

- b. It is suggested that all other intersection pavement markings are also replaced with Epoxy based retro-reflective paint.

7. Reconstructing the curb ramps to provide new detectable warning units, address the areas of ponding water, and provide a continuous smooth transition between the sidewalk and road surface.

Probable Cost to Implement = \$ 50,000. Installation includes excavation, subbase, concrete, pavement restoration and grading, and detectable warning units.

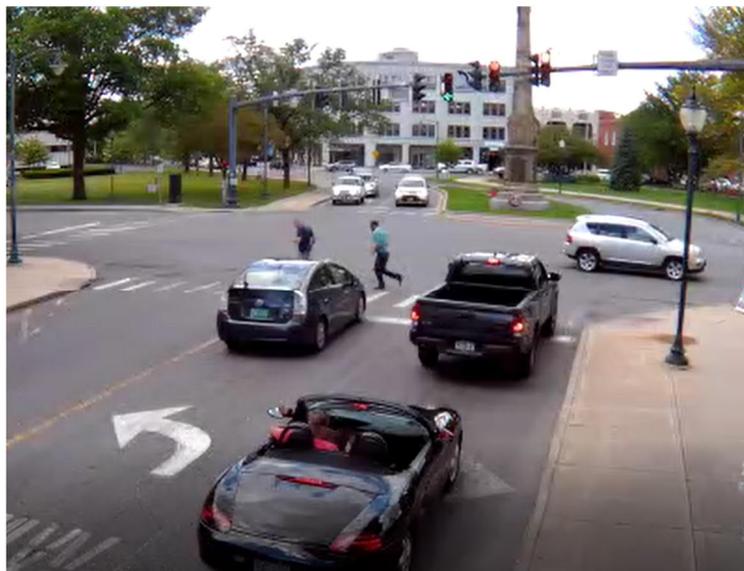
Figure 3.2 – Pedestrians crossing without using the push button

3. Many of the pedestrians did not press the push button when crossing. This was more common during non-peak hours or at early hours in the morning when vehicle traffic was lighter. Many of these pedestrians would cross without hesitation, in some instances caused conflict between vehicles with the green light having to wait on pedestrians.

Figure 3.2 was captured during the video recordings. The two pedestrians were attempting to cross South St. without using the push button. The vehicle in the left turn lane had the left turn green arrow but had to wait for the pedestrians to cross in this instance.

5. Replace the existing pedestrian push buttons with Latching Pedestrian Push Buttons. The Latching pedestrian push button assembly provides visual confirmation with a red LED light that the button was activated and the call was placed to the signal controller. The button itself can be fabricated with an arrow for direction of travel or even upgraded to include the City logo or a theme for the area.

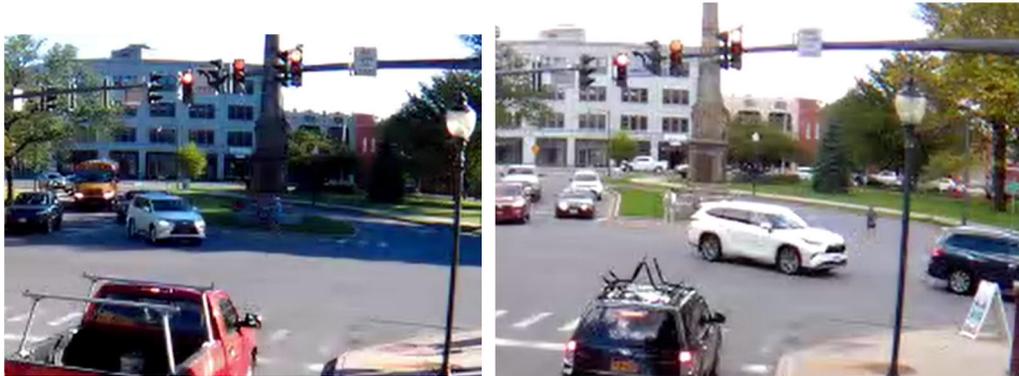
Figure 3.3 – Pedestrians stopped in the Bay St. Median

4. The pedestrian refugee island at the Bay St. crossing was also problematic causing people to get trapped on the island for one of two reasons.
  - a. Some would stop to read the Civil War monument
  - b. Pedestrians traveling westbound (on Glen St.) that did not use the push button and wait for the "walk" light; would begin to cross, and southbound vehicles would get the green light, trapping them at the island.

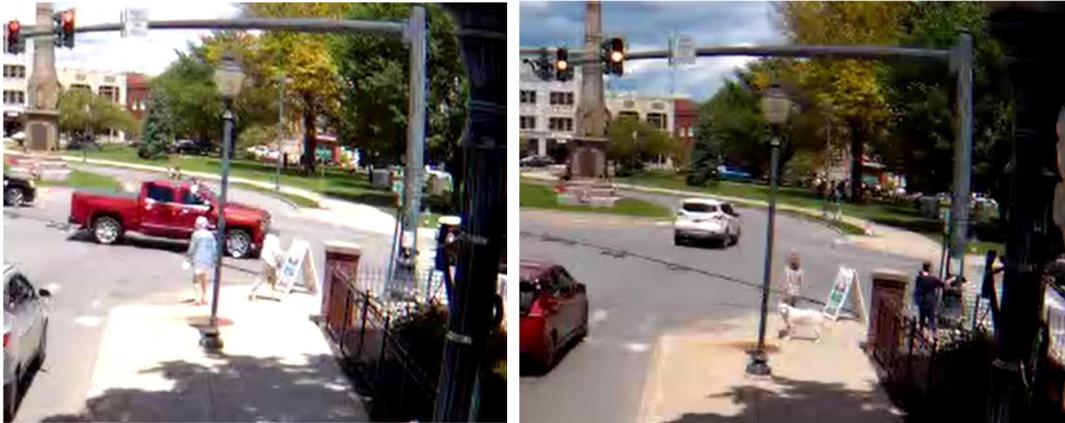
Figure 3.5 – Pedestrians searching for the push button

7. There were many instances of pedestrian confusion when looking for the push button to cross South St on both sides of South St. At the southeast corner, the push buttons to cross Glen St. and South St. are both located on the traffic signal pole that is adjacent to the Glen St. crosswalk, this pole is 15 ft. away from the South St. sidewalk ramp which may contribute to the confusion. At the southwest corner both push buttons to cross Glen St. and South St. are located on the same pedestrian signal pole that is adjacent to the Glen St. sidewalk ramp and 14 ft. away from the South St. sidewalk ramp.

4. Provide an additional push button only pole at the southeast and southwest corners for pedestrians looking to cross South St.

Probable Cost to Implement = \$ 7,000. Installation includes standard push button, pole, pedestrian crossing sign, conduit, and wiring.

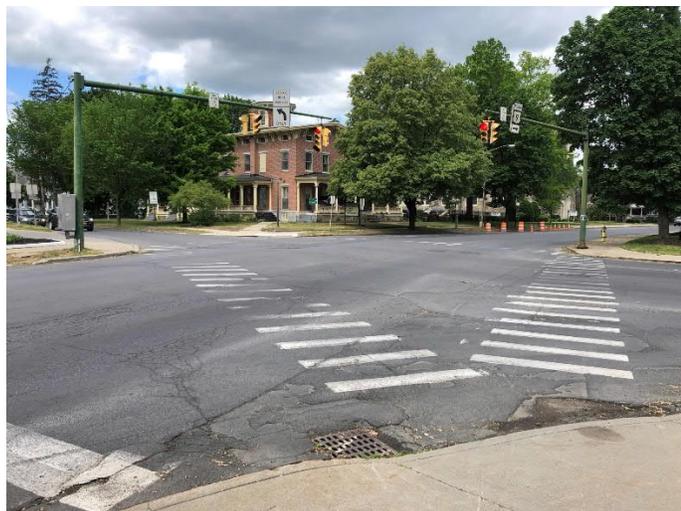
1. Pedestrian volume overall was lower than at the Glen St. and South St./Bay St. intersection.
2. Pavement striping – Existing striping is faded and not visible in some locations. Please see Figure 3.6 below.
3. The existing curb ramps do not meet current ADA requirements. The ramps do not include detectable warning units, there are drainage structures located at the base of the ramp, and the positioning of the ramps do not line up with the crosswalk direction. Please see Figure 3.6 below for a close-up view of the south side ramps.

4. Reconstructing the curb ramps to meet current ADA requirements, provide new detectable warning units, relocate drainage structures, and provide a continuous smooth transition between the sidewalk and road surface.

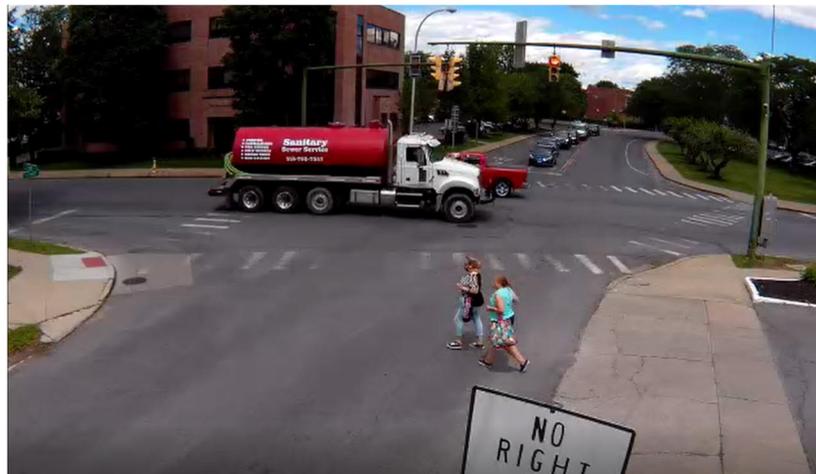
Figure 3.7 – Pedestrians crossing at the Stewart’s driveway

7. Pedestrians were observed to walk through Stewart’s parking lot and cross the street mid-block behind the crosswalk. This crossing pattern is most likely due to the stop bar being located behind the Stewart’s driveway.
