Final Glen St. Intersections Pedestrian Study

Memo To: Mr. Aaron Frankenfeld, Director
Adirondack/Glens Falls Transportation Council (A/GFTC)
11 South Street, Suite 203
Glens Falls, NY 12801

Date: 12/23/2021

From: Barton & Loguidice, D.P.C.

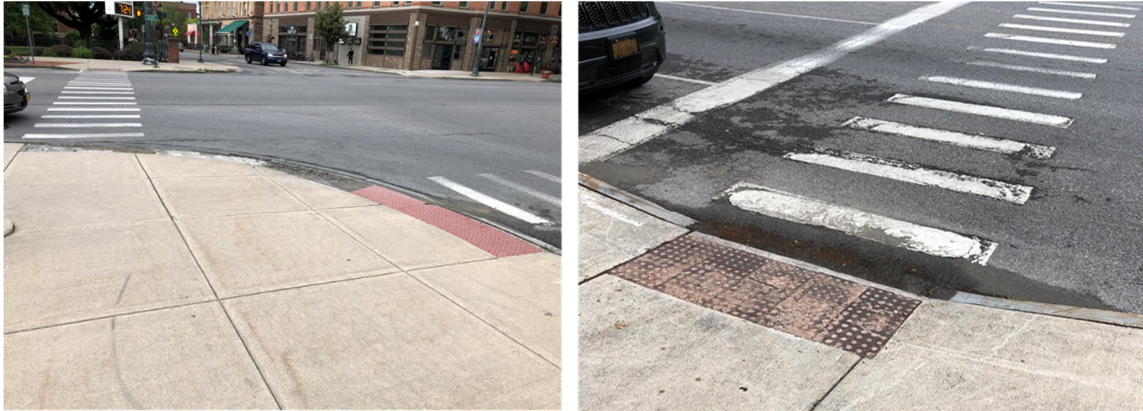
Figure 3.1 – Glen/South/Bay intersection striping and sidewalk ramp condition

1. Pavement striping – Existing striping is faded and not visible in some locations. Please see Figure 3.1 below.
2. Curb ramps – Several of the ramps are showing signs of deterioration with damaged sections of concrete, curb, detectable warning units, and ponding water, as shown in Figure 3.1. Several pedestrians with strollers were witnessed having a difficult time traversing the existing ramps.

3. Re-Striping the pavement would aid in guiding vehicles through the intersection and bring attention to the crosswalks.
 - a. High Visibility Crosswalks should be installed at this intersection to provide improved driver awareness of the pedestrian crossing locations. The crosswalks include the addition of two transverse lines to the perpendicular ladder bars that are on site currently as shown in the figure below. The pavement markings should be Epoxy paint with glass bead for retro-reflectivity or retro-reflective thermoplastic pavement marking tape.

- b. It is suggested that all other intersection pavement markings are also replaced with Epoxy based retro-reflective paint.

7. Reconstructing the curb ramps to provide new detectable warning units, address the areas of ponding water, and provide a continuous smooth transition between the sidewalk and road surface.

Probable Cost to Implement = \$ 50,000. Installation includes excavation, subbase, concrete, pavement restoration and grading, and detectable warning units.

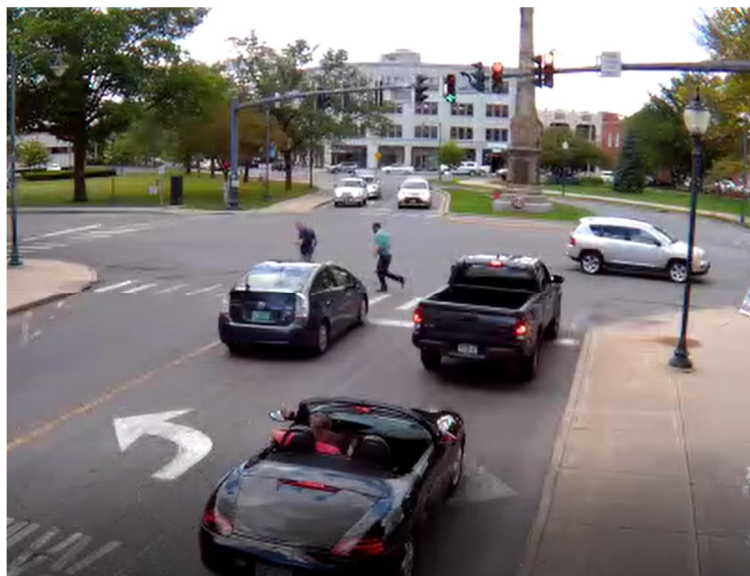
Figure 3.2 – Pedestrians crossing without using the push button

3. Many of the pedestrians did not press the push button when crossing. This was more common during non-peak hours or at early hours in the morning when vehicle traffic was lighter. Many of these pedestrians would cross without hesitation, in some instances caused conflict between vehicles with the green light having to wait on pedestrians.

Figure 3.2 was captured during the video recordings. The two pedestrians were attempting to cross South St. without using the push button. The vehicle in the left turn lane had the left turn green arrow but had to wait for the pedestrians to cross in this instance.

5. Replace the existing pedestrian push buttons with Latching Pedestrian Push Buttons. The Latching pedestrian push button assembly provides visual confirmation with a red LED light that the button was activated and the call was placed to the signal controller. The button itself can be fabricated with an arrow for direction of travel or even upgraded to include the City logo or a theme for the area.

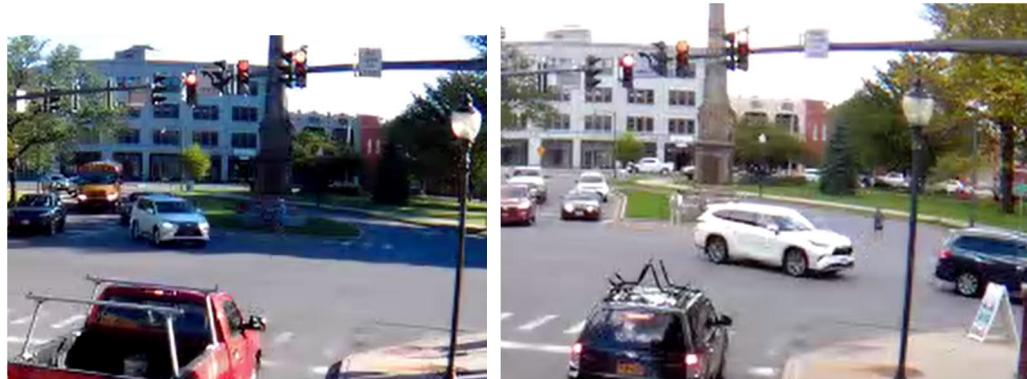
Figure 3.3 – Pedestrians stopped in the Bay St. Median

4. The pedestrian refugee island at the Bay St. crossing was also problematic causing people to get trapped on the island for one of two reasons.
 - a. Some would stop to read the Civil War monument
 - b. Pedestrians traveling westbound (on Glen St.) that did not use the push button and wait for the "walk" light; would begin to cross, and southbound vehicles would get the green light, trapping them at the island.

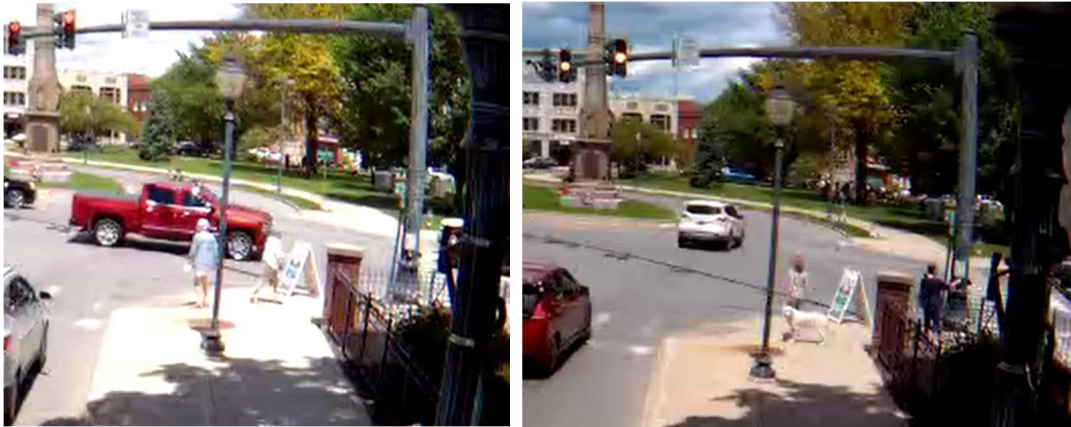
Figure 3.5 – Pedestrians searching for the push button

7. There were many instances of pedestrian confusion when looking for the push button to cross South St on both sides of South St. At the southeast corner, the push buttons to cross Glen St. and South St. are both located on the traffic signal pole that is adjacent to the Glen St. crosswalk, this pole is 15 ft. away from the South St. sidewalk ramp which may contribute to the confusion. At the southwest corner both push buttons to cross Glen St. and South St. are located on the same pedestrian signal pole that is adjacent to the Glen St. sidewalk ramp and 14 ft. away from the South St. sidewalk ramp.

4. Provide an additional push button only pole at the southeast and southwest corners for pedestrians looking to cross South St.

Probable Cost to Implement = \$ 7,000. Installation includes standard push button, pole, pedestrian crossing sign, conduit, and wiring.

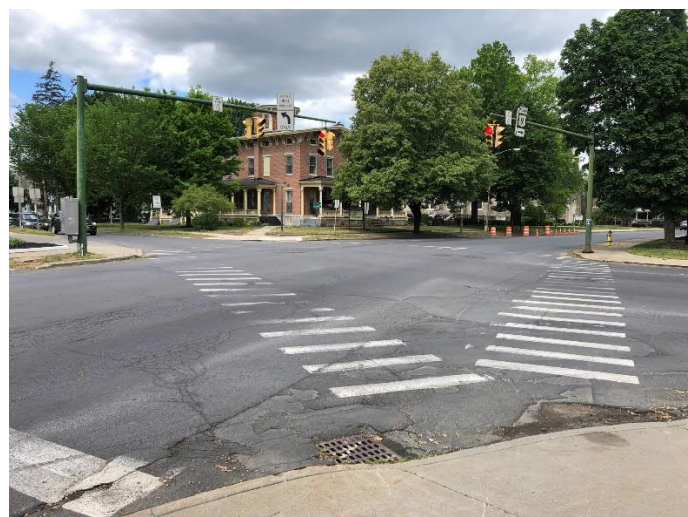
1. Pedestrian volume overall was lower than at the Glen St. and South St./Bay St. intersection.
2. Pavement striping – Existing striping is faded and not visible in some locations. Please see Figure 3.6 below.
3. The existing curb ramps do not meet current ADA requirements. The ramps do not include detectable warning units, there are drainage structures located at the base of the ramp, and the positioning of the ramps do not line up with the crosswalk direction. Please see Figure 3.6 below for a close-up view of the south side ramps.

2. Re-Striping the pavement would aid in guiding vehicles through the intersection and bring attention to the crosswalks.
 - a. High Visibility Crosswalks should be installed at this intersection to provide improved driver awareness of the pedestrian crossing locations. The crosswalks include the addition of two transverse lines to the perpendicular ladder bars that are on site currently as shown in the figure below. The pavement markings should be Epoxy paint with glass bead for retro-reflectivity or retro-reflective thermoplastic pavement marking tape.

4. Reconstructing the curb ramps to meet current ADA requirements, provide new detectable warning units, relocate drainage structures, and provide a continuous smooth transition between the sidewalk and road surface.

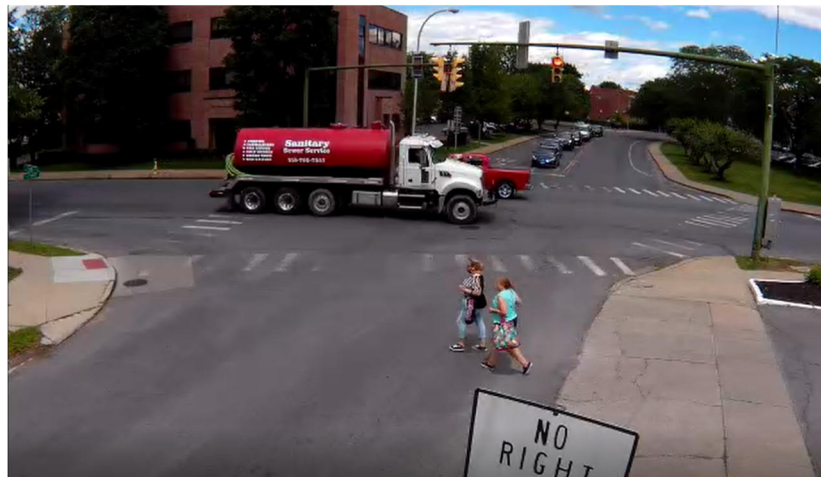
Figure 3.7 – Pedestrians crossing at the Stewart’s driveway

7. Pedestrians were observed to walk through Stewart’s parking lot and cross the street mid-block behind the crosswalk. This crossing pattern is most likely due to the stop bar being located behind the Stewart’s driveway.

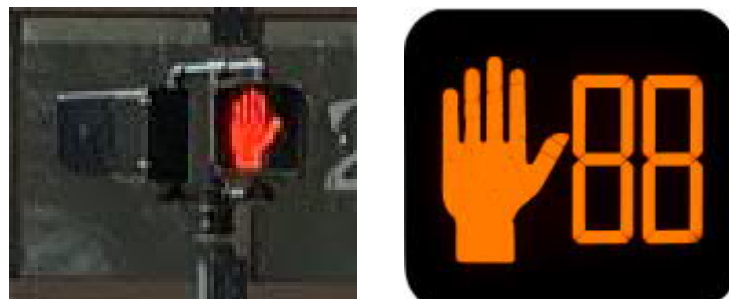
Figure 5.1 – Existing Hand/Person Signal and Replacement Combination Signal

Yes, this is a good observation noted by the public in attendance with the November 3rd meeting. Pedestrian countdown timer signals could be added to the current signal system at the intersection in addition to the other recommendations presented in this report. Currently, each direction has a single 16" x 18" signal unit that displays the Hand/Person figures. These units can be replaced with 16" x 18" combination Countdown and Pedestrian Signal units, See figure 5.1. Many current pedestrian signal applications will include two side by side 12" x 12" units for each direction of control, one unit displays the Hand/Person symbols and the other is the countdown timer. These side by side units could be installed here if a full scale replacement is undertaken by the City, although the singular combination units will allow for a more economical upgrade with a direct replacement of the existing signal heads.

Probable Cost to Implement = \$1,200 Each x 8 Signals = \$ 9,600.
