Argyle Pedestrian Network Extension Study Village and Town of Argyle

Washington County, New York

October 2018

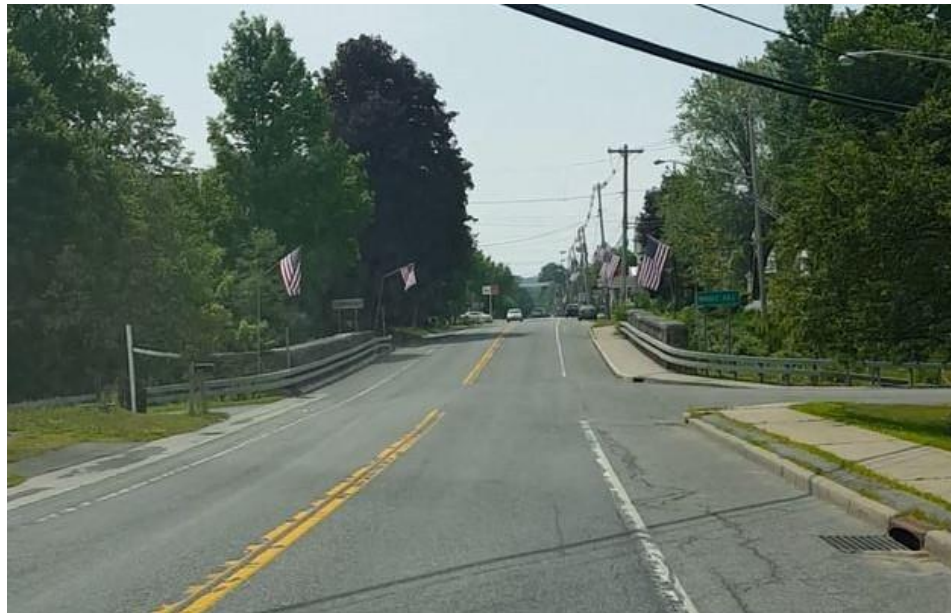
NYS Route 197 at Moses Kill Bridge: View looking south

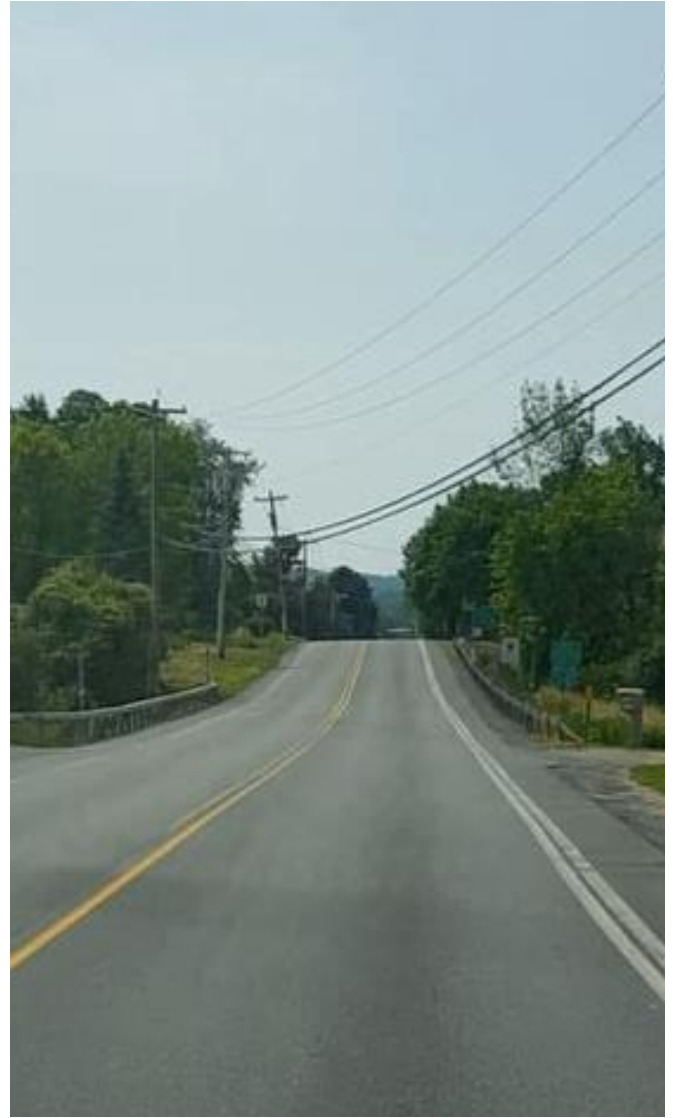
NYS Route 197: View of Crest Vertical Curve approaching from the North

The surrounding terrain consists of rolling hills. The roadway is generally flat throughout the study area. However, there is a crest vertical curve that peaks near the Argyle Laundromat, which limits sight distance. The nature of this crest curve is discussed further in Section 3-1.

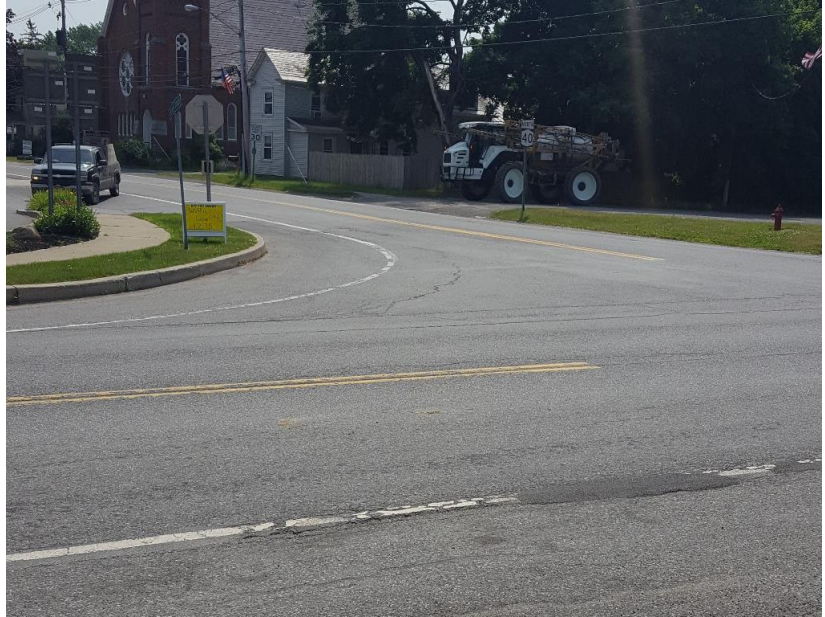
The intersection of NYS Route 197 and NYS Route 40 is a T-intersection with one lane in each direction. NYS Route 40 forms the south and east legs of the intersection, and NYS Route 197 forms the north leg. The westbound approach (east leg) is the stop-controlled approach. This intersection is located at the center of the Village of Argyle.

NYS Route 197 and NYS Route 40 Intersection: View Looking East

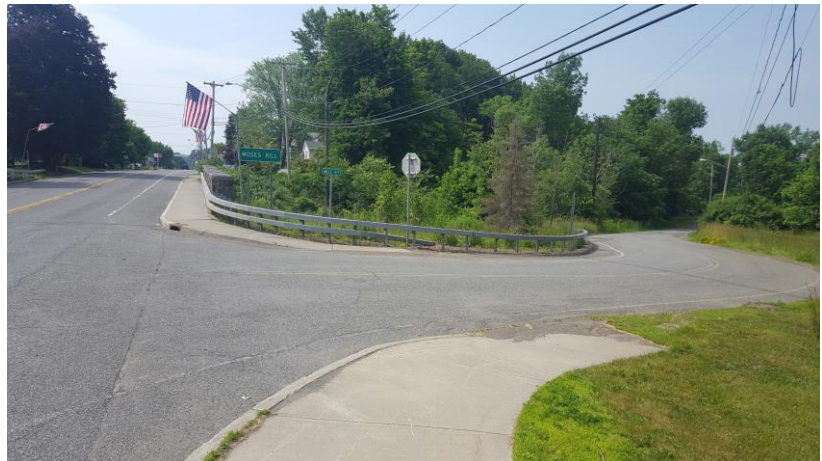
The intersection of NYS Route 197 and Mill Street is a T-intersection with one lane in each direction. The eastbound approach on Mill Street is the stop-controlled approach. This intersection is located next to the Moses Kill Bridge (north side) and is approximately 800 feet north of the NYS Routes 197/40 intersection.

NYS Route 197 and Mill Street Intersection: View Looking South

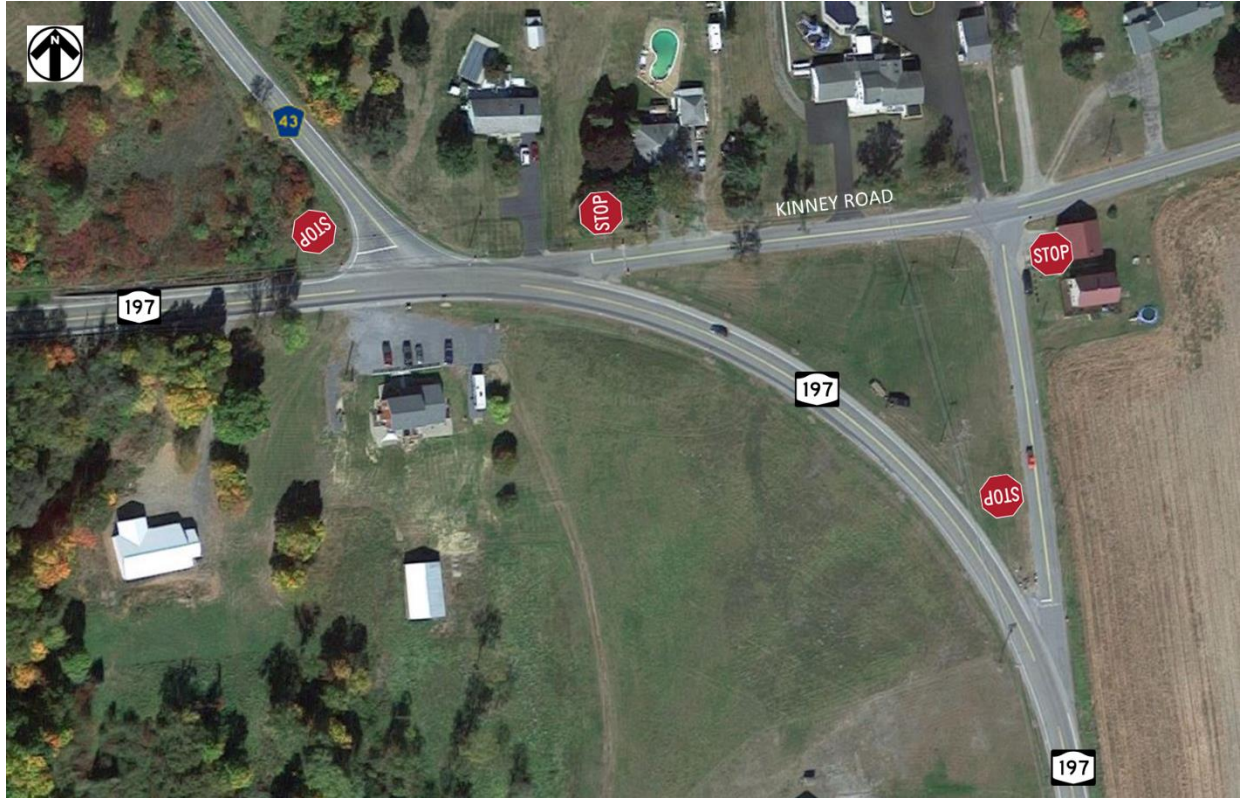
The intersection at NYS Route 197 and County Route 43/Kinney Road is a non-conventional configuration of several stop-controlled intersections located in the Town of Argyle, north of the Village. This grouping of intersections is along a horizontal curve of NYS Route 197, which forms the eastbound and northbound approaches. All of the roadway approaches to this collective intersection consist of a single travel lane.

NYS Route 197 and CR43/Kinney Road Intersection: Aerial View

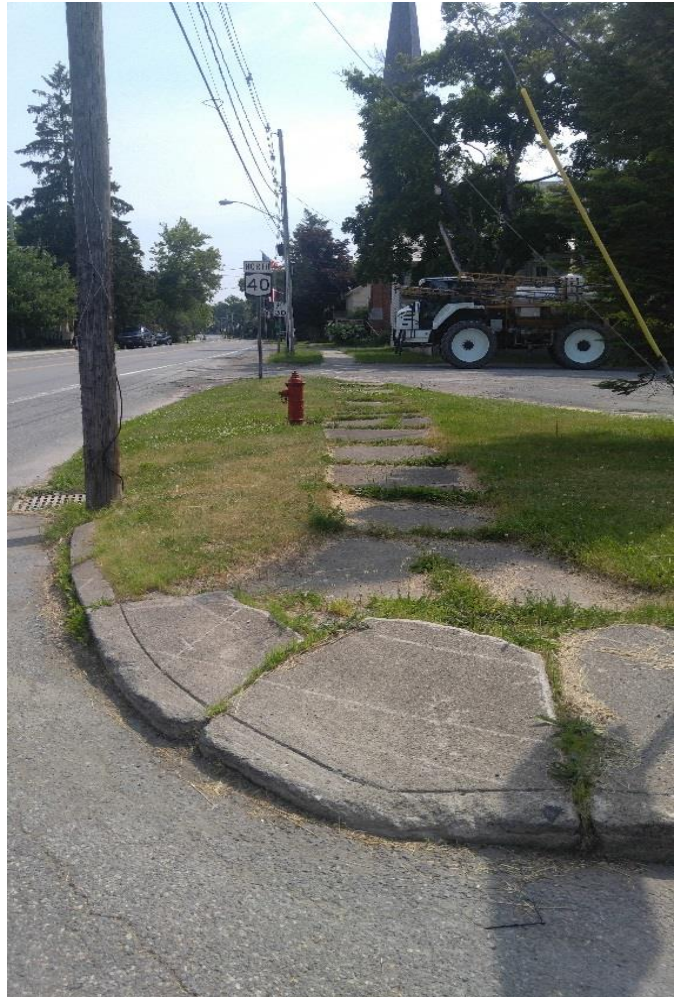
Sidewalk at southeast corner of NY Route 197 and NY Route 40: poor condition and not ADA accessible

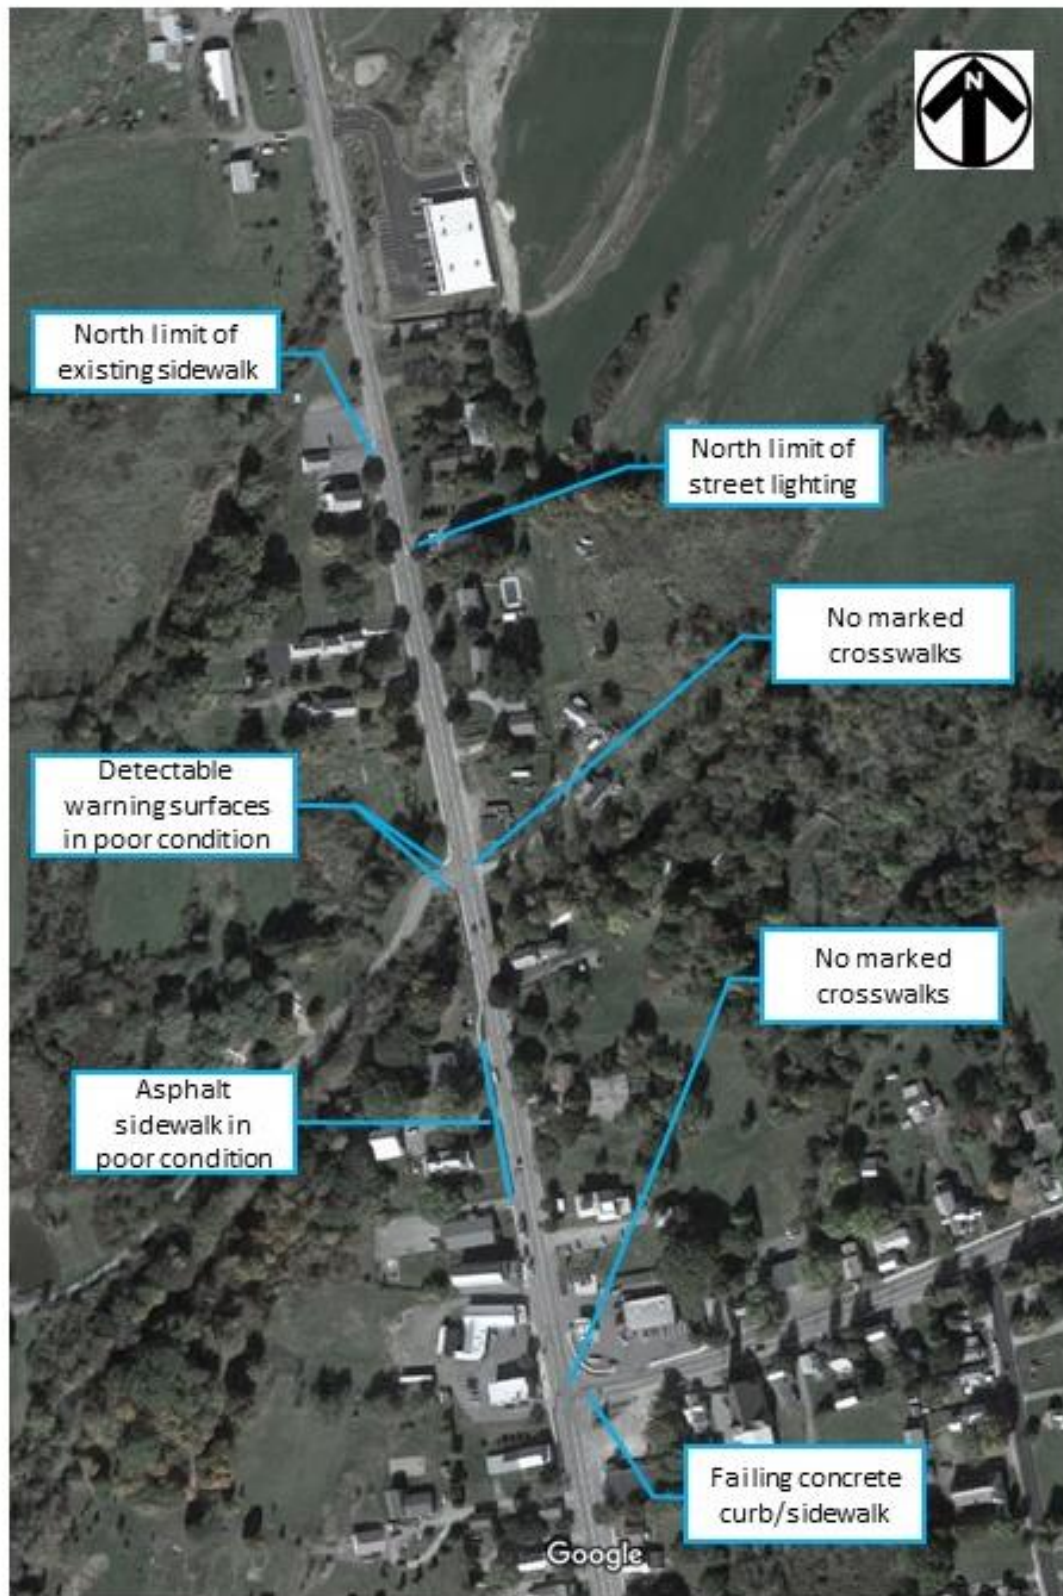
Exhibit 2-1: Existing Roadway Characteristics

As part of the field visit, it was noted that the existing sidewalk was experiencing deformation and cracking in multiple areas. Locations of sidewalks in poor condition include the following, which are also shown on Exhibit 2-1:

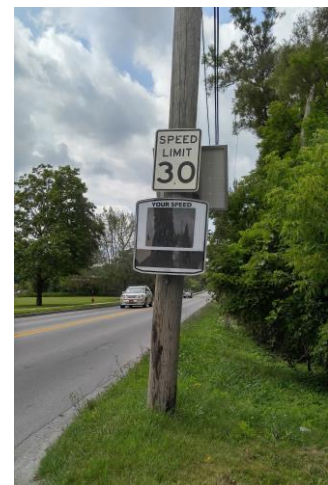
This speed data indicates that speed enforcement and/or driver speed feedback signing should be considered to achieve better compliance in the 30-mph zone. Driver speed feedback signs measure the speed of an

Driver Speed Feedback Sign

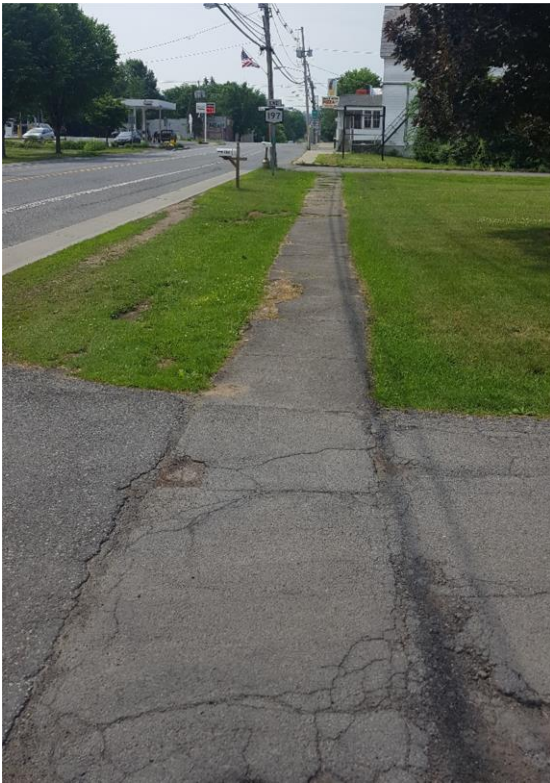
Several sections of the existing sidewalk along the west side of NYS Route 197 are in poor physical condition. These include the 200-foot segment of asphalt sidewalk between 102 Main Street and 109 Main Street (residential properties), and the 75-foot segment of concrete sidewalk in front of 95 Main Street, a commercial property. The existing 100-foot segment of sidewalk on the south side of NYS Route 40 at the intersection with NYS Route 197 is also in poor condition, as noted in Section 2.

Asphalt Sidewalk Section in poor condition and narrow width

The 200-foot segment of asphalt sidewalk is 4 feet wide. While this is less than the preferred minimum 5-ft width, it is consistent with current acceptable design practices of PROWAG and FHWA for this limited distance². However, widening this segment of sidewalk should be considered as part of any capital project to address the noted condition issues, to provide a consistent 5-foot width in the corridor unless there are physical or right-of-way constraints.

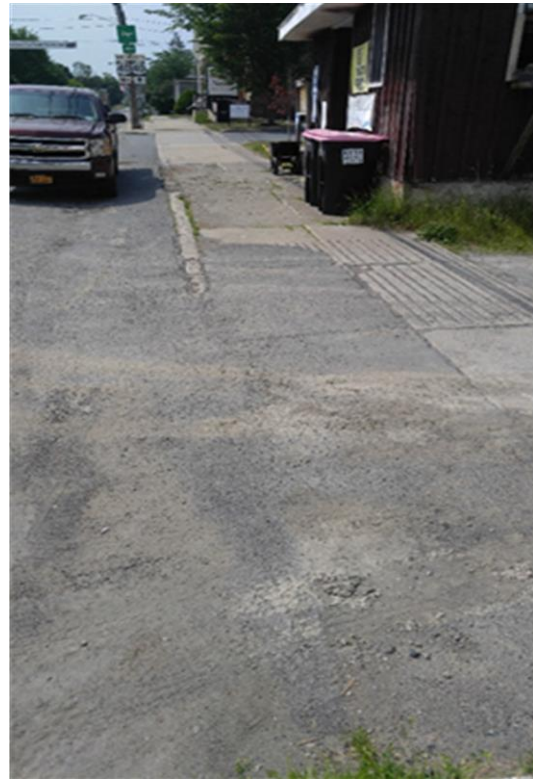
Sidewalk in front of 95 Main Street in poor condition

The tripping hazards associated with these conditions presents a potential safety risk for all pedestrians, but particularly for the elderly and persons with disabilities.

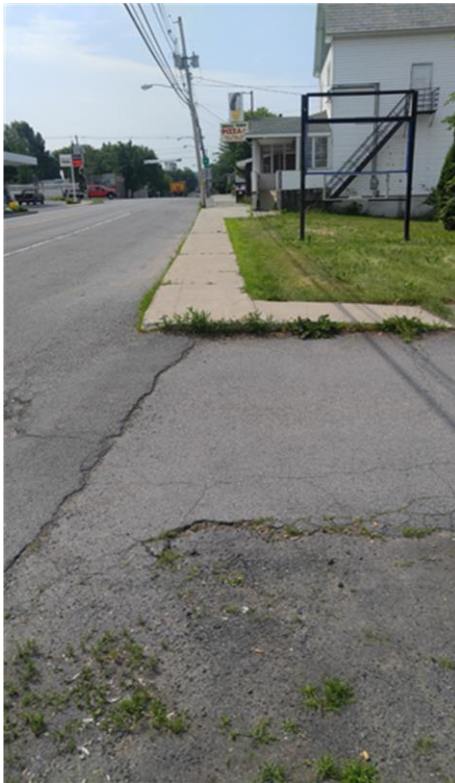
The sidewalk conditions noted above limit accessibility for pedestrians because of the uneven surfaces and cross-slope conditions. Additionally, there are no ADA-compliant pedestrian ramps at the intersection of NYS Route 197 and NYS Route 40 or along the NYS Route 197 sidewalk route within the

Missing ADA Ramp at commercial

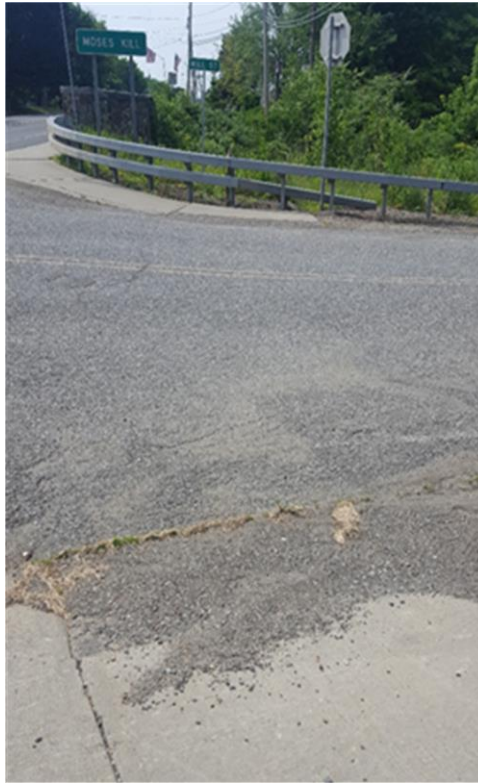
Detectable Warning Surface in poor condition

The existing sidewalk ramps located at Mill Street exceed the maximum recommended grade and cross slopes. Accumulated sediment was also observed on the sidewalk ramp landing. This could be caused by insufficient drainage that allows runoff from the surrounding area to collect at the sidewalk ramp landing. It was also noted that sidewalk ramps at multiple driveways were in poor condition or not provided. These conditions make it difficult for elderly and disabled pedestrians to navigate through this intersection, which reduces accessibility of the pedestrian network.

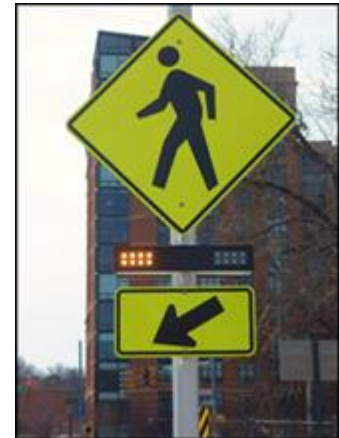
Pedestrian Crossing Signage with Rectangular Rapid Flashing Beacon (RRFB)

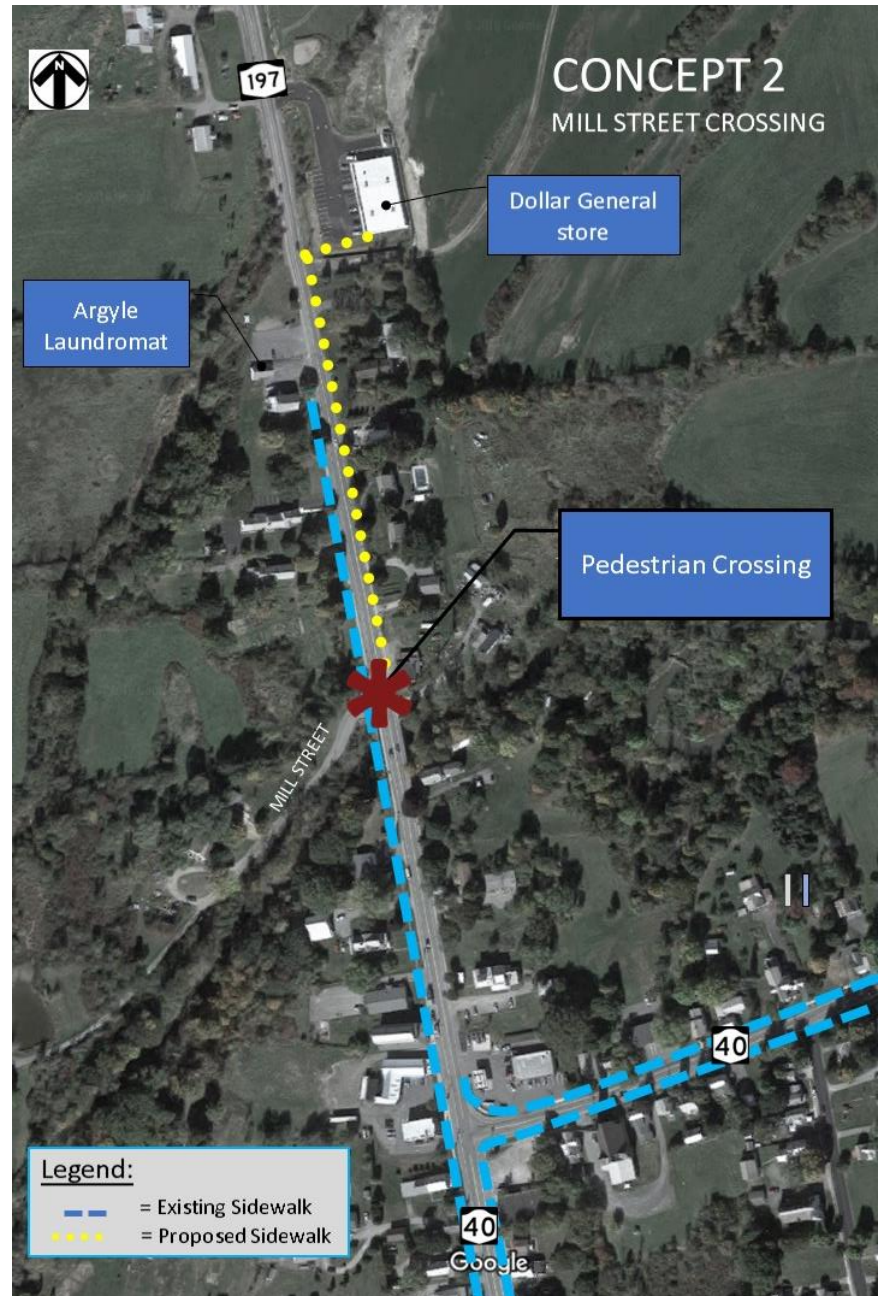
For the purposes of this study, a sidewalk along the east side of NYS Route 197 is presumed to be configured to be curbed to match the existing sidewalk on the west side, and to reduce the right-of-way needed. This concept would involve reconfiguration of the existing drainage gutter and catch basins and could have potential utility impacts. Right-of-way acquisitions and/or temporary easements would also be likely to address grading and driveway tie-ins. This concept increases the pedestrian accessibility in the corridor by extending the sidewalk to more properties along the east side of the road. Another benefit of this concept is that it provides additional distinction of the transition from the rural character of the Town to the developed character of the Village, which can help to induce better compliance of the Village speed limit. The cost of this concept is estimated to be \$355,000.

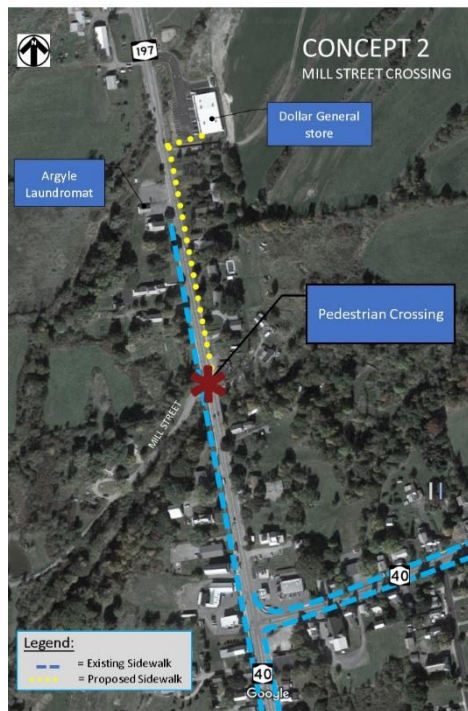
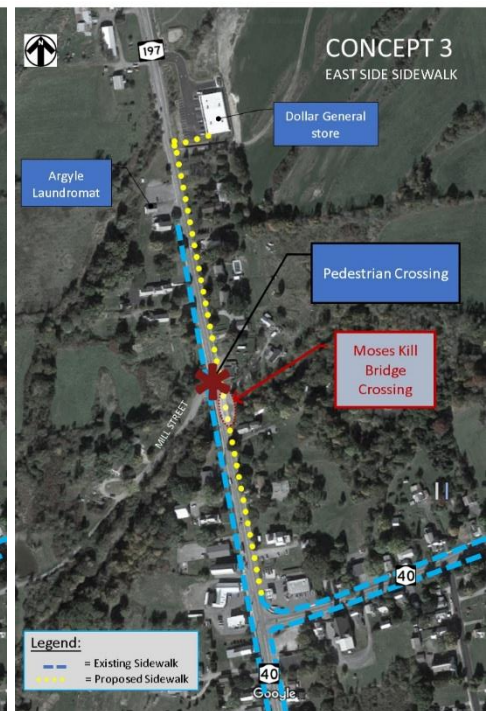
- Concept 1: Argyle Laundromat Crossing
- Concept 2: Mill Street Crossing
- Concept 3: Eastside Sidewalk

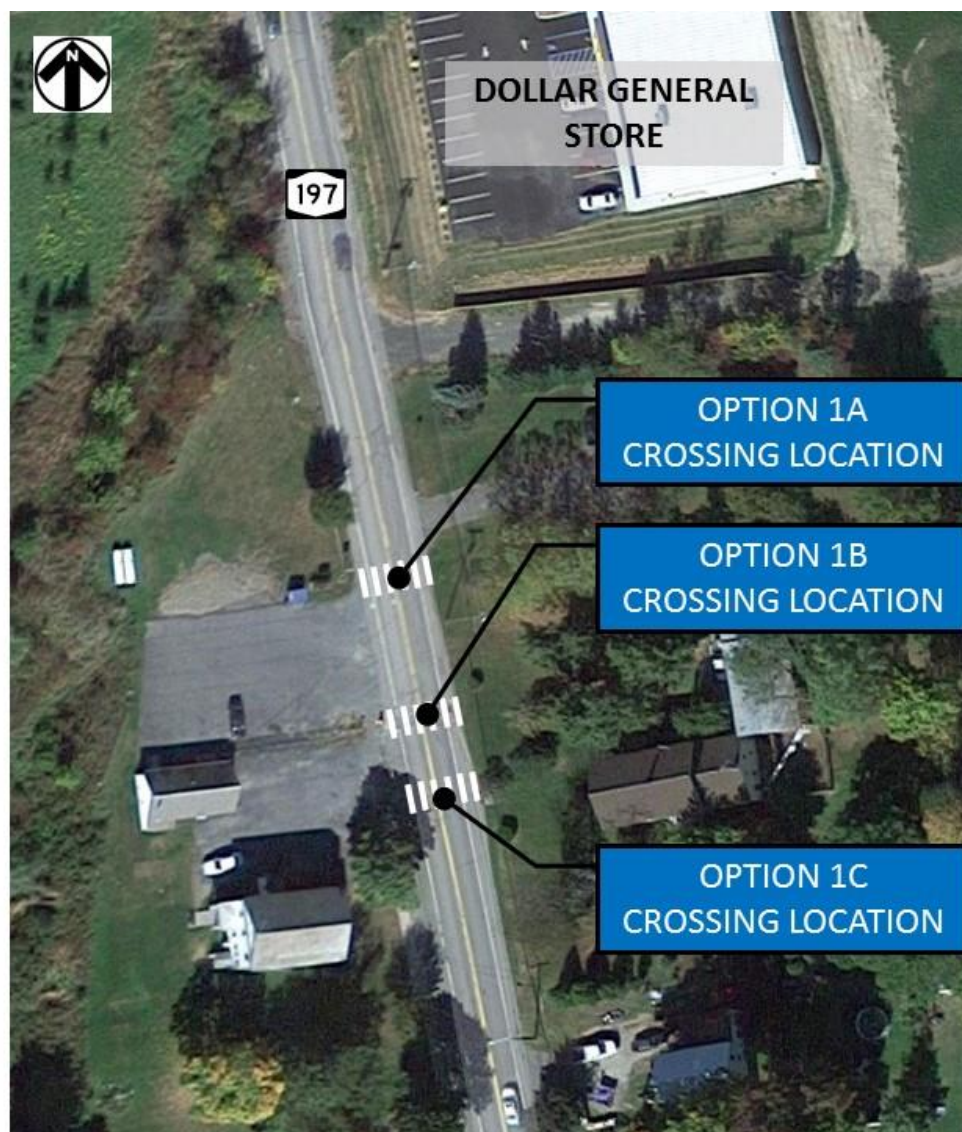
Concept 1 represents the lowest cost alternative, as it represents the shortest amount of new sidewalk and is the closest crossing opportunity to the Dollar General store. There are three potential crossing locations near the Argyle Laundromat that were identified (see below and Appendix C). Each location has different advantages and disadvantages related to pedestrian/driveway traffic interactions and sight distance because of the vertical curve of the roadway. The estimated construction cost of this concept ranges from \$170,000 to \$200,000, depending on which crosswalk location is selected. Crossing Option 1B is the preferred option for a crossing in the area of the Laundromat because this location maximizes the available sight distance. This option is also estimated to be the least cost (\$170,000), including RRFBs.
