Glen St./Sanford St./Grant Ave. Intersection Study

Memo To: Mr. Aaron Frankenfeld, Director
Adirondack/Glens Falls Transportation Council (A/GFTC)
11 South Street, Suite 203
Glens Falls, NY 12801

Date: September 13, 2022

From: Barton & Loguidice, D.P.C.

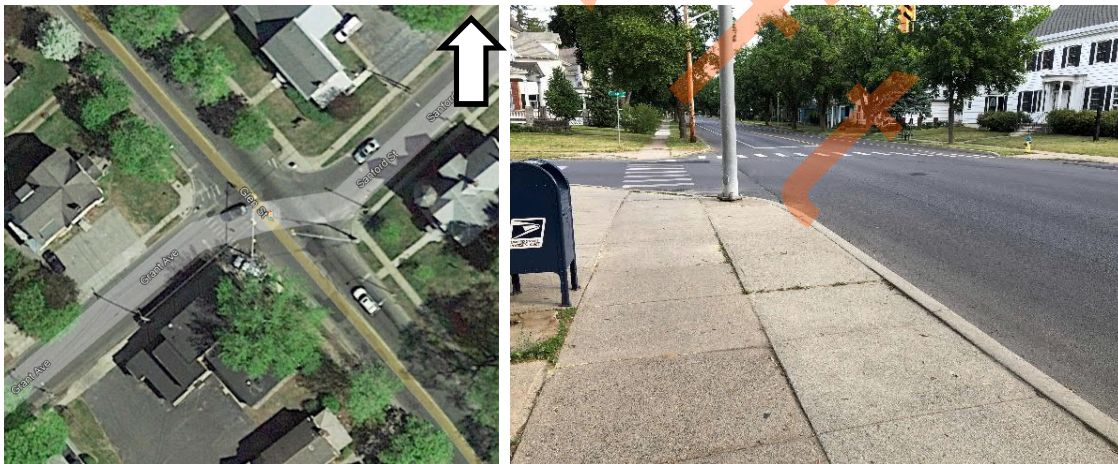
The intersection is signalized for vehicles but does not include pedestrian signal equipment. The Grant Ave. and Sanford St. approaches are offset from one another by approximately 25 ft. Sidewalks are located on all intersection roadway approaches with sidewalk ramps and crosswalks on the north, east and west sides of the intersection. The intersection signal operates in a basic fixed time mode with the minor approaches (Grant Ave. and Sanford St.) operating in the same phase. Glen St. southbound is provided with a leading green light interval, including a green left arrow for 15 seconds to allow turning movements onto Sanford St. After the leading interval, both the southbound and northbound movements have the green ball indication for the remainder of the signal phase.

Figure 2 – Glen St./Sanford St./Grant Ave. Intersection
Source: Google Earth Pro (aerial image)

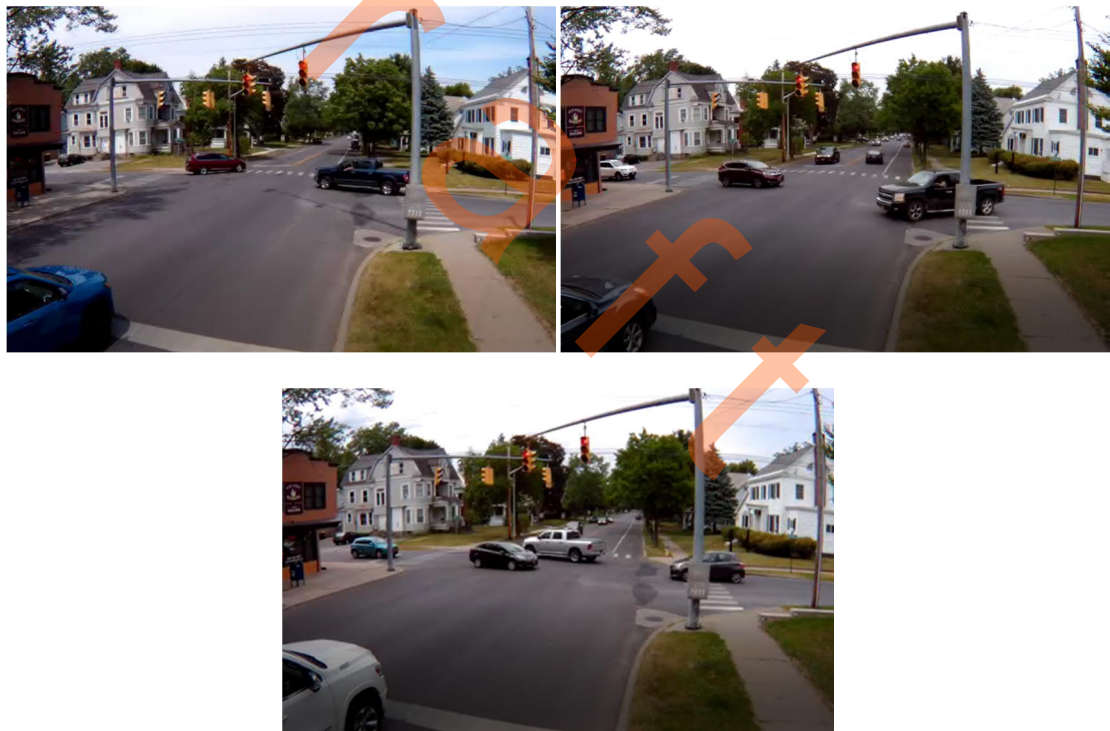
1. The Grant Ave./Sanford St. approaches are offset from one another by 25 ft. at their centerlines. This offset alignment creates confusion and hesitation for drivers making left turn movements from both approaches. There were several instances where the left turning vehicle accelerated out to make the left turn in front of the opposing through movement vehicle. This scenario was witnessed consistently through the observation period.

Figure 3.1 – Grant Ave. and Sanford St. intersection offset

- 5. Re-time and Phase the Traffic Signal: The traffic signal could be re-timed to place the minor approaches of Sanford St. & Grant Ave. on separate phases (this would operate similar to the Glen St. & Sherman Ave. intersection located 1,800 ft. south of this location). Although this split phase operation would increase vehicular delay at the intersection, it would also eliminate the confusion of the opposing offset left turning movements. As an additional benefit, this will allow the crossing guard two separate green phases for the side streets to better assist the students crossing the intersection. Also during the re-timing exercise, the all-red clearance time could be adjusted to allow an additional second or two of all red time before the next green light displays. To offset the additional time added to the cycle length with these changes, the City could also eliminate the 15 second, Glen St. southbound leading green interval and green arrow. It was observed that there did not appear to be a high volume of left turn vehicles for this movement.

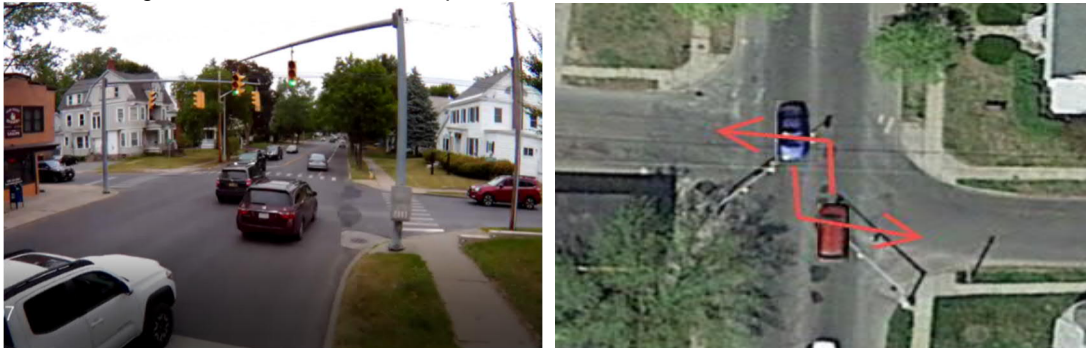
2. The Grant Ave. and Sanford St. offset alignment also creates a regularly occurring issue with Glen St. northbound and southbound left turn vehicles. The sketch below over the google aerial imagery depicts the scenario of the opposing left turn movements. Creating more confusion to the left turn vehicles, the through moving cars will go around the stopped turning vehicle as shown in the picture.

Figure 3.2 – Glen St. left turn movements

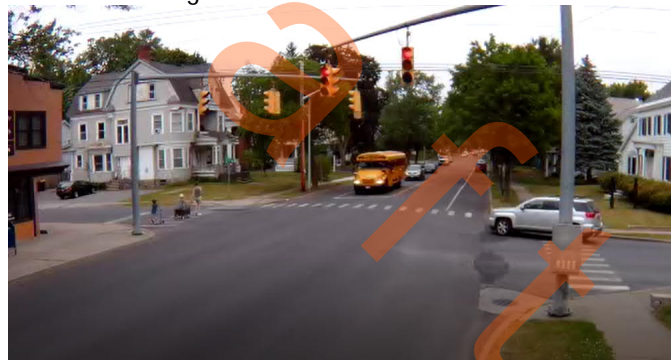
3. Although there were many pedestrians who did wait to cross the road at the correct time (parallel with green light traffic), there were also instances where pedestrians crossed whenever there was a gap in traffic, and some who misjudged their timing against the traffic signal resulting with vehicles that had to slow down or come to a stop. This could be a safety concern if there were an inattentive driver or pedestrian. Below is one example of a family crossing Grant Ave. although Grant Ave. and Sanford St. vehicles have the green light.

Figure 3.3 – Pedestrian crossing without the right of way

3. Install the Pedestrian Cross Only on Green sign (MUTCD # R10-1). This sign will reinforce to the pedestrians that they need to wait for the green traffic signal corresponding with their direction of travel before using the crosswalk. These signs should be mounted near the sidewalk ramps and clearly visible to the pedestrians.

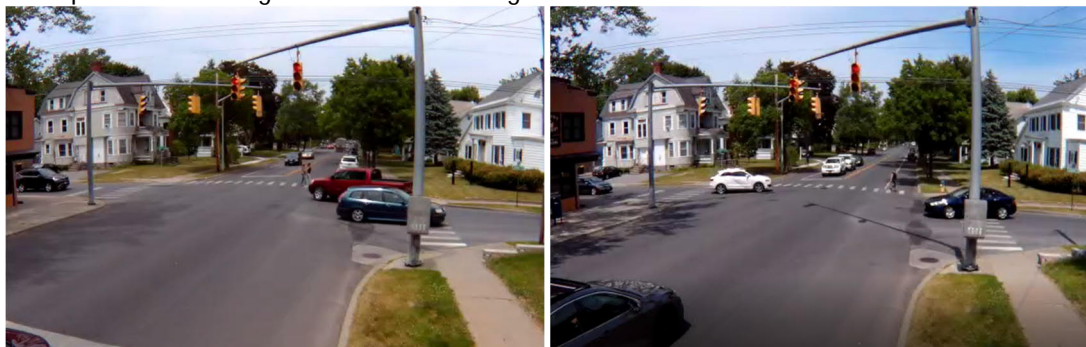
4. Some turning vehicles did have to wait for pedestrians to cross the intersection which is typical at all intersections without dedicated pedestrian signal phases. This is another example of something that could be a dangerous situation if there was a distracted driver.

Figure 3.4 – Turning vehicles with pedestrians crossing

2. Install Turning Vehicles Yield to Pedestrians (MUTCD # R10-15) signs on all intersection approaches (with the exception of Grant Ave. if the Glen St. southern crosswalk is not installed), see Figure 4.3 below. Overhead installation on the signal mast arm will be most effective. Due to the unknown foundation conditions and age of the signal equipment, an analysis of the structural (overturning “moment”) capacity of the footings could not be completed. It is suggested that these signs are installed on the signal poles or roadside rather than installed overhead. If the traffic signal is replaced in the future, these signs can be relocated overhead.

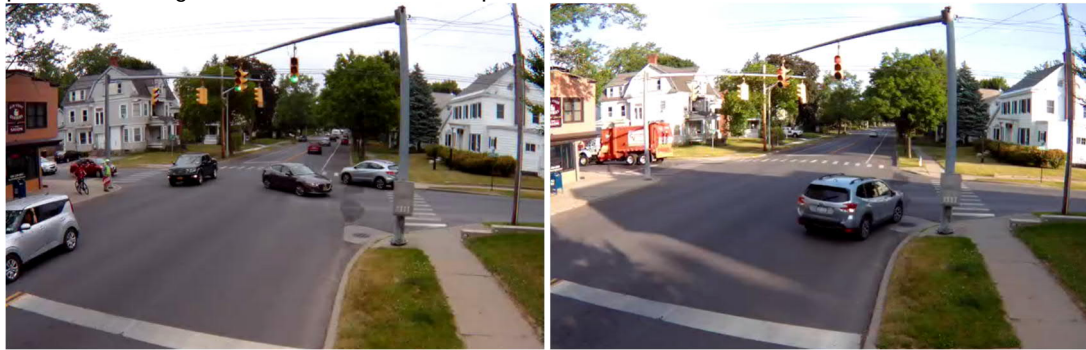
5. Numerous right turn on red movements were observed throughout the data collection period, although there were no vehicle/pedestrian conflicts or near misses witnessed.

Figure 3.5 – Right turn on red movements

1. Install No Turn on Red (MUTCD R10-11 series) signs on all approaches. Although the observations performed during this study did not witness any conflicts with right turn on red vehicles, conflicts with these movements were brought up as a concern from the local crossing guard and the City's Police Department. To aid in restricting and discouraging these movements, a No Turn on Red Sign should be installed roadside near the stop bar. An additional time-of-day plaque may also be placed below the sign to indicate that the restriction is only in place during certain time periods.

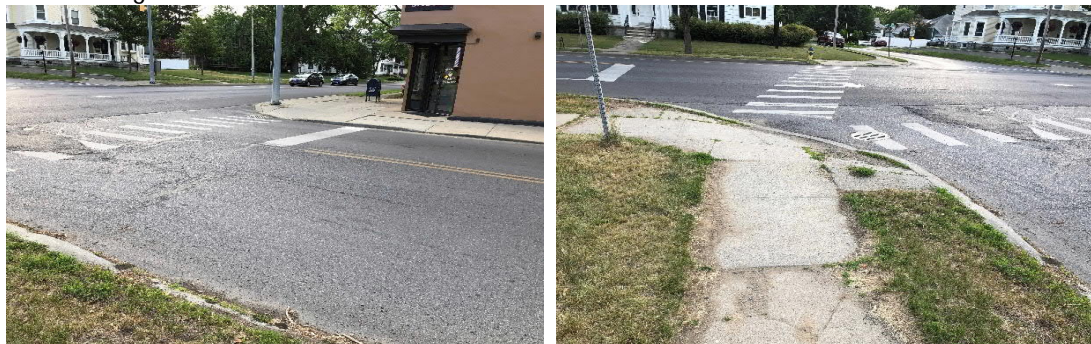
7. The sight distance looking right on the Grant Ave. approach is limited due to the building on the south corner of the intersection being close to the road. A vehicle at the stop bar can see to the right, but sight lines from cars behind the lead car are obstructed by the building.
8. Pavement striping – Existing striping is faded and not visible in some locations.
9. Curb ramps – The existing curb ramps do not meet current ADA requirements. The ramps do not include detectable warning units, there are drainage structures located at the base of the ramp, and the positioning of the ramps do not line up with the crosswalk direction, as shown in Figure 3.3.

Figure 3.7 – Intersection striping and sidewalk ramp condition

4. Re-Striping the pavement would aid in guiding vehicles through the intersection and bring a greater awareness and attention to the crosswalks.
 - a. High Visibility Crosswalks should be installed at this intersection to provide improved driver awareness of the pedestrian crossing locations. The crosswalks include the addition of two transverse lines to the perpendicular ladder bars that are on site currently as shown in the figure below. The pavement markings should be Epoxy paint with glass bead for retro-reflectivity or retro-reflective thermoplastic pavement marking tape.

8. Reconstructing the curb ramps to meet current ADA requirements, provide new detectable warning units, relocate drainage structures, and provide a continuous smooth transition between the sidewalk and road surface.

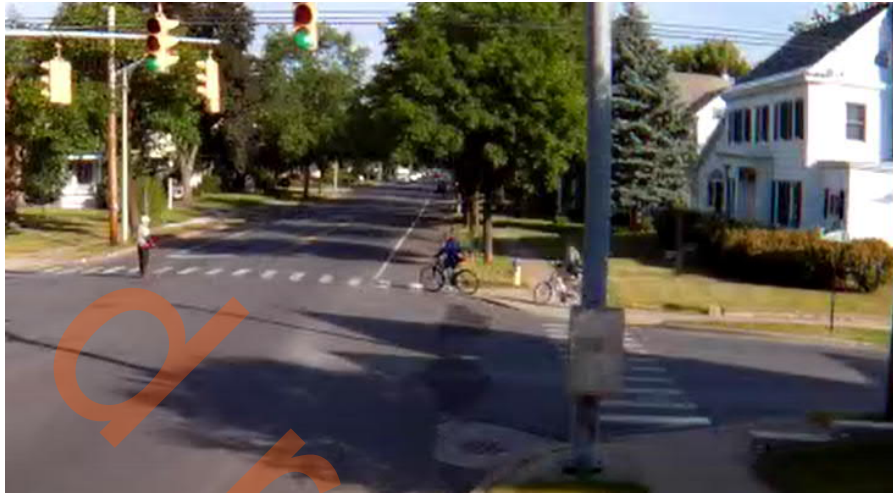
10. There was a high volume of bicycle traffic through the intersection during the observation period, which was expected due to the nice weather in June and the school aged children going to and from school. Bicyclists were often observed utilizing the sidewalk, sidewalk ramps, and crosswalks to travel through the intersection. Although bicycles on sidewalks are not encouraged, the majority of these bicyclists were students and may not be comfortable riding in the road with vehicles yet.

Figure 3.8 – Bicyclists using the sidewalk

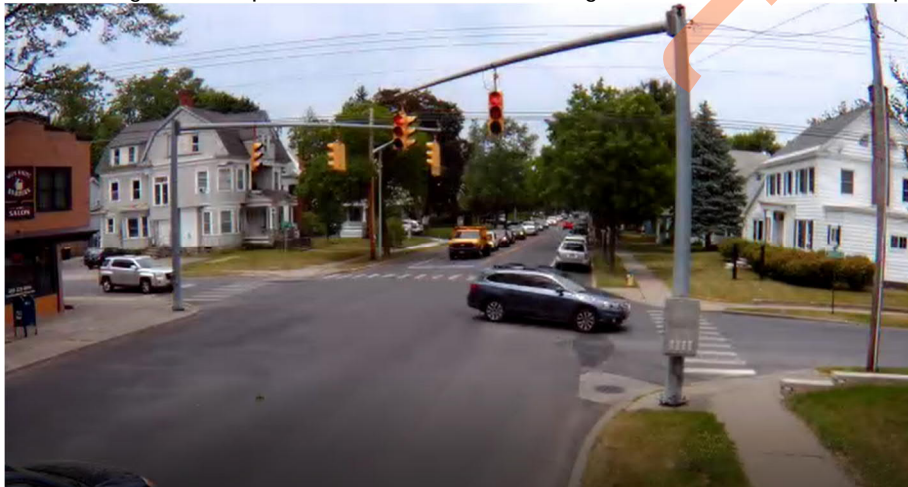
11. Several bicycles did not stop for the red light and cut in front of oncoming vehicles. It is noted that these instances happened outside of the school crossing hours.
12. The existing signal system appears to be operating effectively for the majority of the day, where all vehicles at the intersection are served by the signal during one full cycle length. There were a couple of time periods in the afternoon where longer queues of vehicles were witnessed on Glen St. that backed up several hundred feet as shown in the figure below. After clearing out the queue, the traffic flow and signal returned to normal operation.

Figure 3.9 – Glen St. southbound long queue

7. Vehicular Detection and Pedestrian Signals could be installed and are compatible with the existing traffic signal equipment. Wireless detection sensor units (“pucks”) are the most reliable and easily installed detection equipment that would be feasible at this location. The introduction of detection will allow the signal controller to be re-timed to operate under actuated control (adapt to the demand of the traffic). The actuated signal also allows the introduction of pedestrian signals and pushbuttons, with the pushbuttons acting as the sensor for pedestrian demand. Using actuated control will optimize the intersection operation allowing the pedestrian phases to be skipped if there are no pedestrians. The pedestrian signals will also bring an additional awareness to drivers that pedestrians are present here at this intersection. The pedestrian signals and pushbuttons would also be utilized by the crossing guard rather than following the parallel green light movement only.
