DRAFT Feasibility Report

Old Fort Edward Junction Locks Trail Extension

Prepared for:
Adirondack | Glens Falls Transportation Council

Revision 1
August 2023

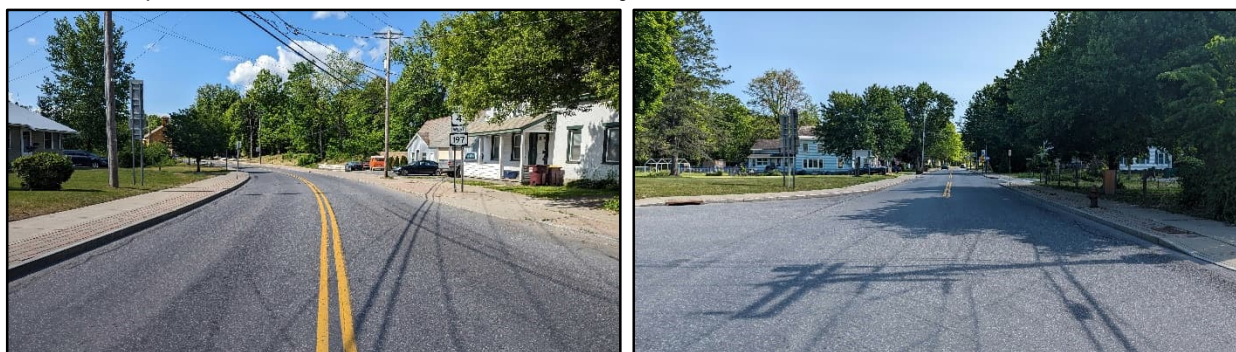
Figure 2-1: Broadway Looking North and South at the Argyle Street Intersection

Broadway is curbed on both sides and currently has a centerline double-yellow pavement stripe with no edge lines. The pavement width is 27 ft. with 13.5 ft. between the curb and the centerline which constitutes a wide-curb lane according to the NYSDOT Highway Design Manual Chapter 2 to accommodate vehicles and bicyclists.

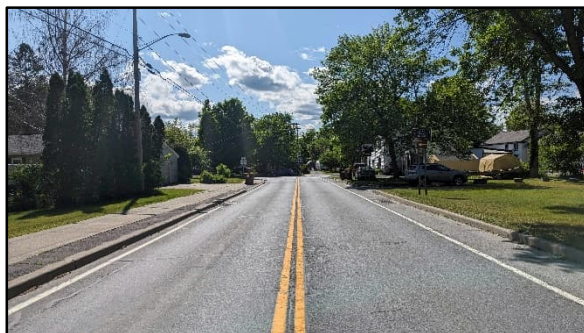
Figure 2-2: Argyle Street Facing East Towards Broadway

Argyle Street consists of two 11 ft. travel lanes in both directions delineated by white edge lines and a center double-yellow line with a 4-ft. shoulder on the north side and a 1-ft. shoulder on the south. Both sides of the roadway are curbed, and the Right-of-Way width is approximately 56 ft., with approximately 25 ft. of available ROW on the north side of roadway between the curb and the ROW boundary.

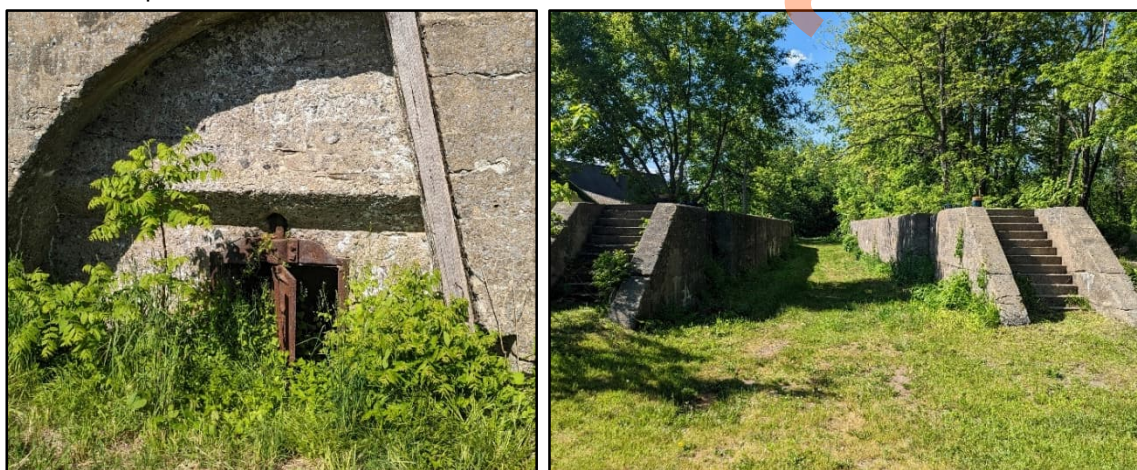
Figure 2-3: Existing Canal Junction Lock Infrastructure

The existing junction lock walls are 19 ft. wide on the southern portion of the structure, then widen to 42-50 ft. on the northern portion where the structure intersects with Bond Creek. The wide section of the lock structure has a concrete slab base that is relatively level. The concrete walls are approximately 8 ft. tall and in good condition. Some of the steel hardware, such as tie-off straps and valve doors, are still intact. See photos below.

Construction debris has been disposed of within the structure walls over the years, such as granite curb pieces, bluestone sidewalk slabs, various other rubble, and plastic sewer pipes. There are also other lock infrastructure remains at the intersection with Bond Creek, such as block retaining walls, a stone arch bridge that carries the towpath on the east side, and another bridge like structure on the west. The northern bank of Bond Creek is contained by a block retaining wall and the southern bank appears to also be contained by a retaining wall as well, but this wall has since collapsed into the creek. There is minor vegetation growth within this area as it appears that it is regularly mowed and maintained. North of the Creek, heavy vegetation overgrowth has enveloped the area between the lock walls, which appear to be mostly intact. The lock structure ends at the southern terminus of Canal Street, adjacent to the Mills Apartments.

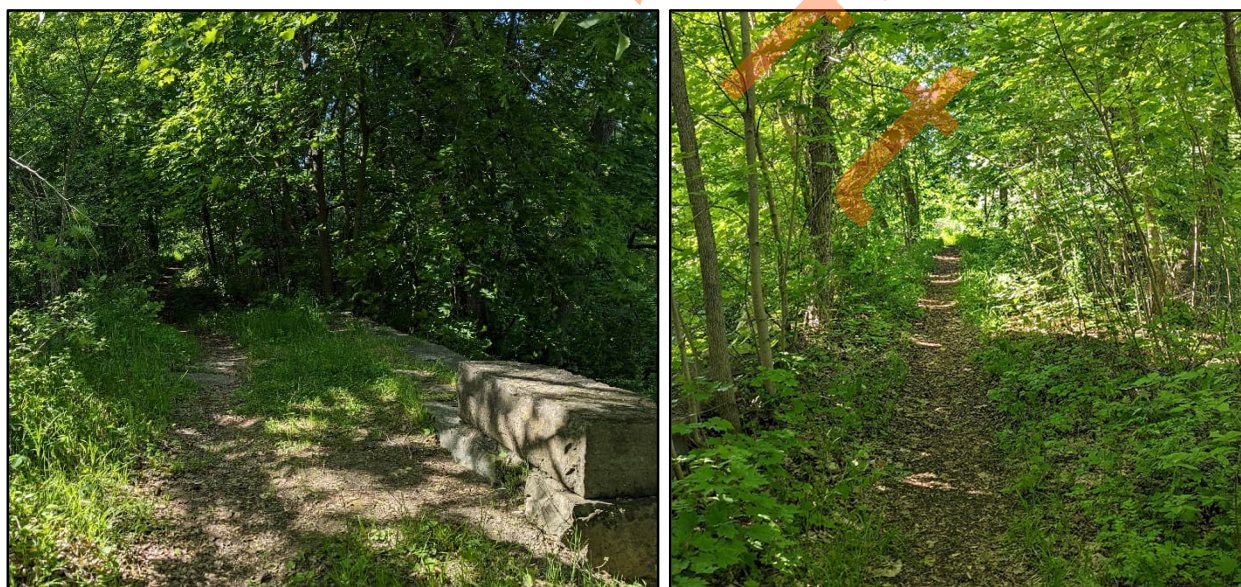
Figure 2-4: Existing Conditions of Adjacent Towpath

The towpath on the east side of the lock structure is directly adjacent to the lock wall and can be accessed from the parking area off Argyle Street via a path just east of the structure. The path rapidly climbs 8 ft. in elevation to become level with the top of the lock walls. The path begins on a narrow plateau that is 8 ft. in width from the concrete wall to the top of bank and is heavily overgrown. The width of the plateau gradually increases in width to approximately 14 ft. Continuing north, the path then crosses Bond Creek over the existing stone arch structure. The path then continues in similar conditions to the southern terminus of Canal Street. See photos below for representative photos of the existing towpath.

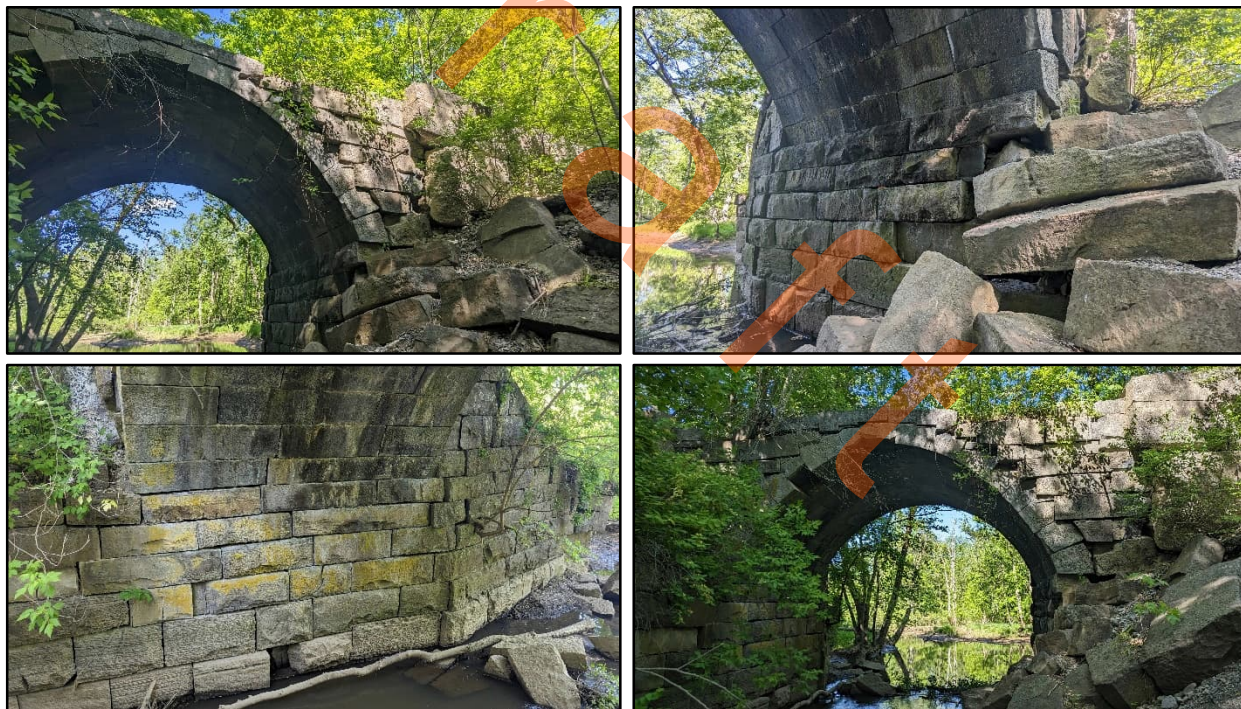
Figure 2-5: Existing Conditions of the Stone Arch Bridge

An existing stone arch bridge carries the towpath over Bond Creek approximately 400 ft. to the North of the Argyle Street entrance. Record documents indicate that this bridge was built in 1830 as part of the Champlain Canal and the lock/gate system. The existing bridge consists of a dry-stacked stone arch with stone abutments, wingwalls and spandrel walls. The stone wingwalls tie-in to the existing stone/concrete walls along the creek and the remains of the canal structure.

A full structural assessment of the stone arch bridge was completed by the Village in May 2022 and can be found in Appendix C. Overall, the arch bridge is in poor condition with several areas of the stone structure that have partially failed. The stone abutment at the southwest corner of the bridge has partially failed with areas of voids, shifted and cracked stones. This condition at the abutment is resulting in loss of compression continuity in the arch stones as evidenced by displaced and missing stones along the east and west fascia and spandrel walls. There are also several areas of the wingwalls that have missing stones and voids and the walls are displaced or bulging toward the creek. The structural assessment indicates that while the bridge appears to be stable at this time, the degradation will continue over time and could result in partial or complete failure of the bridge making it "unsafe for public access in its current condition".

- The existing Stone Arch structure needs significant rehabilitation efforts to be improved for public use. It is noted that these repairs are short-term (10–15-year service life) structural repairs and do not consider historic restoration or historic preservation of the structure (if that is requested by the State Historic Preservation Office):

- Remove stones and debris from the waterway
 - Clear trees adjacent to bridge to alleviate additional tree root damage to structure
 - Re-point joints and cracks in masonry substructures

- Replace and grout missing stones along arch, spandrel walls and substructures
 - Grout voids in the southeast abutment along the creek
- The Arch structure is 11 ft. wide and will require railings to be installed along both sides.

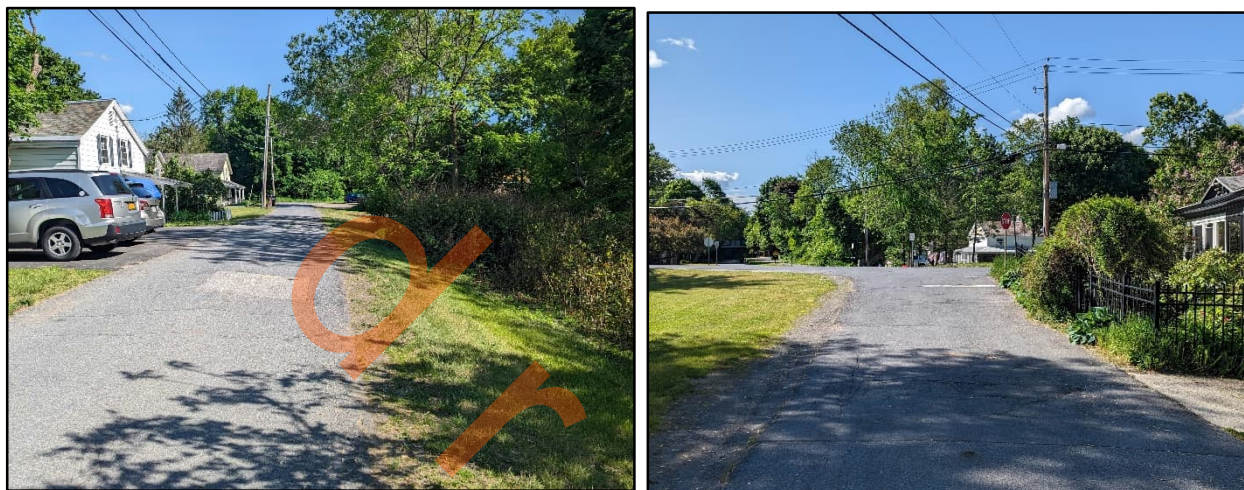
Figure 2-6: Existing Conditions on Canal Street

Canal Street is a dead-end local Village roadway with approximately 12 ft. of available pavement width. There are currently no sidewalks or curbing. The roadway provides access to five residences and has a ROW width of approximately 60 ft. There is approximately 42 ft. of ROW width between the western edge of pavement and the ROW boundary. Existing traffic volumes are not available on the NYSDOT Traffic Data Viewer but is assumed to be a very low volume road only providing access to the five residences.

As discussed in section 2.4, Canal Street is a low volume dead-end local roadway that provides access to five residences. In accordance with the EST Guidelines, Canal Street is classified as a Walk/Bike Roadway which is a very low volume road (fewer than 400 vehicles per day) that is designed to serve pedestrians, bicyclists, and vehicles all within the asphalt roadway area. Due to the low volumes and narrow widths, centerlines should not be marked. Regular pull-off areas to allow for passing event should be provided and is accomplished on Canal Street by the existing driveways and the gravel parking area near Notre Dame Street. Canal Street is recommended to be signed with Share the Road signs as well as the EST assembly.

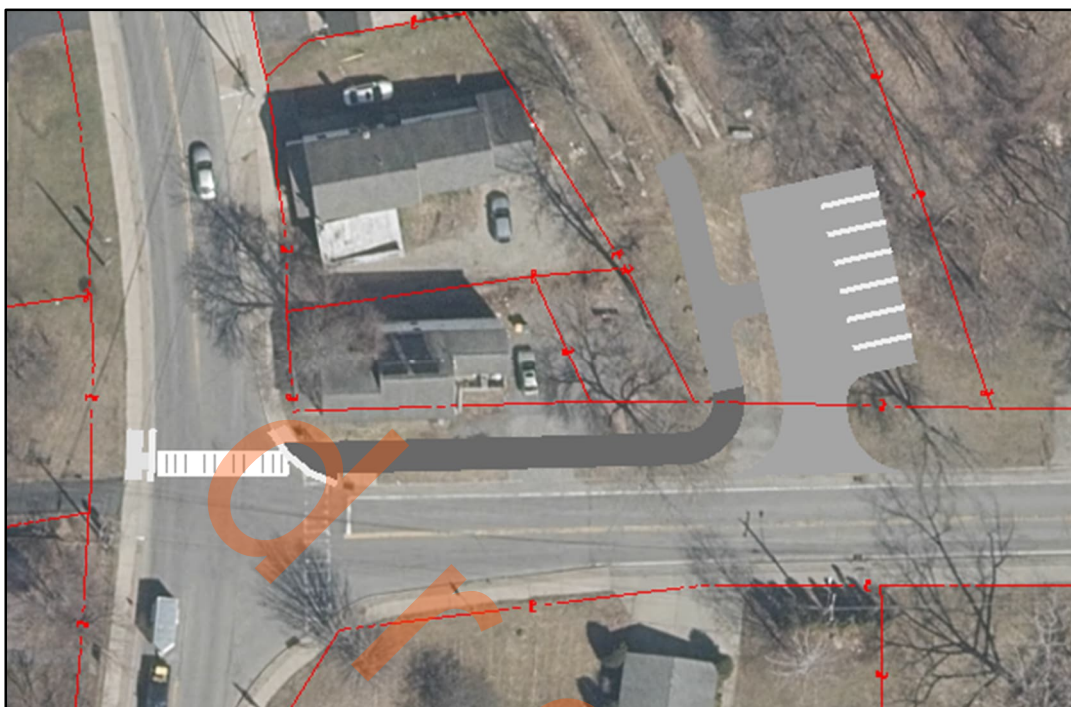
Figure 3-1: Proposed Southern Connection to the EST

The concept shown in figure 3-1 includes a formalized gravel parking area with a new driveway shifted east on Argyle Street to provide direct route for the shared-use path to transition from Argyle Street to the off-road alignment. The minimum available ROW within the Village owned parcel is 85 ft., providing an opportunity to increase the area for vehicle parking.

To connect the southern entrance of the off-road trail to the EST along Broadway, installing an asphalt paved or concrete 10 ft. wide multi-use path on the north side of Argyle Street is proposed. The 175 ft. long path will start in the northeast quadrant of the intersection and extend along Argyle Street where it would meet the existing gravel parking area. From this point the alignment would turn north and become the off-road Junction Locks trail. A durable, impervious surface adjacent to Argyle Street, such as asphalt or concrete, is recommended for use within the NYSDOT ROW to reduce maintenance costs and increase service life. A buffer of 2-4 ft. between the existing curb and the path should be used to provide snow storage and a buffer between the active roadway for pedestrians and cyclists.

The multi-use path on the north side of the roadway can be constructed within the available 25 ft. of ROW and will provide simple access for both pedestrians utilizing the sidewalks and bicyclists utilizing the shared lanes along Broadway. However, consideration should be given to the property adjacent to this proposed portion of the trail. The property is a rental property that has the potential for several cars to park in the adjacent driveway. Potential options to reduce the impacts to the adjacent property on the north side of Argyle Street could include a reduction in the shoulder width on the north side of Argyle Street to 1-ft. to match the southern side. The NYSDOT HDM states that the minimum allowable shoulder width on curbed Urban Arterials with no accommodations for bicyclists may be 0-ft. Additional mitigation measures include installing vegetation screening between the new path and the building, or fencing to shield the view between path users and the residents. If this option is pursued for construction, the design team should consult with the Village and the property owner to make sure that the proposed plan is conveyed and what changes will be made.

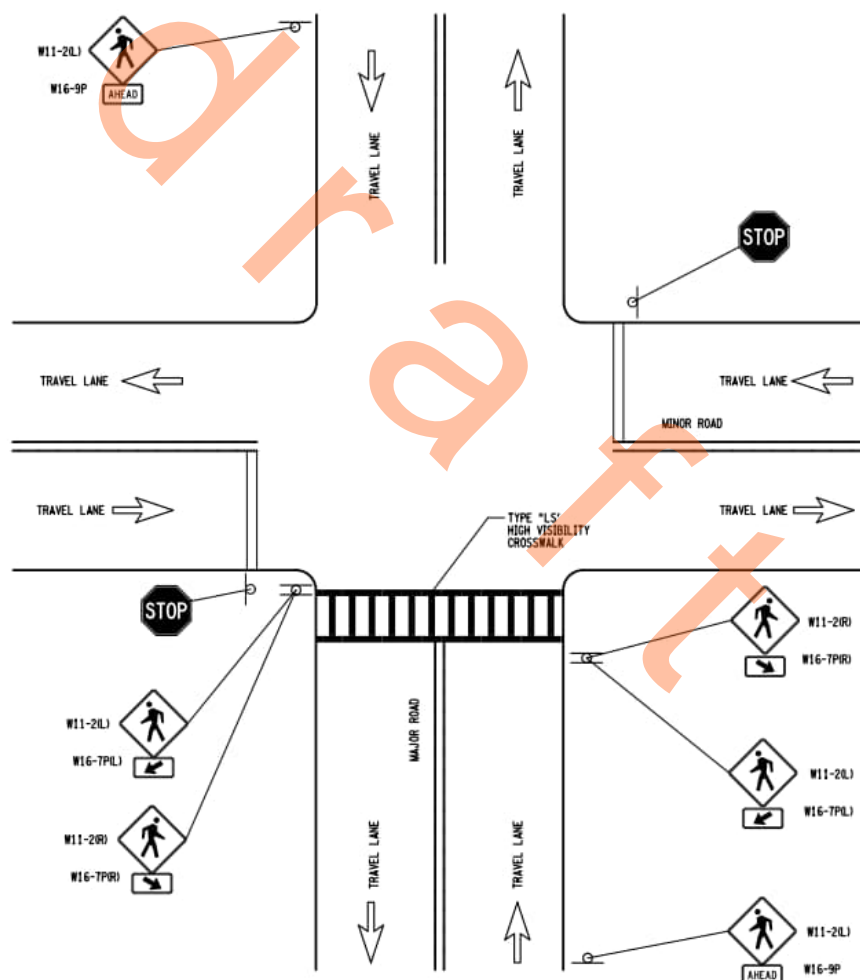
Source: NYSDOT TSMI 17-07 PSAP Countermeasure Details, Drawing UC-2, Detail 3
Figure 3-2: Sign plan for Uncontrolled Crosswalks at Intersections

For the proposed crossing of Broadway, the EST Guide lists a marked and signed crosswalk and Rectangular Rapid Flashing Beacons (RRFB) as the desired treatment. Several additional treatments could also be used based on engineering judgement. As a minimum treatment, ADA compliant features such as curb ramps and detectable warning units should be installed at the crossing and advanced pedestrian crossing signage and pavement markings should be installed on Broadway in accordance with Figure 3-2. The warning signs should be fluorescent yellow-green and should include the retroreflective signpost strip and the crosswalk should be "NYSDOT Type LS" that includes parallel stripes and ladder bars to enhance visibility.

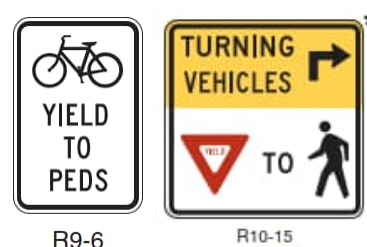
Figure 3-3: Additional crossing signage options

Additional signage that should be installed at this crosswalk location include an R10-15 ("Turning Vehicles Yield to Pedestrians") sign which reminds vehicles that are turning right from Argyle Street to yield the Right of Way to pedestrians in the crosswalk. Another sign that should be installed on the multi-use path at the crosswalk is an R9-6 sign which reminds cyclists that pedestrians have the right of way within a crosswalk and on the multi-use path, or to remind cyclists that may be on Broadway that they need to yield to pedestrians within the crosswalk.

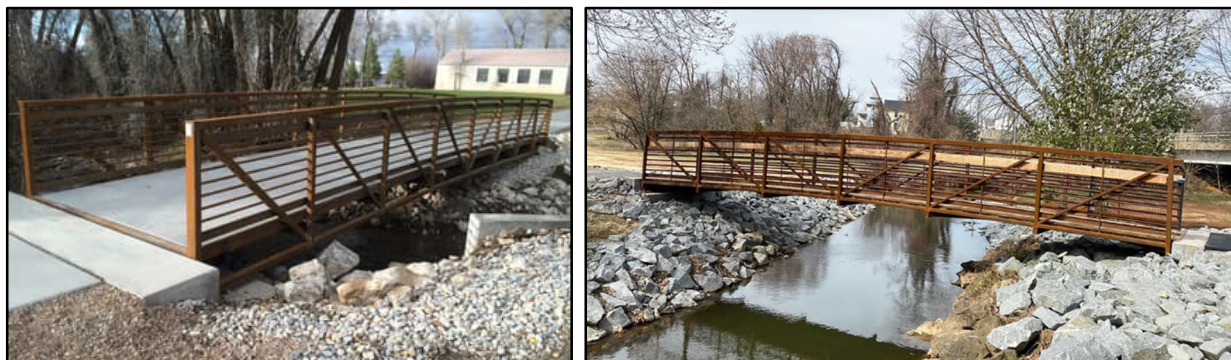
Figure 3-4: Potential Bond Creek Bridge Option

The major constraint to this alternative is the crossing of Bond Creek. There is currently no bridge in this location and no obvious alternative to cross the creek using the existing infrastructure. A pre-fabricated steel or concrete pedestrian bridge could be installed at this location to carry the trail over the Bond Creek. The prefabricated bridge would have a span length of approximately 30 ft. to cross the natural banks of Bond Creek. The steel or concrete bridge superstructure would be supported on concrete footings and abutments. The bridge would carry a width of 10 ft. to match the trail on the approaches and would include pedestrian railing along both sides.

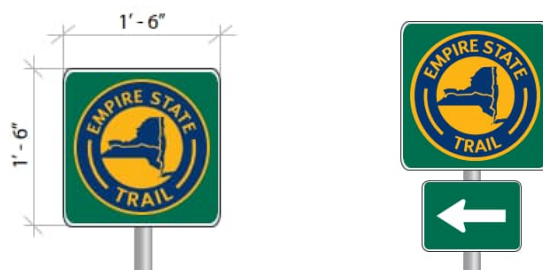
Figure 3-6: EST Wayfinding Signs

The Village's goal for this trail is to shift the existing alignment of the EST along Broadway and Notre Dame Street to this primarily off-road trail. All proposed wayfinding signage should be consistent with the EST Guidelines and will consist of the EST confirming/reassurance assembly that should be placed just beyond intersections or locations where a turn has been made. Also, the Route Sign Assembly with Auxiliary Arrow Panels will be used to indicate directional changes in the route.

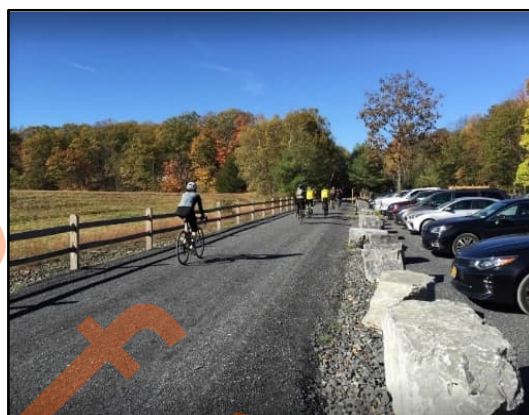
Ashokan Rail Trail, Ulster County, New York

Crushed stone aggregate surface course that is bound by clay particles has proven to be successful in demanding environments and the natural materials of this surface course appeals to the environmental setting of this project. Examples of this durable stone course system use includes NYS OPRHP Minnewaska State Park, the Rockefeller State Park Preserve, and the Ashokan Rail Trail in Ulster County.

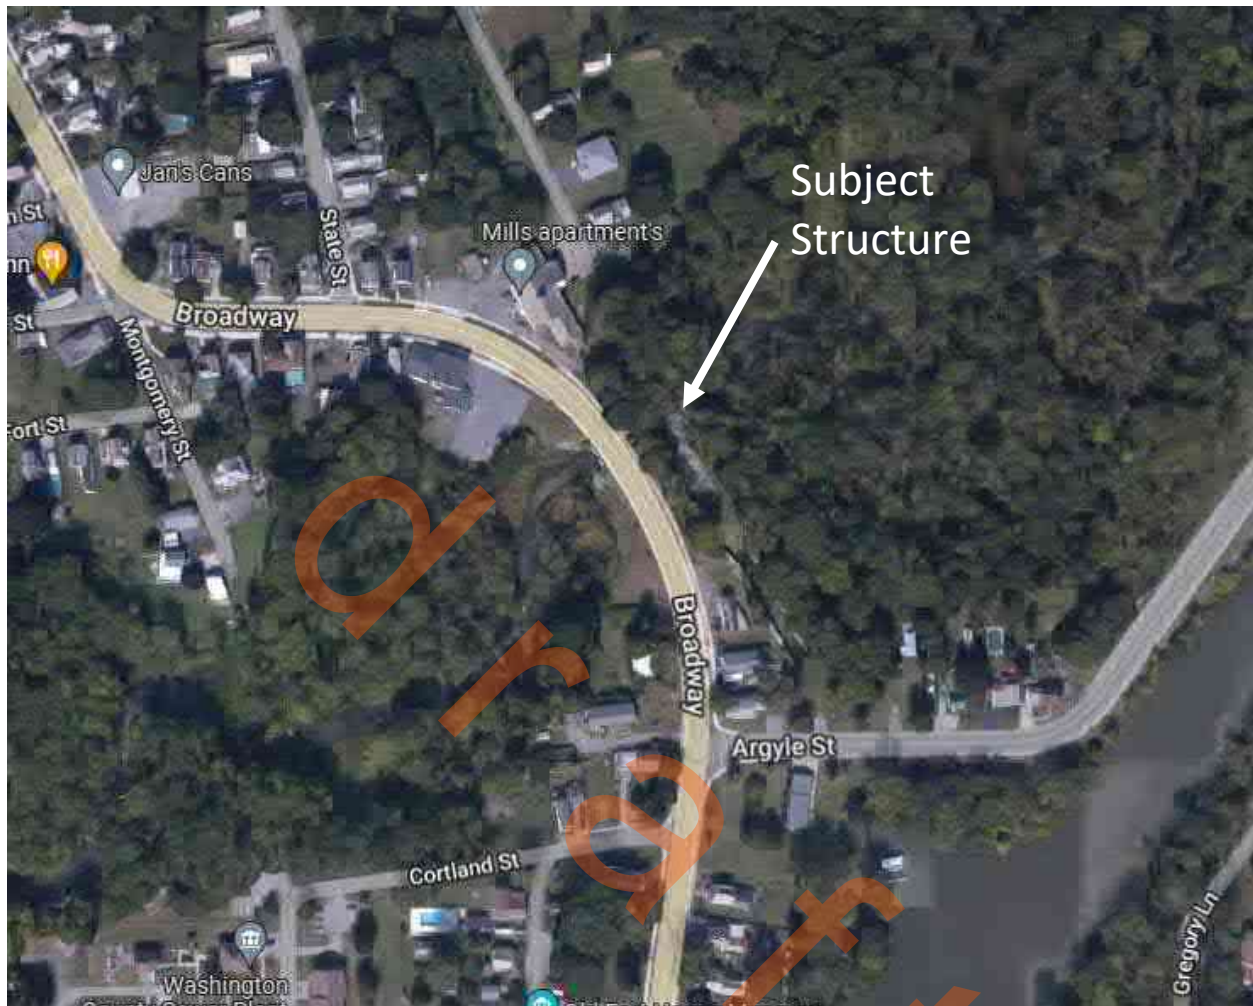
The subject structure is located approximately 400-feet north of the intersection of Argyle Street and Broadway and approximately 100-feet to the east of Broadway spanning "Little Wood Creek" in the Village of Fort Edward, Washington County, New York New York (project site). The subject structure is adjacent to an existing concrete foot bridge and a vehicular bridge along Broadway.

Figure 1: Aerial View of the Project Site
(Aerial Photograph taken from google.com/maps)

An overview photograph (aerial view) of the project site is provided in Figure 1.

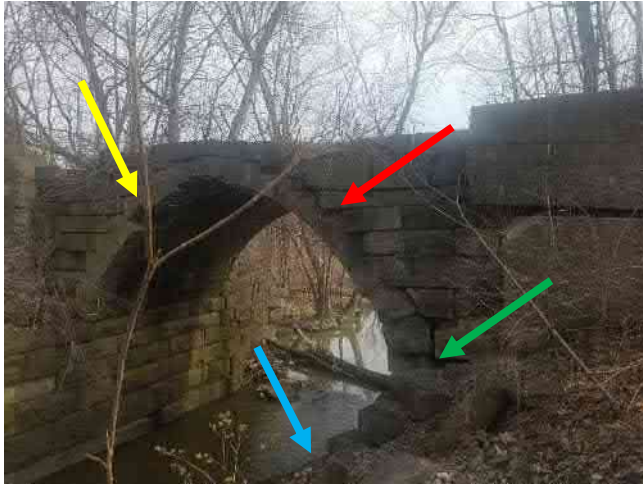
1. The abutment and wing wall has partially failed at the southwest corner of the bridge (outlet). Abutment stones have fallen into the creek, there are voids within the abutment, and stones have shifted and cracked. Reference Photographs #1, and 4-7.

Photograph (1): General view. West Elevation (outlet). Displaced stone (red arrow), voids in abutment (green arrow) missing stone (yellow arrow).

2. One stone is missing / broken within the primary arch along the east elevation. Reference Photograph #1 and 8.
 - a. This missing piece of stone (in addition to the displaced arch stones along the west elevation) is likely due to the displaced stones and voids at the southwest abutment. As the abutment continues to erode and settle, additional shifting (sagging) of the arch and loss of compression continuity is expected which can lead to progressive or catastrophic failure.

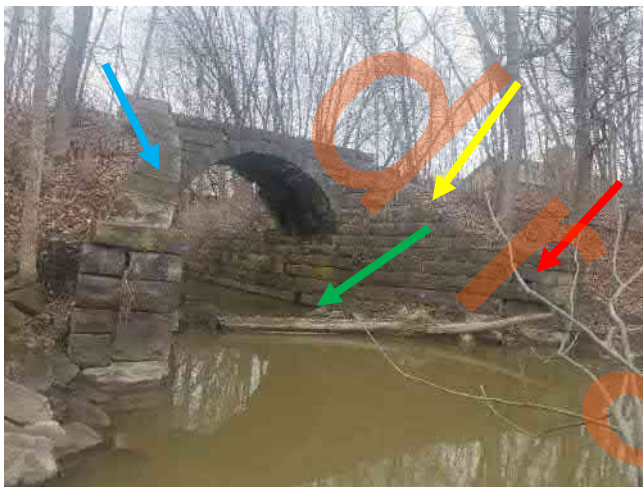
Photograph (2): General view. East Elevation (inlet). Debris restricting flow. Displaced stones (red arrow). Leaning / bulging wing wall (blue arrow). Missing cap stones (yellow arrow). Missing stone / undercut at north abutment (green arrow).

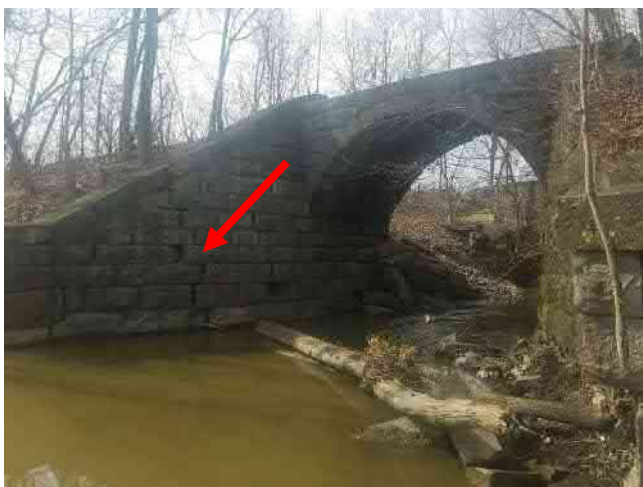
4. The southeast wing wall has displaced toward the creek (bulging) resulting in gaps and cracks in the wall. Reference Photograph #3. This condition is not directly impacting the stability of the bridge but may lead to progressive failure and slope erosion.

Photograph (3): General view. East Elevation. Displaced stones.

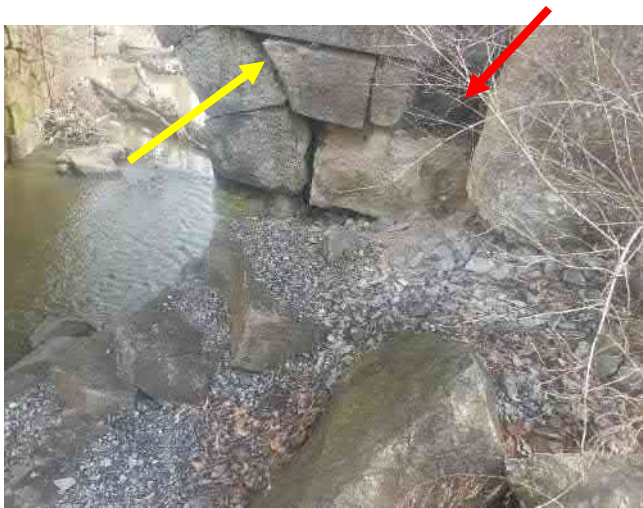
Photograph (4): Void within southwest abutment (red arrow), displaced stones (yellow arrow).

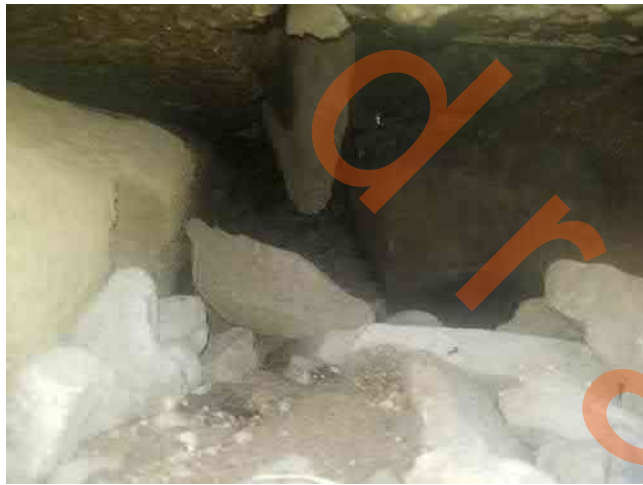
Photograph (5): Closeup view of void at southwest abutment as shown in Photograph #4.

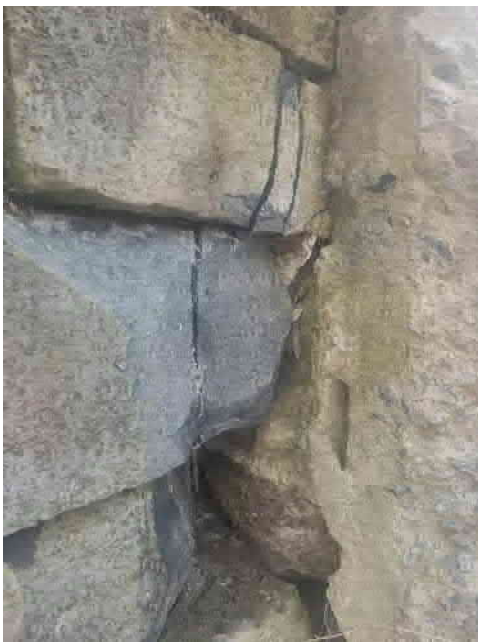
Photograph (6): Cracked stones at southwest abutment.

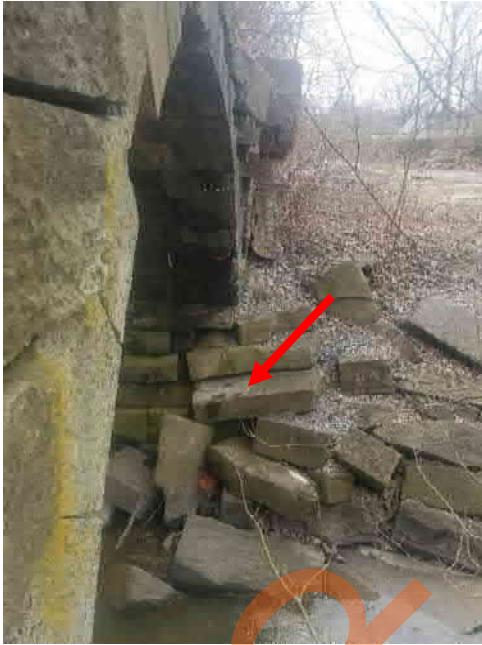
Photograph (7): Displaced stones / voids at southwest abutment.

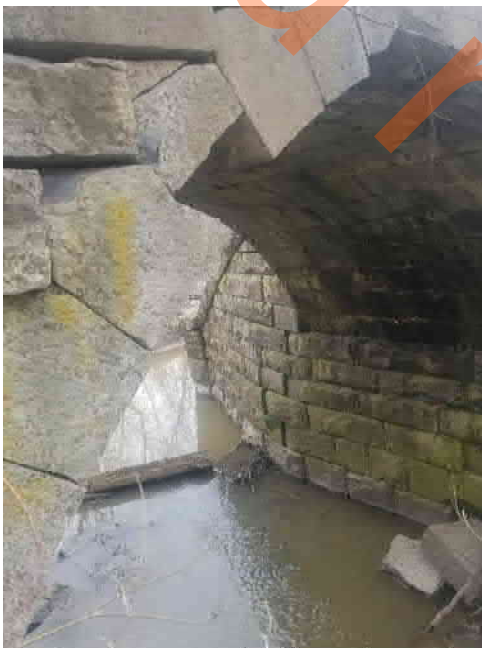
Photograph (8): Missing / displaced stones along the west elevation.

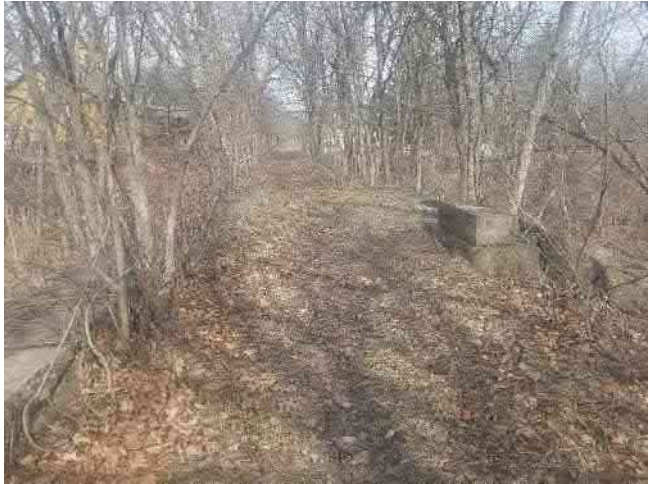
Photograph (9): View of trail along top of bridge. Vegetation / trees growing along bridge.

5. The bridge deck was not observable as it was covered with soil and vegetation including small trees. Tree roots can cause significant damage to structures as they grow and put pressure on joints and allow moisture infiltration. Reference Photograph #9.
