Revised Draft Report

Hudson Avenue Pedestrian Safety Improvements

Barton & Loguidice, D.P.C.
10 Airline Drive, Suite 200
Albany, New York 12205

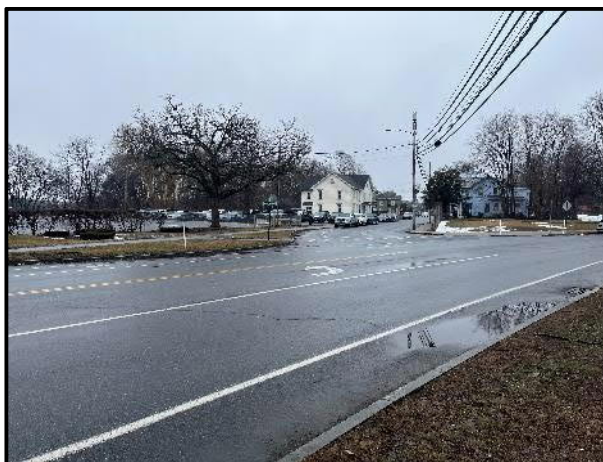
Figure 2-3: Hudson Ave./South St. Int.

Hudson Ave. is classified as an NHS Urban Principal Arterial with an AADT of 10,767 vpd and consists of two 11 ft. travel lanes, two 5 ft. bike lanes, an 11 ft. turn lane for vehicles turning left onto South St, and sidewalks on both sides. The pavement markings within the vicinity of the intersection are in fair condition but do exhibit wear especially within the vehicle travel lanes. Parking on Hudson Ave. is prohibited within the vicinity of the intersection and the pavement width narrows similar to a pedestrian “bump-out” to reduce the pedestrian crossing distance to approximately 42 ft. across Hudson Ave., located on the west side of the intersection with South St. The crossing distance across South St. is approximately 48 ft. Pedestrian warning signs are installed at the crosswalk on the right hand side of the roadway approaching either marked crosswalk. However, the signs do not include the diagonal downward pointing arrow as required by the 2009 MUTCD. The intersection is located approximately 1/2 mile from the Big Cross Street School and provides the most direct route from the Village Green apartments to the school.

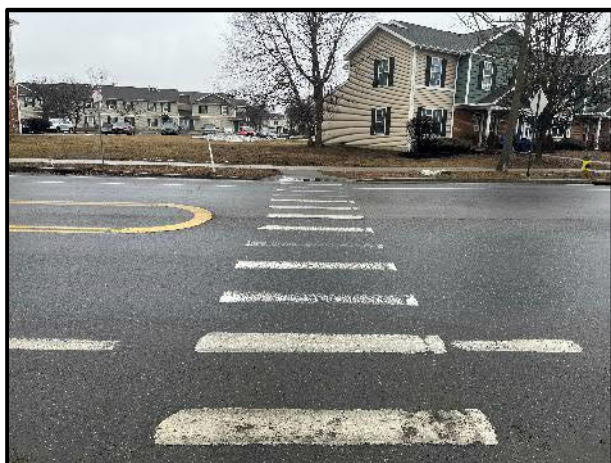
Figure 2-4: Crosswalk crossing Hudson Ave at the intersection with South St.

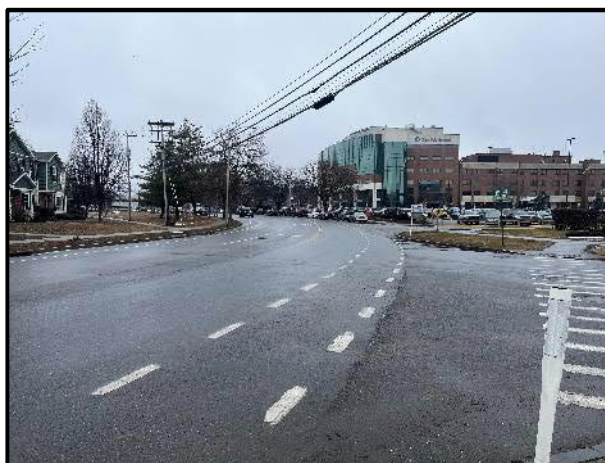
Figure 2-5: Horizontal curve on Hudson Ave looking east

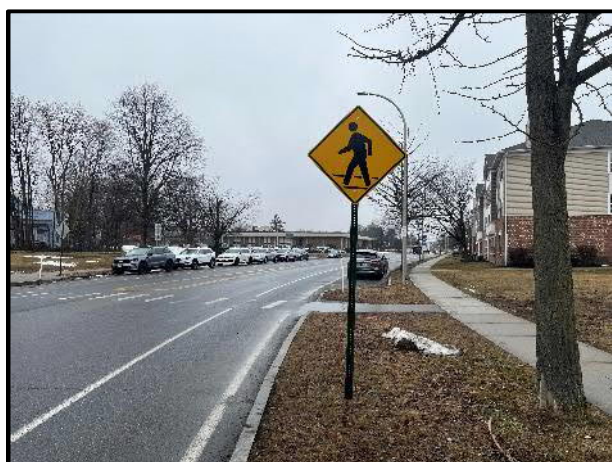
Figure 2-6: Pedestrian warning sign installed on the east approach to the Crosswalk

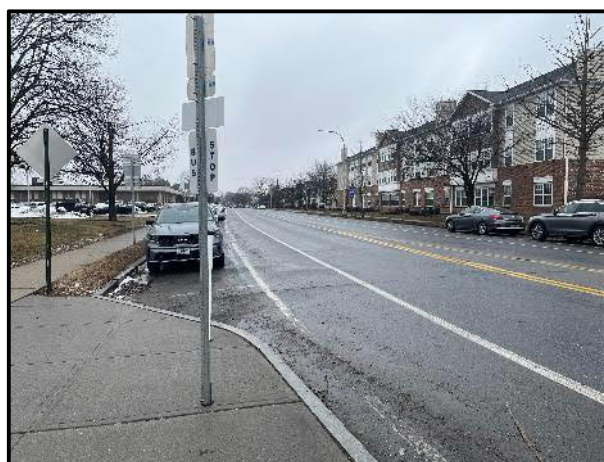
Figure 2-7: West approach to the Crosswalk on Hudson Ave.

The sight distance for westbound traveling vehicles to the crosswalk is limited by trees planted within the snow storage area between the curb and sidewalk on the inside of the horizontal curve on Hudson Ave. The measured stopping sight distance to the crosswalk for vehicles traveling west is 200 ft. which is below the minimum standard of 250 ft. for a design speed of 35 mph (posted speed limit plus 5 mph) in accordance with Exhibit 2-4a of the New York State Department of Transportation (NYSDOT) Highway Design Manual (HDM).

Remove the trees between the curb and the sidewalk within 250 ft. of the westbound approach to the intersection. Currently, the trees between the curb and the sidewalk on the curve restrict the stopping sight distance of vehicles approaching the intersection and potentially cause a hazardous condition for pedestrians utilizing the crosswalk, or waiting to cross Hudson Ave.

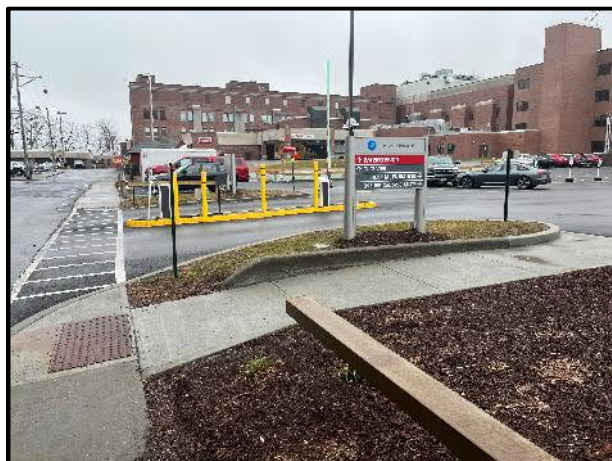
Figure 2-12: Crosswalk crossing School St. at the intersection with Park St.

School St. is classified as an Urban Local Road that is owned and maintained by the City with a curb-to-curb width of 28 ft., and sidewalks on both sides. An additional 10 ft. of pavement surface is provided in front of the entrance to the Surgical Specialists of Glens Falls Hospital for patient drop-off and pick-up. Traffic volumes on School St. are not available on the NYSDOT Traffic Data Viewer, however it is assumed to be low based on our site observations and review of the video footage. Pedestrian activity between the parking lot and this building entrance is high during working hours. There are currently no markings or signs consistent with a mid-block crossing here, although on School Street at the entrance to the Hospital parking lot, the wayfinding sign directs vehicles to park in the Hospital parking lot for the Surgical Specialists. Also, the sidewalks on either side of the parking lot entrance have a curb ramp and detectable warning units, giving the impression that this is a crossing location. Currently, to legally cross this street, pedestrians should utilize the sidewalks to walk to either the Park St. or Hudson Ave. sidewalk ramps and use the existing crosswalks at these intersections.

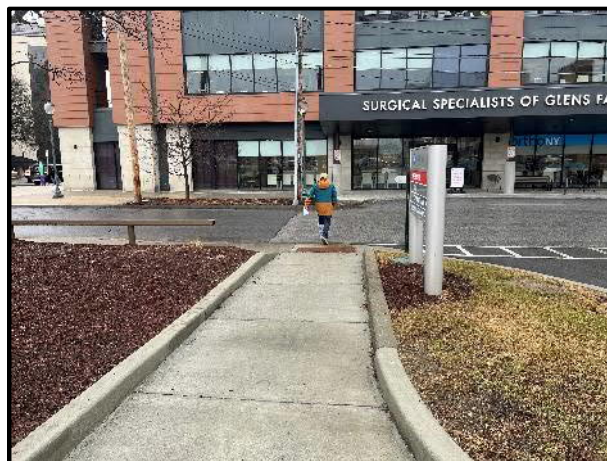
Figure 2-13: Patron of the Surgical Specialists crossing mid-block on School St.

1. On School St., most pedestrians were observed to cross mid-block from the parking lot to the Surgical Specialists of Glens Falls Hospital. Many crossers are assumed to be patients, with a significant majority of users in strollers, wheelchairs, and walkers.

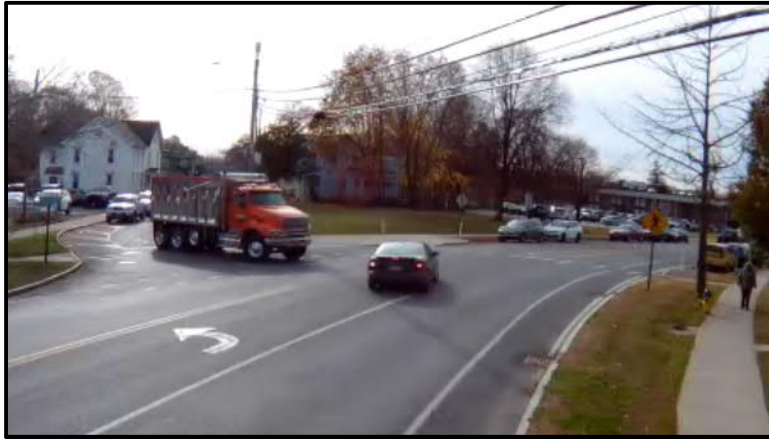
1. Hudson Ave. at the intersection with South St. is situated on a curve. This curved alignment creates poor sightlines for pedestrians crossing Hudson Ave. and drivers turning onto Hudson Ave. There were two observed instances of left-turning trucks from South St. accelerating in front of opposing left turning vehicles onto South St.

Figure 3-1: Left Turn Conflicts

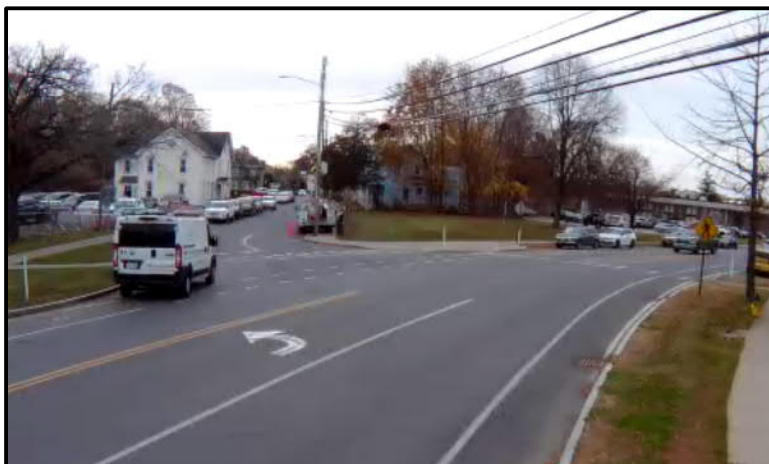
2. The curve on Hudson Ave. also creates a shallow angle of approach to the intersection when travelling westbound. A regularly occurring issue was with vehicles making wide left turns onto South St. at excessive speeds and crossing through the opposing travel lanes. This is a safety concern since it could result in a head-on collision with vehicles or a collision with a pedestrian in the crosswalk who is not expecting a vehicle to make this maneuver.

Figure 3-2: Hudson Ave. wide left turn movements

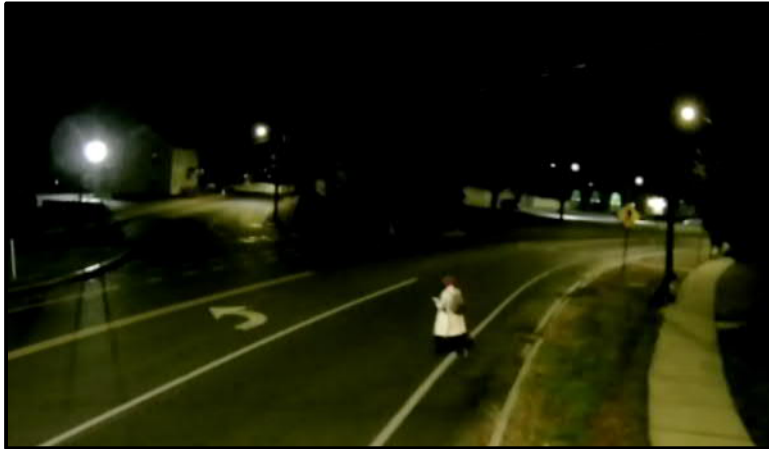
3. Although most pedestrians crossed the intersection at the marked crosswalk, there were also instances where pedestrians crossed diagonally across Hudson Ave. This could be a safety concern since many of these crossings occurred at night, especially with an inattentive driver or pedestrian.

Figure 3-3: Pedestrian crossing outside the crosswalk

4. The lighting at the intersection is not focused on the crosswalks, especially on the southern half of the crosswalk. See Figure 3-3 above.
5. Some vehicles did stop and wait for pedestrians to cross the intersection, which is required by NYS Law when a pedestrian is within a marked crosswalk but is not always observed. These vehicles often had to stop abruptly, especially when traveling westbound, to let the pedestrians cross the roadway.

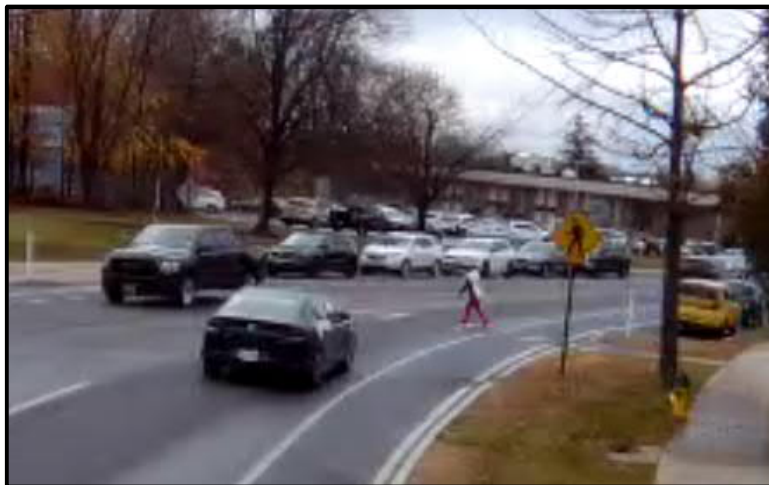
Figure 3-4: Car stopped to let pedestrians cross

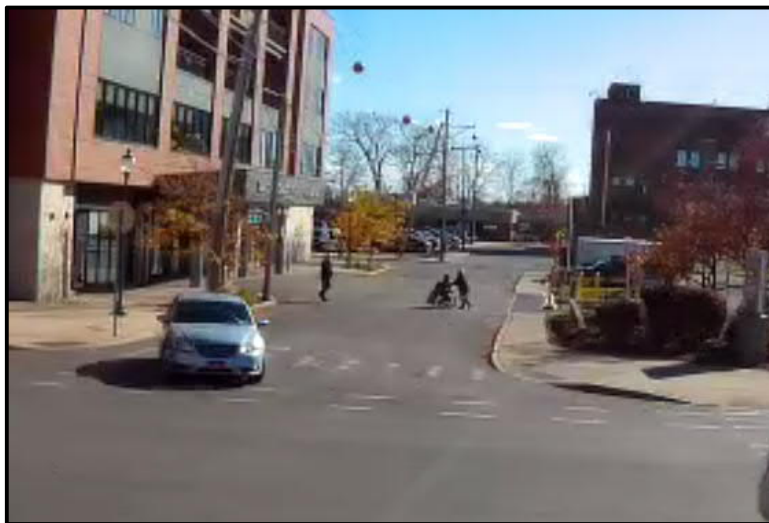
Figure 3-5: Wheelchair user conducting a mid-block crossing

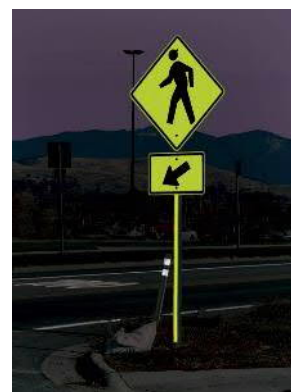
Figure 4-1: Sign plan for Uncontrolled Crosswalks at Intersections

As a minimum treatment, advanced pedestrian crossing signage should be installed on Hudson Ave. in accordance with Figure 4-1. The warning signs have the option to be yellow or fluorescent yellow-green. Fluorescent yellow-green is recommended for greater visibility and should include the retroreflective signpost strip to increase awareness to motorists. Pedestrian signs with the downward diagonal pointing arrow should be installed on both sides of the road at each approach to the crosswalk, and the pedestrian signs with “ahead” plaque below should be installed in advance of the crosswalk

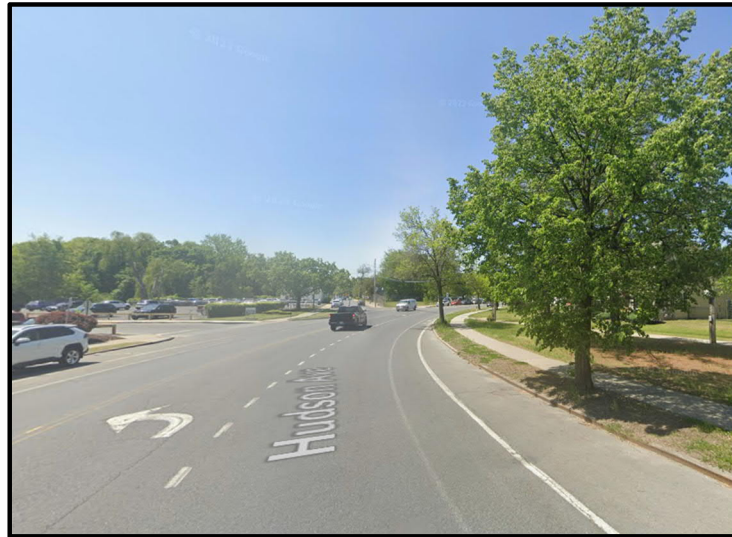
Figure 4-4: Restricted Sight Distance on Hudson Ave. approaching South St. from the east

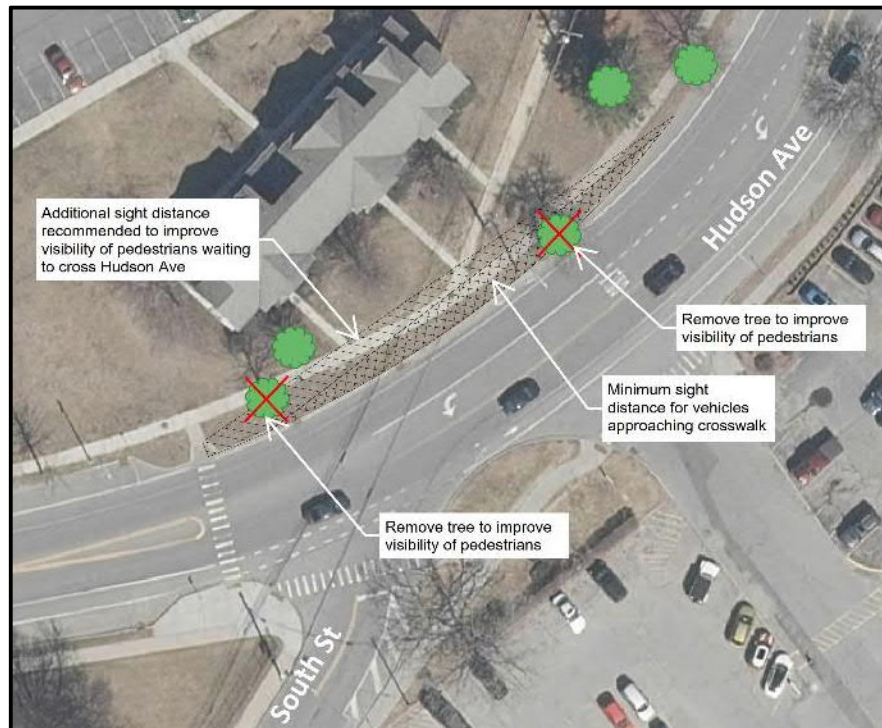
Figure 4-5: Recommended Tree Removals to Improve Sight Distance

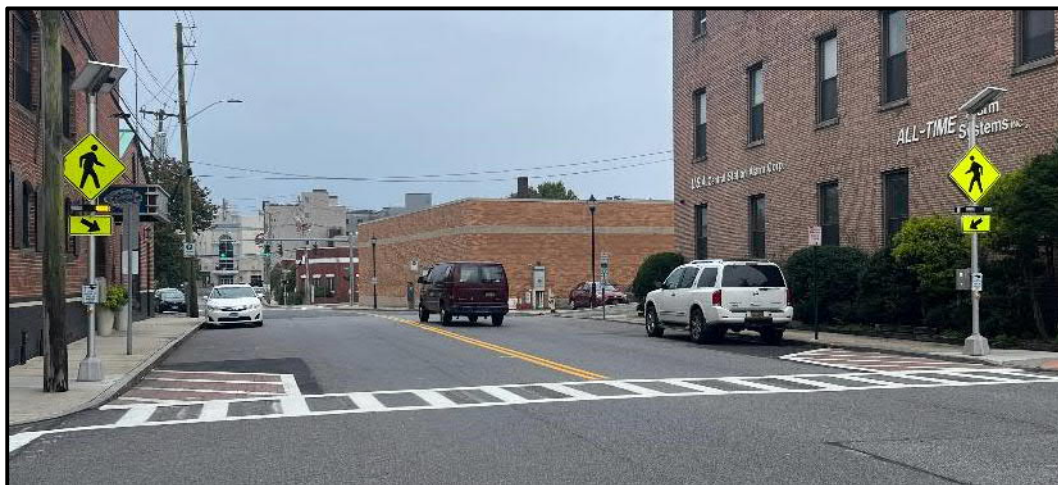
RRFB's consist of a rapid high intensity flashing yellow beacon mounted to a standard pedestrian warning sign installed just at a crosswalk of an uncontrolled approach to an intersection. The beacons are activated when a pedestrian pushes a button to cross the roadway. The installation of these are relatively low cost and have been proven to be highly effective at improving the yield rate of motorists at marked crosswalks. RRFB's can be solar powered or can be hard-wired into the electric grid to provide electrical power. In this installation scenario, two beacon assemblies would be installed, one on the north side, and one on the south side of Hudson Ave. The pedestrian warning signs and flashing beacons would be installed on both sides of the posts to provide two warning signs and flashing beacon assemblies for each approach to the crosswalk. Advanced pedestrian warning signs should also be installed as noted in section 4.2.1.1 on the sign plan for uncontrolled crosswalks.

Figure 4-6: Typical RRFB Installation at an Intersection

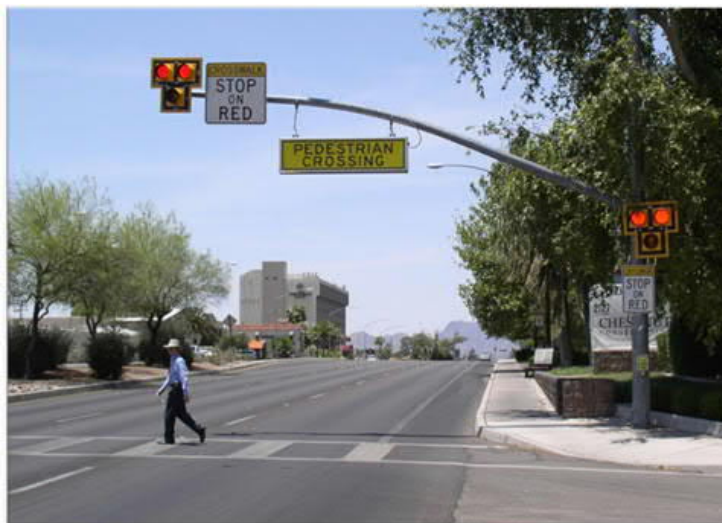
Figure 4-9: Example of a HAWK Signal in Tucson, Az.
