*Final Report*

# Hudson Avenue Pedestrian Safety Improvements

Revision 2  
August 2024

Barton & Loguidice, D.P.C.  
10 Airline Drive, Suite 200  
Albany, New York 12205

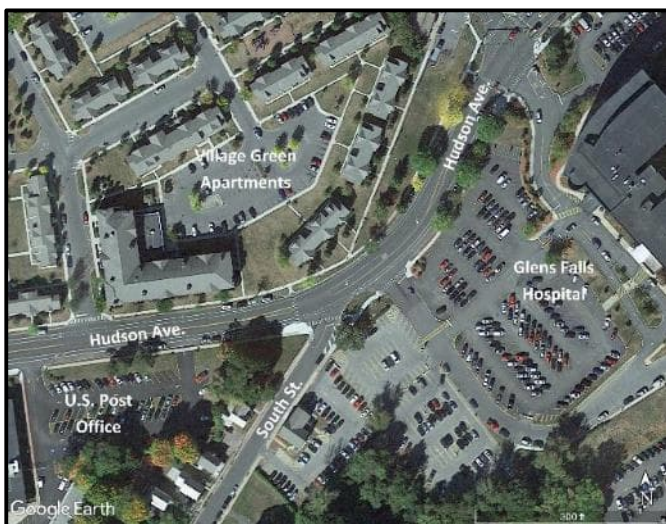
Figure 2-1: South St. & Hudson Ave. Project

This is a three-way intersection with stop control on the minor leg (South St.) and uncontrolled on Hudson Ave. Both roadways are included in the City-wide 30 mph speed limit as well as owned and maintained by the City. South St. intersects Hudson Ave. on a horizontal curve at a skew, with a sharp turn at the northern end of South St. to become nearly perpendicular with Hudson Ave. Surrounding land uses consist of the Village Green apartment complex to the north, a Post Office to the southwest of the intersection, and the Glens Falls Hospital to the east. South St. is classified as a Local Urban Minor Arterial with an Average Annual Daily Traffic (AADT) 2,766 vehicles per day (vpd), includes a curb-to-curb width of 28 ft., and sidewalks on both sides. Parking is permitted on the east side of the roadway, however, is prohibited by signage and pavement markings within 50 ft. of the intersection.

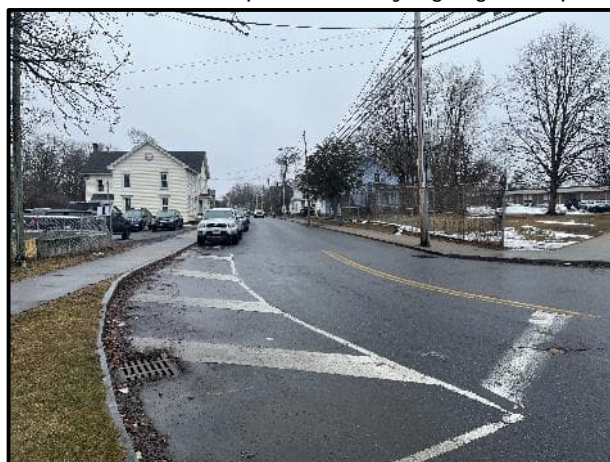
Figure 2-2: Looking South on South St.

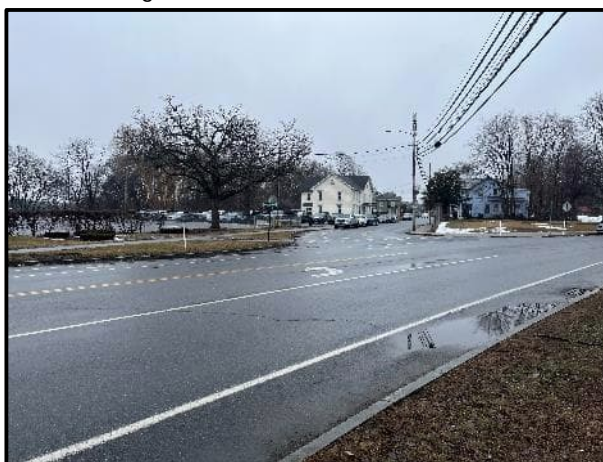
Figure 2-3: Hudson Ave./South St. Int.

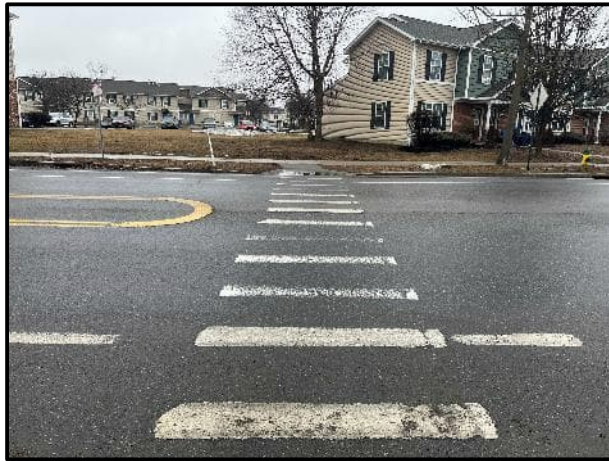
Figure 2-4: Crosswalk crossing Hudson Ave at the intersection with South St.

To increase awareness of the crosswalk, high-visibility crosswalks should be installed on Hudson Ave. to alert motorists of the potential for pedestrian activity at this location. The crosswalk should be "NYSDOT Type LS" that includes parallel stripes and ladder bars to enhance visibility. The pavement markings should be Epoxy paint with glass beads for retro-reflectivity or retro-reflective thermoplastic pavement markings. It is suggested that the South Street crossing is upgraded to the Type LS crosswalk as well.

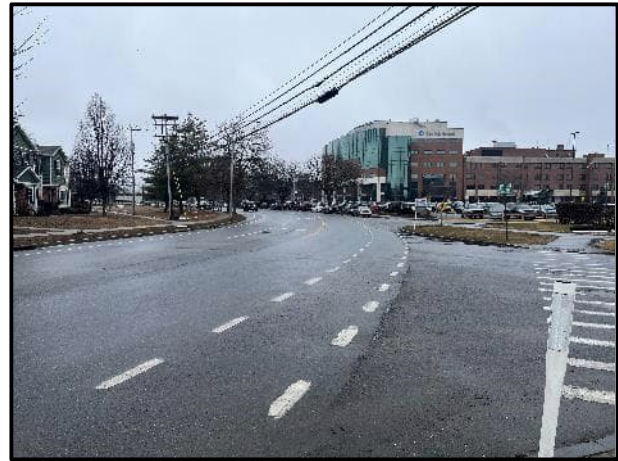
Figure 2-5: Horizontal curve on Hudson Ave looking east

The sight distance for westbound traveling vehicles to the crosswalk is limited by trees planted within the snow storage area between the curb and sidewalk on the inside of the horizontal curve on Hudson Ave. The measured stopping sight distance to the crosswalk for vehicles traveling west is 200 ft. which is below the minimum standard of 250 ft. for a design speed of 35 mph (posted speed limit plus 5 mph) in accordance with Exhibit 2-4a of the New York State Department of Transportation (NYSDOT) Highway Design Manual (HDM).

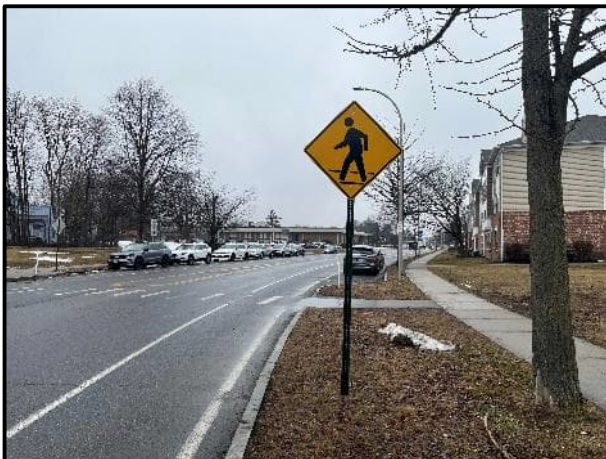
Figure 2-7: Pedestrian warning sign installed on the east approach to the Crosswalk

As a minimum treatment, advanced pedestrian crossing signage should be installed on Hudson Ave. in accordance with Figure 4-1. The warning signs have the option to be yellow or fluorescent yellow-green. Fluorescent yellow-green is recommended for greater visibility and should include the retroreflective signpost strip to increase awareness to motorists. Pedestrian signs with the downward diagonal pointing arrow should be installed on both sides of the road at each approach to the crosswalk, and the pedestrian signs with “ahead” plaque below should be installed in advance of the crosswalk

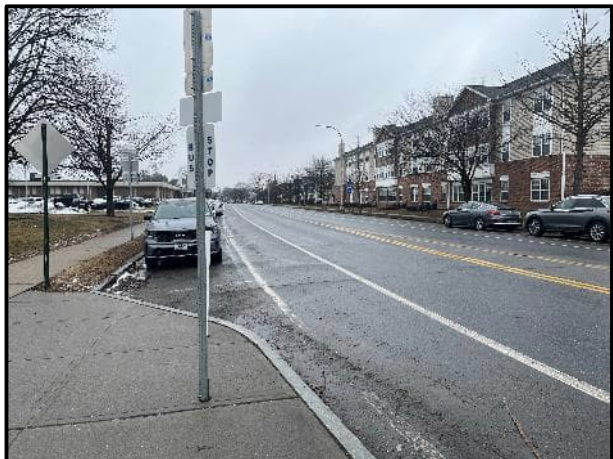
Figure 2-6: West approach to the Crosswalk on Hudson Ave.

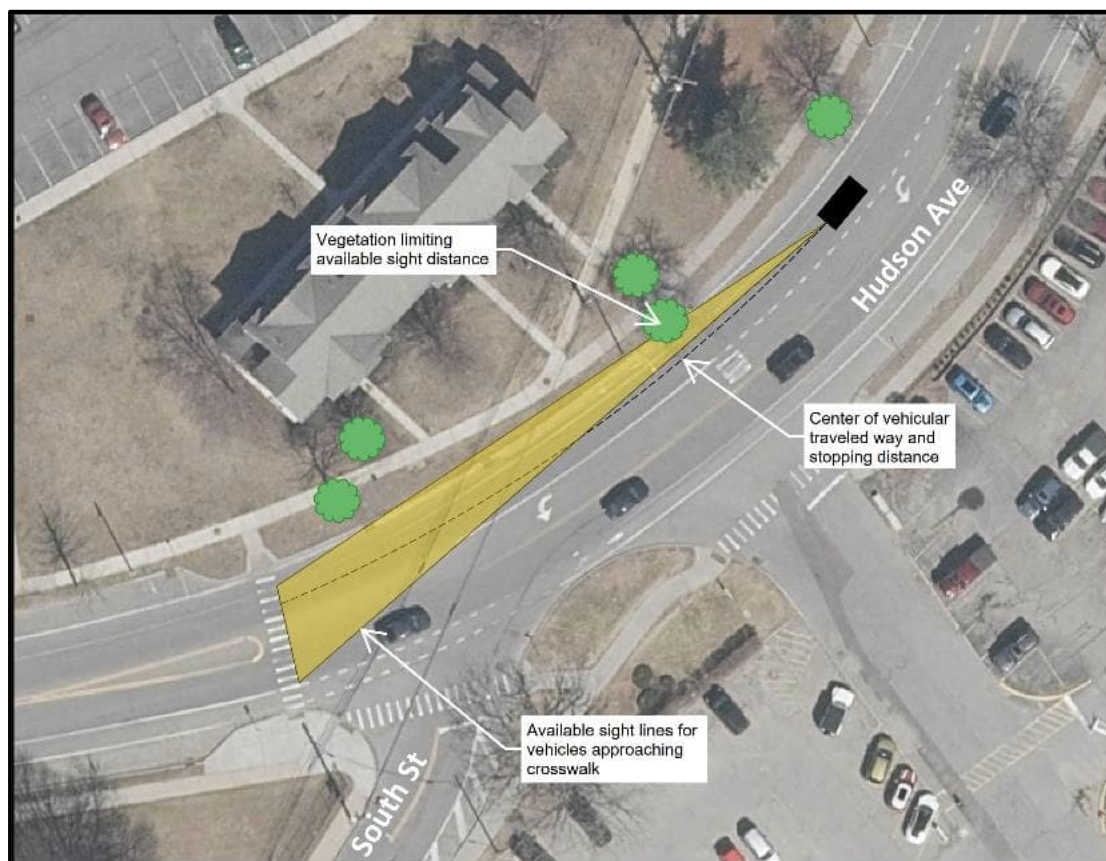
Figure 2-8: Available Sight Distance Figure

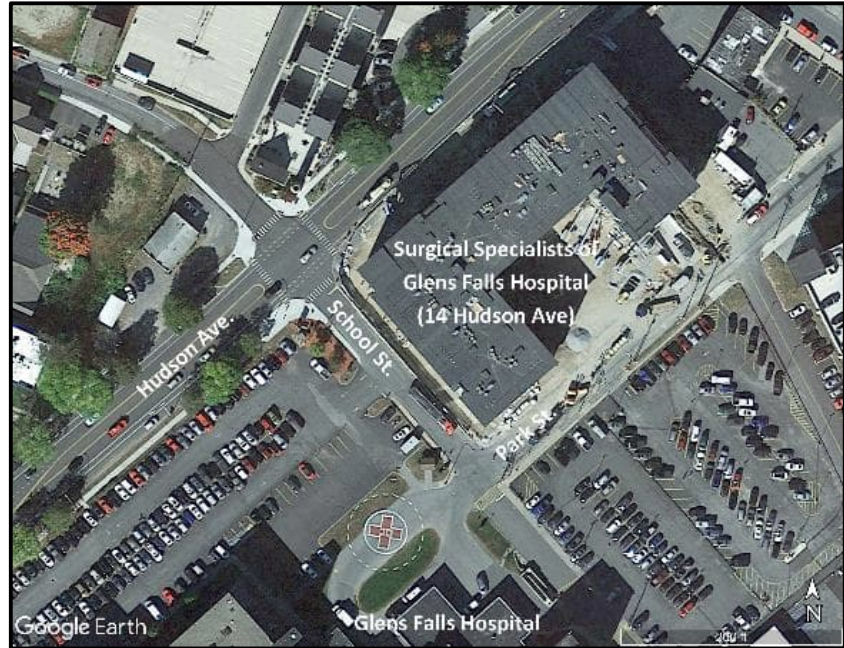
Figure 2-9: School St. Project Location Map.

This section of School St. included in the study area is a short city block between Hudson Ave. (to the north) and Park St. (to the south) Within this block is the entrance to the Surgical Specialists of Glens Falls Hospital (14 Hudson Ave.) and the entrance to a large parking lot that services this building and the Glens Falls Hospital. The Hudson Ave.

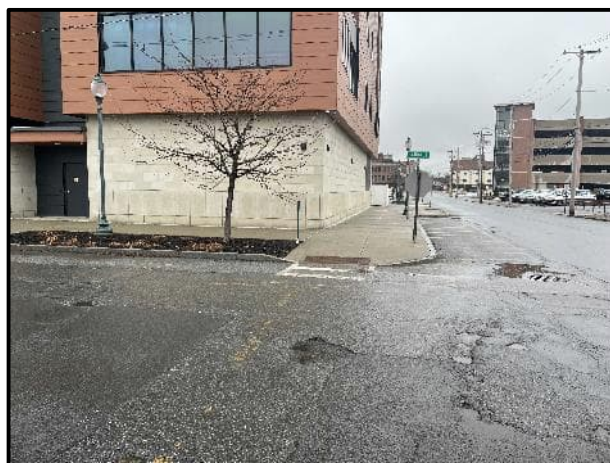
Figure 2-10: Crosswalk crossing School St. at the intersection with Park St.

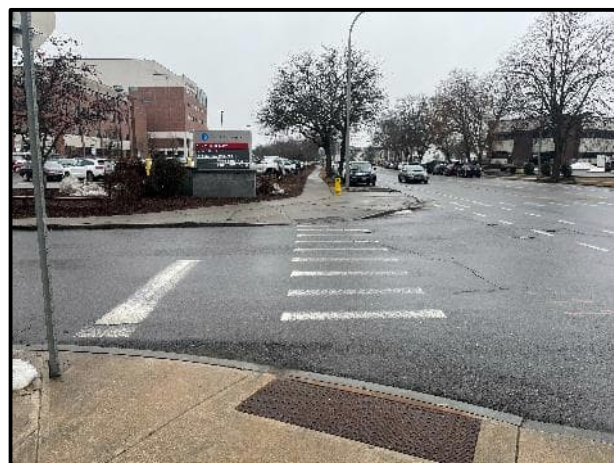
Figure 2-11: Crosswalk crossing School St. at the intersection with Hudson Ave.

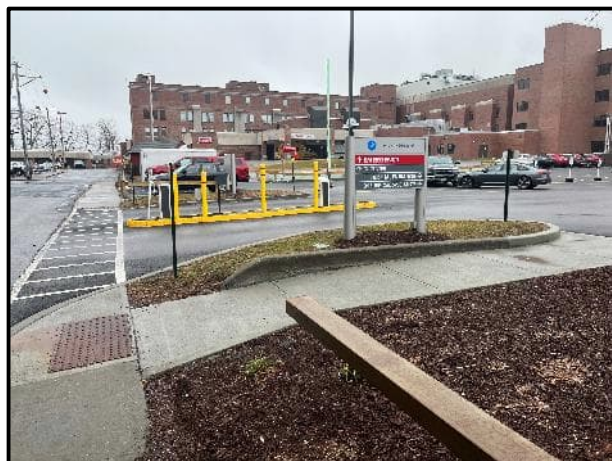
Figure 2-12: Crosswalk crossing School St. at the intersection with Park St.

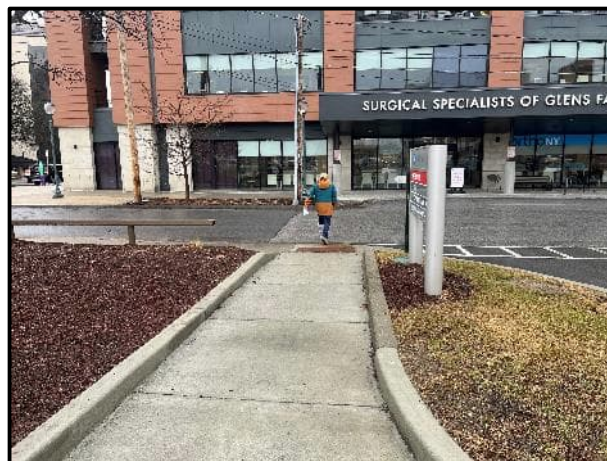
Figure 2-13: Patron of the Surgical Specialists crossing mid-block on School St.

1. On School St., most pedestrians were observed to cross mid-block from the parking lot to the Surgical Specialists of Glens Falls Hospital. Many crossers are assumed to be patients, with a significant majority of users in strollers, wheelchairs, and walkers.

Given these considerations, the most prudent recommendation is to install a mid-block crosswalk and appropriate signage from the existing curb ramp on the north side of the parking lot driveway to the entrance to the Surgical Specialists of Glens Falls Hospital building. Due to the short distance from the nearest intersection to the proposed location of the crosswalk, the pedestrian warning sign with the downward diagonal arrow installed (back-to-back) on both sides of the crosswalk should be sufficient signage on the roadway. See figure 4-1 for the specific signs to be installed. High-visibility fluorescent yellow sign post strips should also be installed along with a high-visibility crosswalk as shown in figure 4-3. A double yellow centerline on School St may also be beneficial to delineate the travel lanes and visually narrow the roadway for vehicles. The roadway is currently unstriped and may appear to be wider than it is intended.

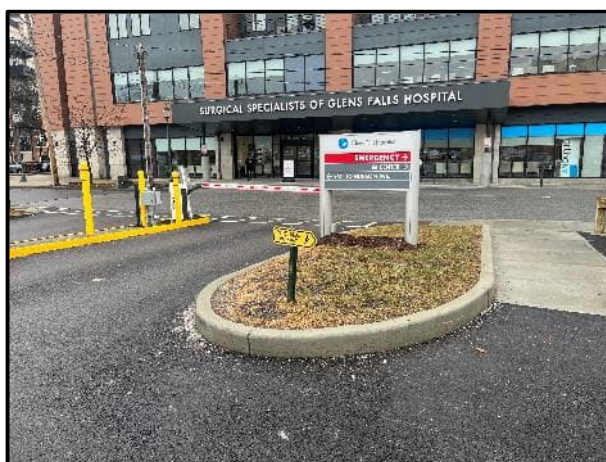
Figure 2-14: Signage directing pedestrians to the sidewalks adjacent to the parking lot driveway.

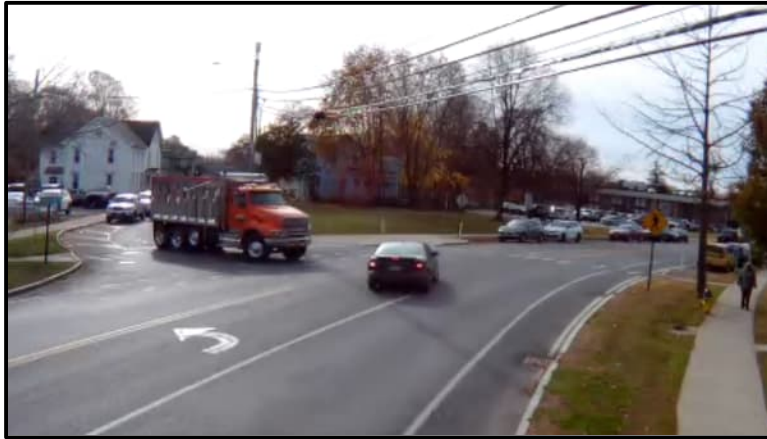
1. Hudson Ave. at the intersection with South St. is situated on a curve. This curved alignment creates poor sightlines for pedestrians crossing Hudson Ave. and drivers turning onto Hudson Ave. There were two observed instances of left-turning trucks from South St. accelerating in front of opposing left turning vehicles onto South St.

Figure 3-1: Left Turn Conflicts

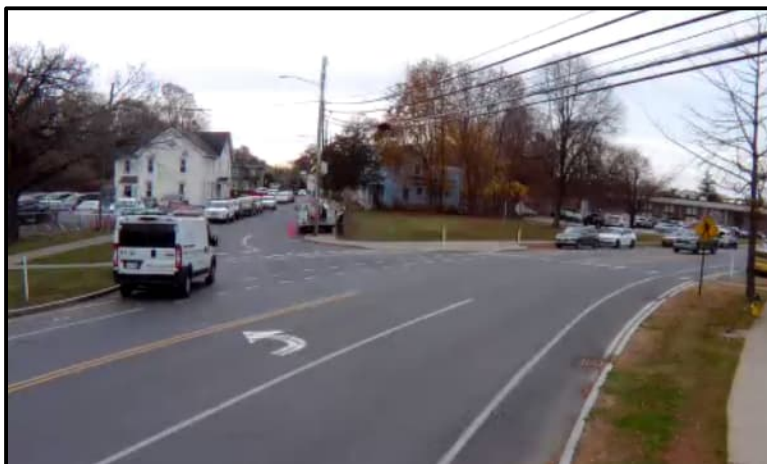
2. The curve on Hudson Ave. also creates a shallow angle of approach to the intersection when travelling westbound. A regularly occurring issue was with vehicles making wide left turns onto South St. at excessive speeds and crossing through the opposing travel lanes. This is a safety concern since it could result in a head-on collision with vehicles or a collision with a pedestrian in the crosswalk who is not expecting a vehicle to make this maneuver.

Figure 3-2: Hudson Ave. wide left turn movements

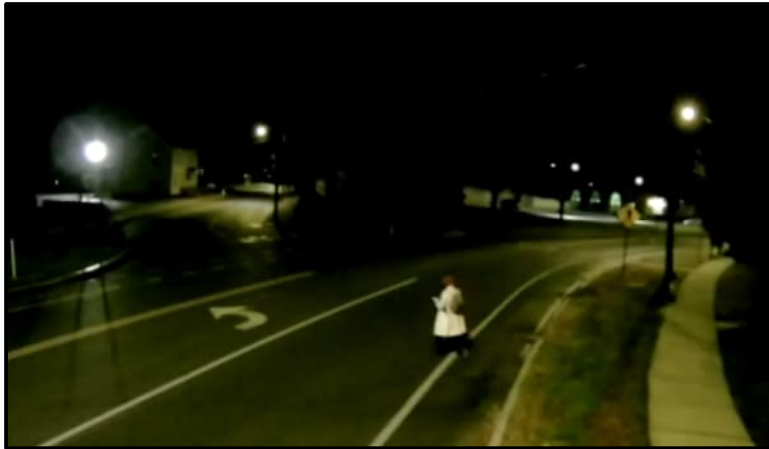
3. Although most pedestrians crossed the intersection at the marked crosswalk, there were also instances where pedestrians crossed diagonally across Hudson Ave. This could be a safety concern since many of these crossings occurred at night, especially with an inattentive driver or pedestrian.

Figure 3-3: Pedestrian crossing outside the crosswalk

4. The lighting at the intersection is not focused on the crosswalks, especially on the southern half of the crosswalk. See Figure 3-3 above.
5. Some vehicles did stop and wait for pedestrians to cross the intersection, which is required by NYS Law when a pedestrian is within a marked crosswalk but is not always observed. These vehicles often had to stop abruptly, especially when traveling westbound, to let the pedestrians cross the roadway.

Install a new light pole on the southwest corner of the intersection to illuminate the southern side of the Hudson Ave. crosswalk, sidewalk ramp, and any pedestrians for vehicles approaching from the intersection. The existing light pole on the north side of the intersection currently illuminates the northern half of the crosswalk and should remain in operation.

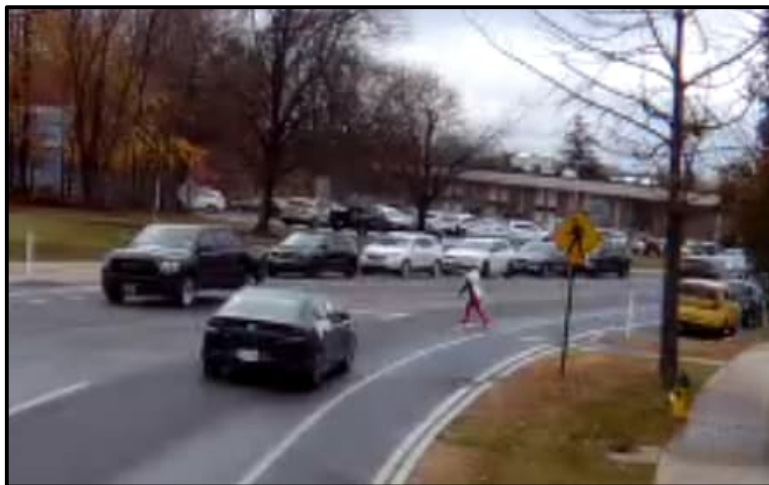
Figure 3-4: Car stopped to let pedestrians cross

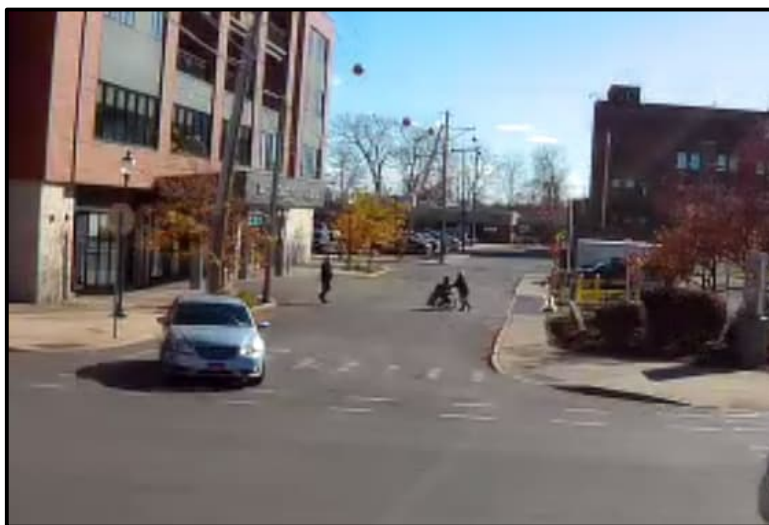
Figure 3-5: Wheelchair user conducting a mid-block crossing

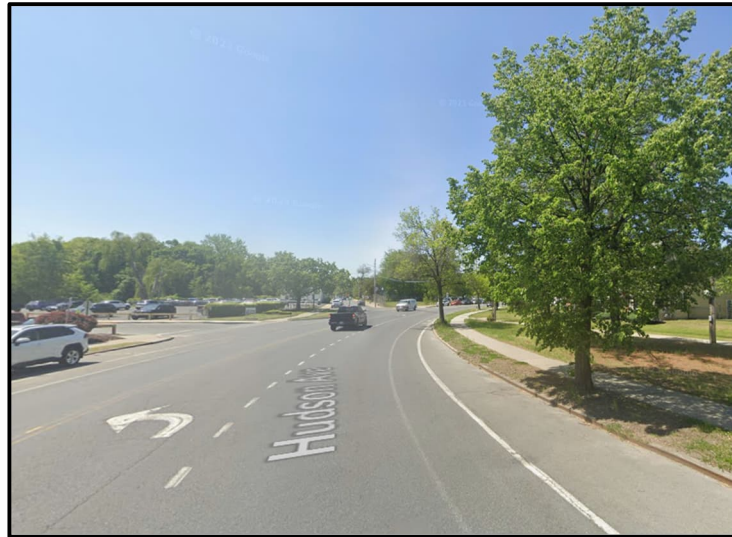
Remove the trees between the curb and the sidewalk within 250 ft. of the westbound approach to the intersection. Currently, the trees between the curb and the sidewalk on the curve restrict the stopping sight distance of vehicles approaching the intersection and potentially cause a hazardous condition for pedestrians utilizing the crosswalk, or waiting to cross Hudson Ave.

Figure 4-4: Restricted Sight Distance on Hudson Ave. approaching South St. from the east

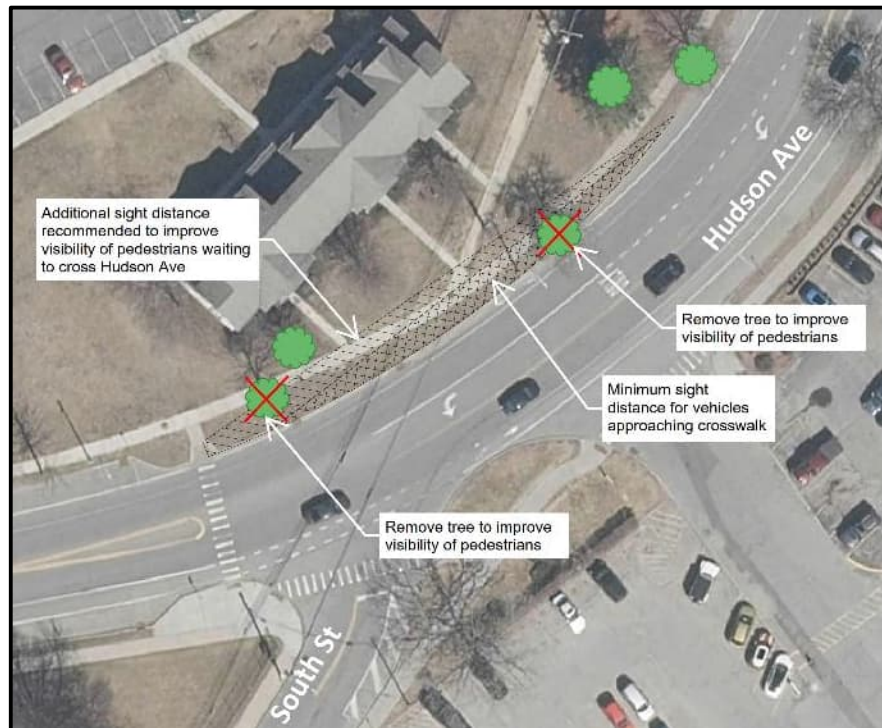
Figure 4-5: Recommended Tree Removals to Improve Sight Distance

Cost to Implement = \$ 6,000

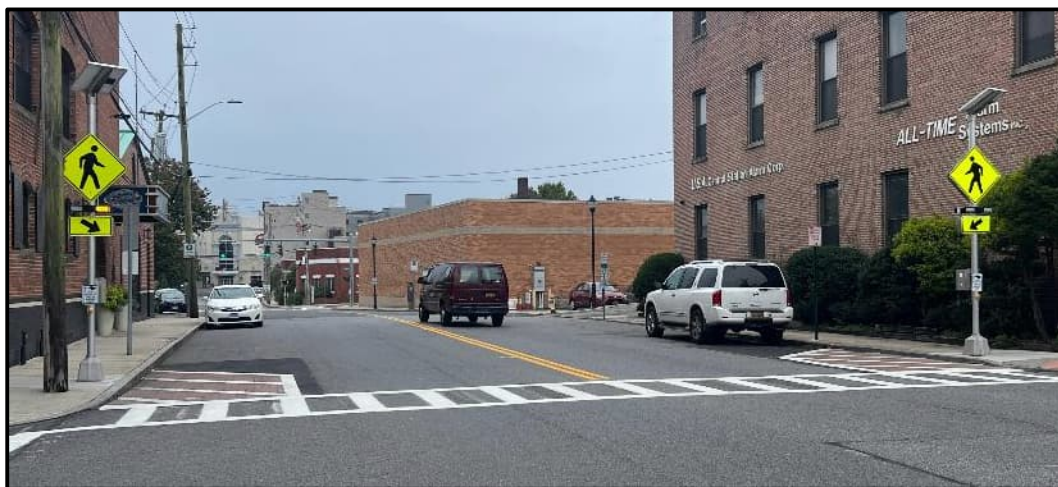
RRFB's consist of a rapid high intensity flashing yellow beacon mounted to a standard pedestrian warning sign installed just at a crosswalk of an uncontrolled approach to an intersection. The beacons are activated when a pedestrian pushes a button to cross the roadway. The installation of these are relatively low cost and have been proven to be highly effective at improving the yield rate of motorists at marked crosswalks. RRFB's can be solar powered or can be hard-wired into the electric grid to provide electrical power. In this installation scenario, two beacon assemblies would be installed, one on the north side, and one on the south side of Hudson Ave. The pedestrian warning signs and flashing beacons would be installed on both sides of the posts to provide two warning signs and flashing beacon assemblies for each approach to the crosswalk. Advanced pedestrian warning signs should also be installed as noted in section 4.2.1.1 on the sign plan for uncontrolled crosswalks.

Figure 4-6: Typical RRFB Installation at an Intersection

Cost to Implement = \$ 12,500 per pole x 2 poles = \$ 25,000

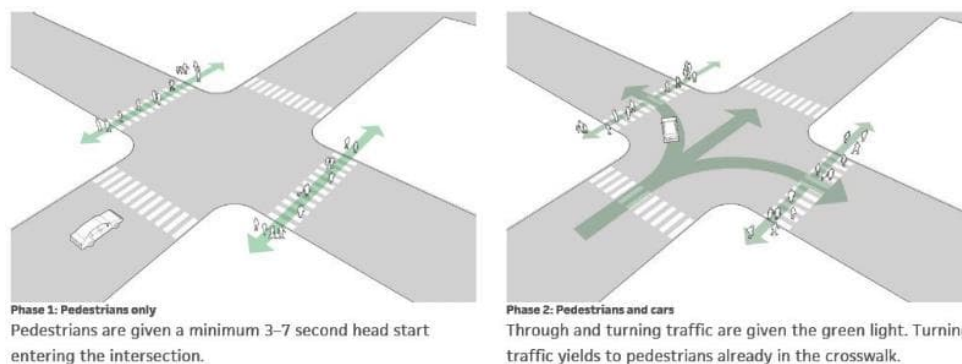
A new traffic signal controller will also allow for a Leading Pedestrian Interval (LPI) to be programmed. A LPI is typically a 3-7 second head start for pedestrians when entering an intersection with a corresponding green signal in the same direction of travel. LPI's are recommended at intersections where high vehicular turning volumes come into conflict with higher volumes of crossing pedestrians during their shared phase of the signal cycle. Coupled with the Yield to Pedestrian sign, these two items would increase driver awareness of pedestrians at this intersection.

Figure 4-7: LPI Phasing Diagram

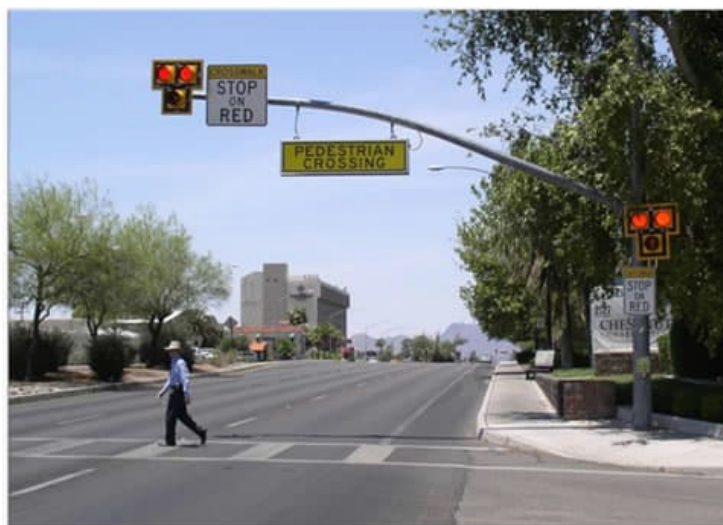
Figure 4-9: Example of a HAWK Signal in Tucson, Az.

Cost to Implement = \$ 180,000\*  
 \*Includes Design and Construction Costs
