FINAL Technical Memorandum
Village of Granville Trail Connections Analysis
CR 24 (North Street) Complete Streets

Memo To: Mr. Jack Mance, Senior Transportation Planner
Adirondack/Glens Falls Transportation Council

Date: February 21, 2025

From: Barton & Loguidice, D.P.C. (B&L)

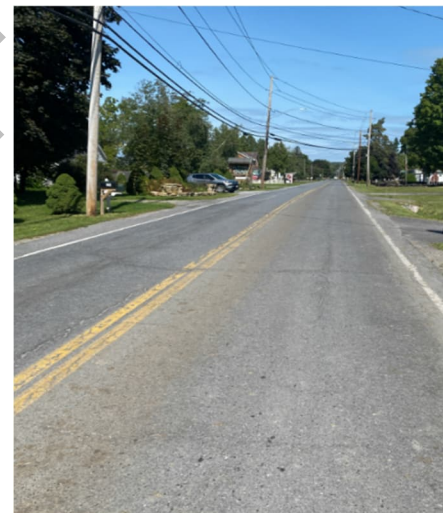
Figure II-1 – CR 24 Roadway

CR 24 is classified as a Rural Minor Collector with an annual average daily traffic (AADT) of 2,403 vehicles per day and an 85th percentile speed of 38 mph, as documented by the NYSDOT Traffic Data Viewer. The NYSDOT traffic and speed data were collected near the Village line, approximately where the D&H Rail Trail crosses CR 24. This area is more urban in setting with curbing and buildings close to the road. North of where the data was collected, the speed limits changes from 30mph to 35mph, and traffic speeds likely similarly increase through the more rural setting. The travel lanes are approximately 11 ft. wide, while shoulder widths vary between 0 and 4 ft. Currently, the corridor lacks designated bike lanes and appropriate signage to support bicycles and most of the corridor does not include sidewalks to accommodate pedestrians. For detailed measurements and further information, please refer to Appendix 1.

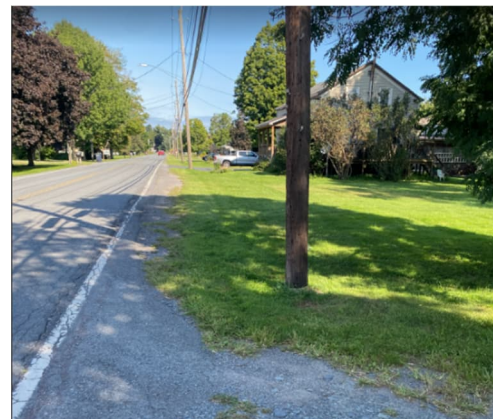
The roadside conditions along CR 24 vary significantly. Drainage infrastructure is unevenly distributed; open ditches are present intermittently, such as between some driveways, but are notably absent in several adjacent areas. Many private driveways are equipped with drainage pipes beneath them to convey the stormwater to the ditches. The field observations documented the existing conditions within 15 ft. of the pavement edge on both sides of the roadway. The identified constraints include 60 utility poles, 15 trees, 13 locations with ditches, and 1 culvert running perpendicular to the roadway. In total, 69 physical constraints were recorded on the East side of the roadway, while 37 were found on the

Figure II-2 Utility pole adjacent to CR 24

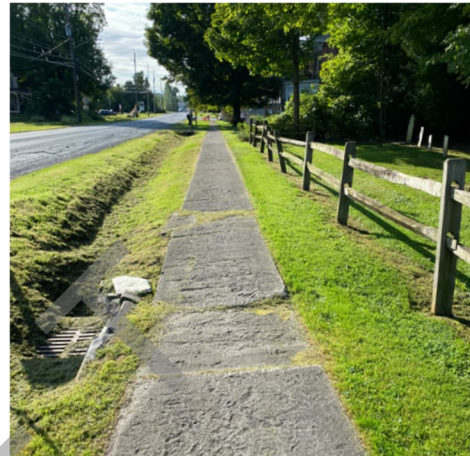
Sidewalks are present along the west side of CR 24 between the intersection with E. Main St. in Granville and 63 North St. (CR 24), and on the east side from E. Main St. to 28 North St. The length of sidewalk on the west side is approximately 2,000 ft. long, and 900 ft. long on the east side. Additionally, sidewalks are present at the north end of the project limits from Chapmans General Store to 1330 North St. (CR 24), a length of approximately 2,000 ft. All of the existing segments were assessed for compliance with the Americans with Disabilities Act (ADA) and evaluated based on several key criteria: missing panels, panel heaving, obstructions, and width. This study also evaluated the 1.3 miles of CR 24 roadway between 63 North St. and 1330 North St. for the addition of pedestrian facilities.

Figure II-3-Existing Sidewalk

Each existing sidewalk segment was analyzed individually, typically representing one block, unless interrupted by significant features such as large commercial driveways or unusually lengthy segments. The assessment revealed that, out of the eight locations surveyed, seven segments were rated as partially accessible or not accessible resulting in non-compliant conditions with ADA standards. The most common deficiency included heaving panels which were found in all but one segment, followed by missing panels which were found in five segments. The segment of sidewalk from E. Main St to 13 North St. was rated as mostly accessible, the only segment in the study corridor. Detailed ADA compliance findings, including specific issues identified and ratings, are provided in Appendix 1.

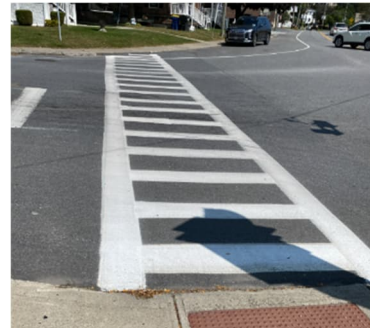
The survey identified five pedestrian crossings. Two of these crossings are marked with painted crosswalks: one at the D&H Trail Crossing and the other at the intersection of North St. and E. Main St. Both crosswalks were observed to be in good condition, with no visible fading. Additionally, pedestrian crossing signage is present at both locations to alert oncoming motorists of the crossing location. One advance warning sign was documented North of the D&H Trail crossing. The intersection located at North St. and E. Main St. was the only location equipped with an ADA-compliant curb ramp, including a detectable warning unit, which was only present on one side of the crosswalk. Please refer to Appendix 1 for further details.

Figure II-4 Crosswalk on CR 24 and Main St.

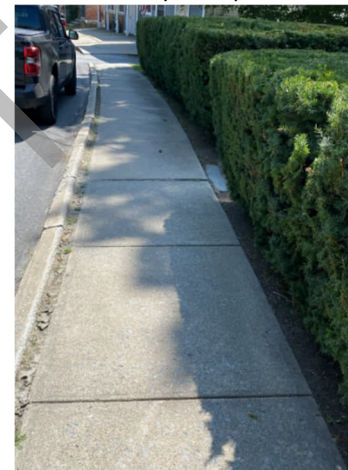
The sidewalk segment from 63 North St. to 13 North St. has been rated as "Not Accessible" due to its narrow width, cracked, and missing panels. The current conditions necessitate a full replacement with a new 5 ft. wide sidewalk to meet ADA standards. The west side of CR 24 from 13 North St. to East Main St. includes a 4 ft. wide sidewalk that widens to over 5 ft. as it nears E. Main St. A driveway between south of 5 Main St. shows signs of deterioration at the sidewalk crossing, with uneven pavement, creating obstacles for individuals with disabilities. Similar conditions were observed at the driveway of the Veterans of Foreign Wars eatery. This segment of the sidewalk is rated as "Partially Accessible" as outside of the noted deficiencies, it is in relatively good shape. The segment from 28 North St. to E. Main St. on the east side of CR 24 has been rated as "Not Accessible" due to minor deficiencies within the sidewalk concrete and utility poles placed in the middle of the sidewalk that restrict the sidewalk width to less than 4 ft. North of 28 North St., the sidewalk diverges onto Pine St. The 900 ft. segment of sidewalk on the east side of CR 24 from E. Main St. to 28 North St. should be replaced with a new 5 ft. sidewalk, and the utility poles should be relocated to behind the new sidewalk to meet ADA requirements. On the west side of CR 24, the 300 ft. segment between E. Main St. and 13 North St. should be spot repaired where panels are heaving, uneven, exhibit large cracks, or where crossings of driveways are not flush with the pavement. North of 13 North St. (CR 24) the entire sidewalk and curb should be replaced, approximately 1,650 ft. Ideally a 4-5 ft. snow storage buffer would be provided between the sidewalk and the curb. However, there does not appear to be adequate width to accommodate this buffer due to roadside features such as retaining walls, buildings, and the existing topography behind the existing sidewalk.

Figure III-2: 13 North St. to E. Main St.

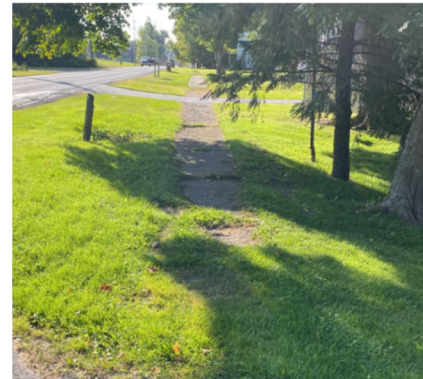
The existing 4-foot-wide sidewalk is located on the west side of the roadway only and exhibits several deficiencies, including panel heaving or missing sections, surface deterioration, and overgrown vegetation. Given the extent of these issues, a complete reconstruction of the sidewalk is necessary. This includes excavation and replacement of the approximately 2,000 ft. of 5 ft. sidewalk, with integrated curb ramps and detectable warning strips at intersections. Reconstruction would not require additional right-of-way acquisitions, as the new sidewalk would be installed in the same location as the existing sidewalk. Minor trimming of overgrown vegetation, including tree branches, may also be required.

Figure III-3: Existing Sidewalk near Cove Lane intersection
