FINAL Technical Memorandum  
Village of Granville D&H Rail Trail  
Crossings and Resurfacing Recommendations

Memo To: Mr. Jack Mance, Senior Transportation Planner  
Adirondack/Glens Falls Transportation Council

Date: February 21, 2025

From: Barton & Loguidice, D.P.C. (B&L)

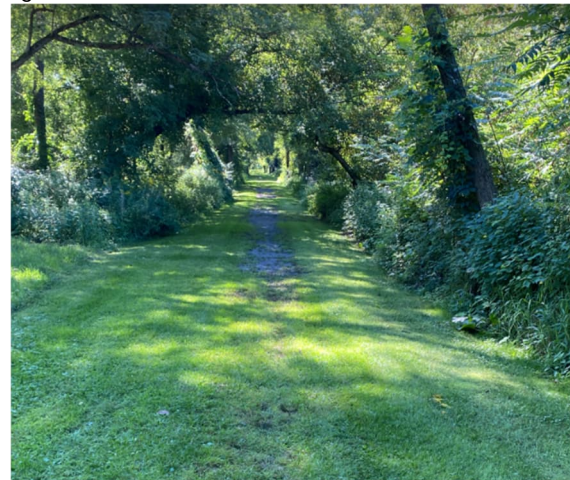
Figure II-2- Trail Section Between Depot St. and CR 24

The geometry of the trail, including surface conditions, width, and clear width, were systematically documented throughout the corridor. Beginning at Depot Street, it was observed that the original gravel surface has been overtaken by grass in many areas, although the trail is still mowed and maintained to its full width in most locations. Despite the growth of grass altering the surface composition and covering parts of the original surface, the overall effective width of the trail remains fully maintained. This grass-covered surface extends for the first 1.5 miles from Depot St to North St. (CR 24). Then from CR 24 to Main Street (0.5 miles), the trail surface was predominantly gravel, though grass had started to impede from the edges. From the Station House to Water Street (0.2 miles), the trail was entirely grass with no visible remnants of the former trail surface or rail bed. The trail then crosses over the Mettawee River via a bridge before meeting up with Water Street. This 0.1 mile section of the trail has a gravel surface on each approach to the bridge. From Morrison Ave. to Church Street, a 4 ft. wide asphalt path was present (0.06 mi). For the following 0.5 miles southeast of Village, the trail remained largely grass-covered, the final 1.9 miles that continued to the south consisted mainly of gravel, with occasional grass strips along the center in certain sections.

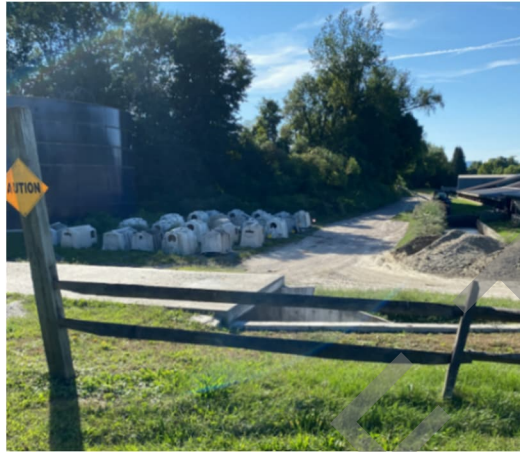
*Figure II-5 Crossing through active farmland*

In addition to the roadway crossings, there were six driveway crossings, including one that passes through an active farm where vehicles, livestock, and heavy equipment frequently cross. The high volume and type of traffic at this crossing may impact trail user safety, warranting further consideration in the trail's design and operational planning. The remaining driveway crossings appear to exhibit low traffic volumes and are not expected to significantly affect trail user access or safety.

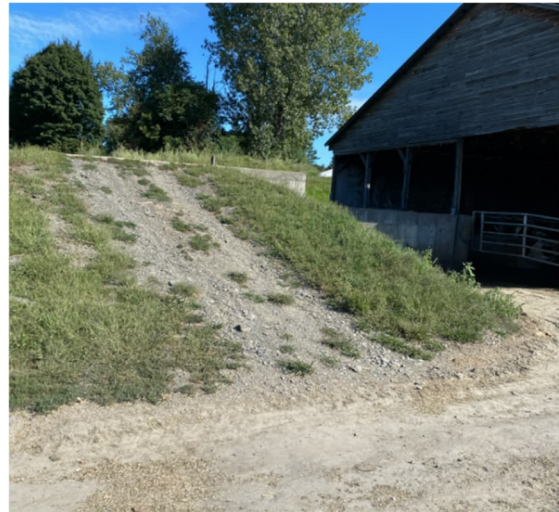
*Figure II-6 - Steep slope*

Within the farm section located at the Kenneth property (parcel ID 108.-1-3.4), the farm's operations and much of its infrastructure are situated within the trail right-of-way, utilizing dirt roadways on and across the existing trail. The farm appears to use the trail ROW for its regular operations as well as an area for storing cow hutches. Additionally, the trail features a cow pass located beneath it, which is a component of the farm's infrastructure. The cow pass stands approximately 7 ft. high, resulting in a steep and unstable slope that trail users must navigate. Figure II-7 displays a photograph of the steep slope. It should be noted that this location is outside of the Village of Granville and is assumed to be under the jurisdiction of NYS Office of Parks and Recreation. As such, no improvements or changes have been proposed under the auspices of the current analysis.

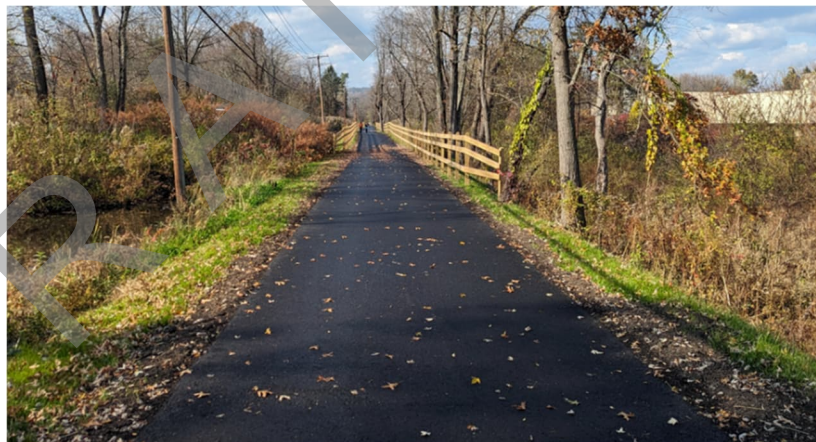
*Figure III-1-Kingston Rail Trail, Ulster County*

An Asphalt surface provides a smooth, durable top course that enhances accessibility for a variety of users, including pedestrians, cyclists, and individuals with mobility impairments. Asphalt is well-suited for trails due to its longevity and minimal maintenance requirements. The smooth, paved surface also improves user comfort and safety, especially for cyclists, in-line skaters, and wheelchair users, reducing the likelihood of rutting and erosion.

Asphalt is best suited for snowmobile trails in areas where snow accumulates 1 ft. or more and consistently covers the surface. This snow layer acts as a protective barrier, reducing wear on the asphalt from snowmobiles' studded tracks, which could otherwise wear on the trail surface.

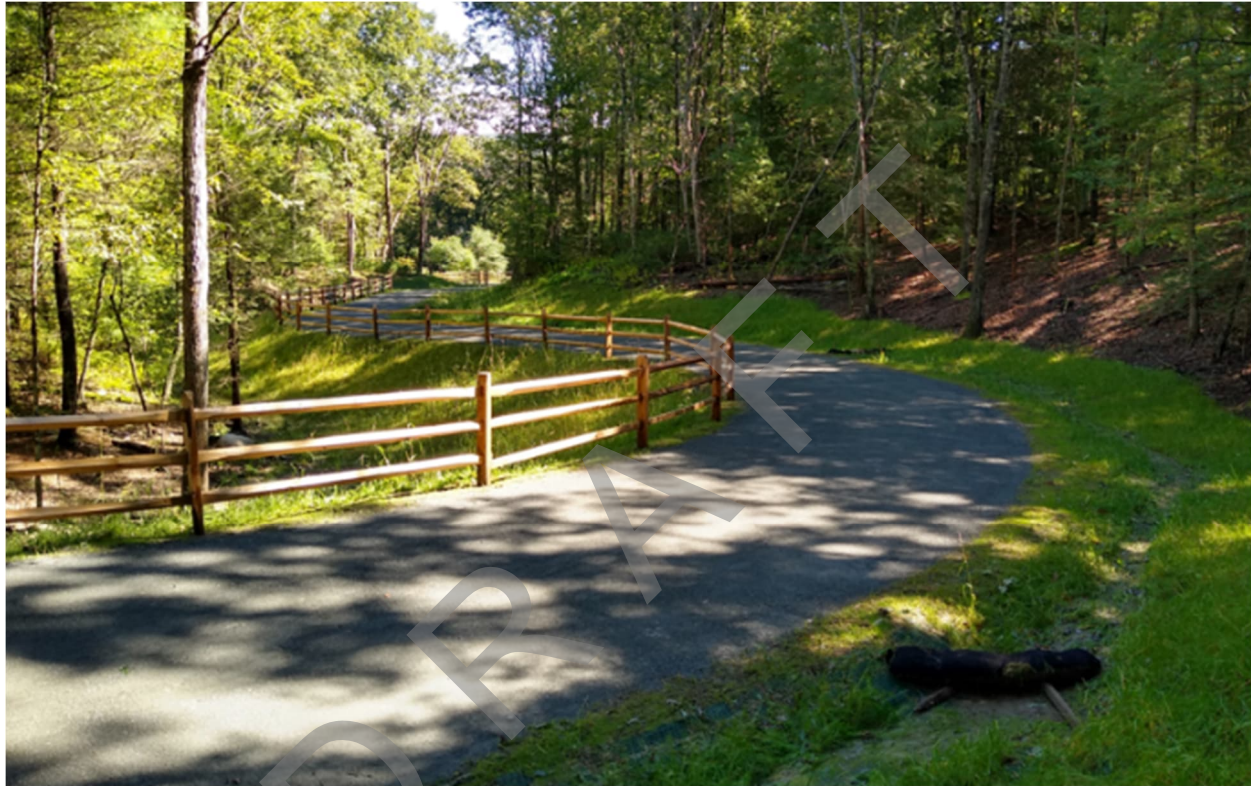
*Figure III-2 D&H Canal Trail, Town of Mamakating*

An alternative to the traditional hard surface material, is a crushed stone aggregate surface course that is bound by clay particles. The natural materials of this surface course appeal to the environmental setting of the project by maintaining the natural aesthetic and feel of the D&H corridor, blending with the surrounding environment. Examples of this durable stone course system use includes the D&H Canal Trail in the Town of Mamakating, NYS OPRHP Minnewaska State Park, the Rockefeller State Park Preserve, and the Ashokan Rail Trail in Ulster County.

Crushed Stone paths provide a durable and relatively flat surface, making them suitable for various types of trail users. While crushed stone trails can be ADA compliant, they may not offer the same level of convenience and smoothness as other surface materials, such as asphalt. Crushed stone is susceptible to vegetation growth impeding the trail width from the sides of the trail, which can occur if the trail is not regularly maintained.

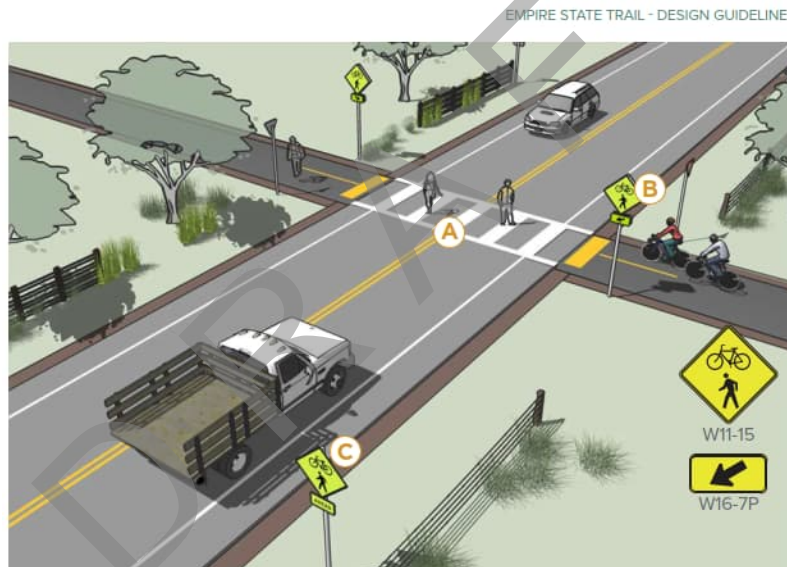
Figure III-3: Trail Crossing Components

An ideal at-grade roadway crossing has a variety of features present that warn the trail users that there is a roadway crossing present, and that warns roadway users that pedestrians and bicyclists may be crossing the roadway. The emphasis of safety should be placed on both interactions equally as it is both users responsibility to operate safely at crossings. Nearly all of the crossings evaluated need some level of improvements to the warning signs posted at and in advance of the trail crossing. At a minimum, each crossing should have pedestrian/bicyclist warning signs (B) and a crosswalk (A) installed at the location of the trail crossing, and advanced pedestrian/bicyclist crossing warning signs (C). The advanced pedestrian warning signage should be installed 200 ft. from all of the D&H Rail Trail crossings. See figure below from the Empire State Trail design guide.

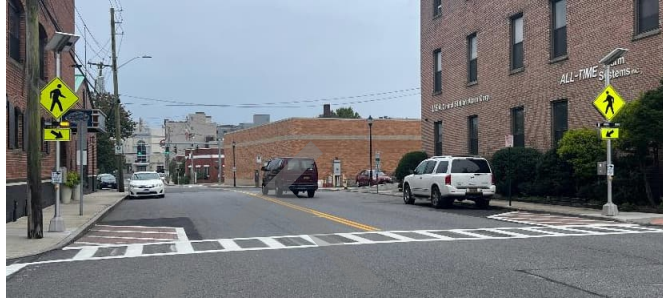
Figure III-3: RRFB Installation

Due to the existing speeds on the roadway reportedly exceeding the posted speed limit, Rectangular Rapid Flashing Beacons (RRFBs) should be installed at this location in addition to the standard pedestrian-bicycle crossing signage. RRFBs are high-intensity flashing yellow beacons mounted on standard pedestrian warning signs at uncontrolled crosswalks, see Figure III-4 for an installed example. These beacons are activated by pedestrians pressing a button before crossing. RRFB installations are cost-effective and have been proven to significantly improve motorist yield rates at marked crosswalks. The beacons can be powered by either solar energy or a connection to the electrical grid. For this installation, two beacon assemblies should be positioned on the west and east sides of CR 24, with flashing beacons installed on both sides of the posts to provide coverage for each approach to the crosswalk.

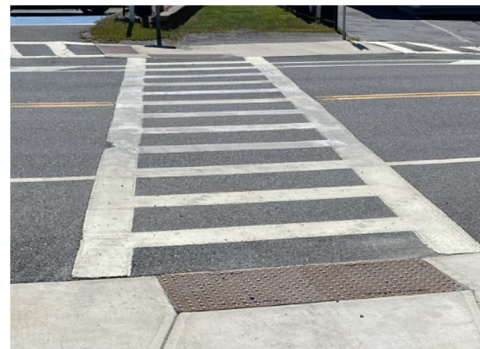
Figure III-5: Main St Crossing

The Main Street crossing appears to have been recently constructed, featuring a painted crosswalk and ADA-compliant curb ramps equipped with detectable warning strips. Proper signage is also in place to warn motorists of the crossing. Advance warning signage should be installed 200 ft. prior to the crossing in each direction. For specific signage requirements at each crossing, refer to Table III-2.

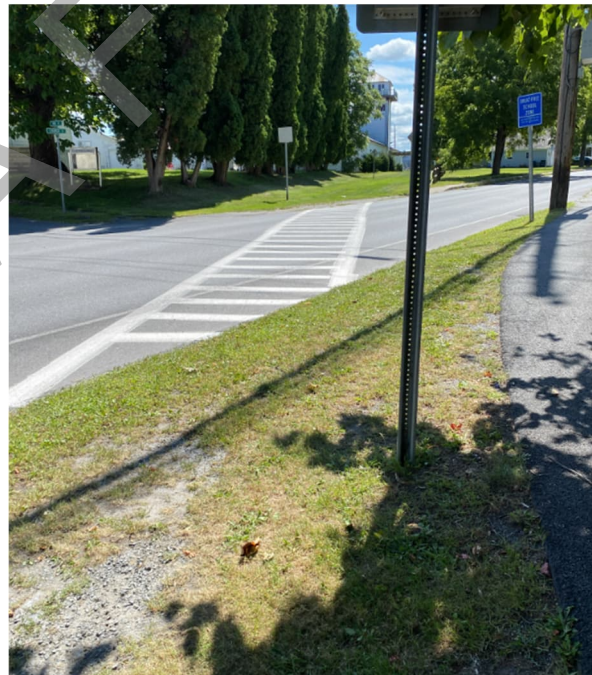
*Figure III-6: Church St Crossing*

Church Street was identified as having the highest AADT among all the evaluated crossings with 2,997 vehicles per day. The current crossing features a recently painted crosswalk with grass approaches on both sides. However, these grass approaches exhibit an elevation difference between the trail and the edge of the pavement, making the crossing inaccessible for users with disabilities and inconvenient for cyclists. To address this issue, a curb ramp matching the width of the trail should be installed, with detectable warning strips spanning the full width of the trail. This will provide a smooth transition from the trail to the roadway while ensuring compliance with ADA standards.

Additionally, the crosswalk is currently oriented at an angle across the roadway, creating an 80 ft. crossing distance and prolonging pedestrian exposure to traffic. It is recommended that the crosswalk be reconfigured so that the crossing is perpendicular to the roadway, reducing the crossing distance to 30 ft. and reducing the crossing time by more than 50%.

Reconfiguring the crossing to achieve a perpendicular alignment would likely necessitate minor property acquisition to accommodate the trail adjustment.

The crossing currently includes warning signs on one side of each post. Signage should be added so it is present on both sides of the posts, ensuring visibility from both directions of the crossing. Finally, advance warning signage should be installed 200 ft. in advance of the crossing. See Table III-2 for details on recommended signage. Additionally, due to the higher traffic volume, Rectangular Rapid Flashing Beacons (RRFBs) should be installed to enhance driver awareness of the crossing location.
