FINAL Technical Memorandum
Village of Granville Trail Connections Analysis
CR 24 (North Street) Complete Streets

Memo To: Mr. Jack Mance, Senior Transportation Planner
Adirondack/Glens Falls Transportation Council

Date: February 21, 2025

From: Barton & Loguidice, D.P.C. (B&L)

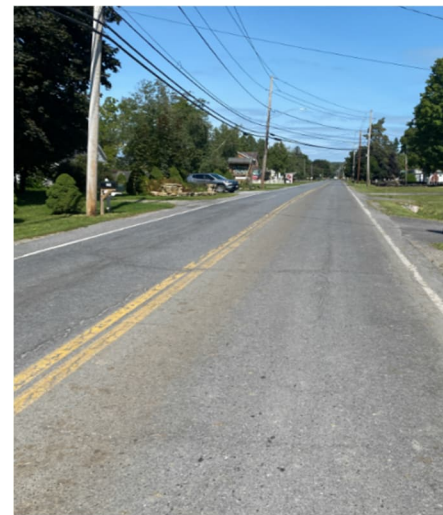
Figure II-1 – CR 24 Roadway

CR 24 is classified as a Rural Minor Collector with an annual average daily traffic (AADT) of 2,403 vehicles per day and an 85th percentile speed of 38 mph, as documented by the NYSDOT Traffic Data Viewer. The NYSDOT traffic and speed data were collected near the Village line, approximately where the D&H Rail Trail crosses CR 24. This area is more urban in setting with curbing and buildings close to the road. North of where the data was collected, the speed limits changes from 30mph to 35mph, and traffic speeds likely similarly increase through the more rural setting. The travel lanes are approximately 11 ft. wide, while shoulder widths vary between 0 and 4 ft. Currently, the corridor lacks designated bike lanes and appropriate signage to support bicycles and most of the corridor does not include sidewalks to accommodate pedestrians. For detailed measurements and further information, please refer to Appendix 1.

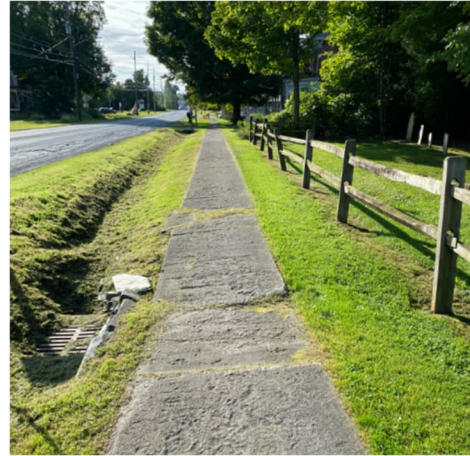
Figure II-3-Existing Sidewalk

Sidewalks are present along the west side of CR 24 between the intersection with E. Main St. in Granville and 63 North St. (CR 24), and on the east side from E. Main St. to 28 North St. The length of sidewalk on the west side is approximately 2,000 ft. long, and 900 ft. long on the east side. Additionally, sidewalks are present at the north end of the project limits from Chapmans General Store to 1330 North St. (CR 24), a length of approximately 2,000 ft. All of the existing segments were assessed for compliance with the Americans with Disabilities Act (ADA) and evaluated based on several key criteria: missing panels, panel heaving, obstructions, and width. This study also evaluated the 1.3 miles of CR 24 roadway between 63 North St. and 1330 North St. for the addition of pedestrian facilities.

Each existing sidewalk segment was analyzed individually, typically representing one block, unless interrupted by significant features such as large commercial driveways or unusually lengthy segments. The assessment revealed that, out of the eight locations surveyed, seven segments were rated as partially accessible or not accessible resulting in non-compliant conditions with ADA standards. The most common deficiency included heaving panels which were found in all but one segment, followed by missing panels which were found in five segments. The segment of sidewalk from E. Main St to 13 North St. was rated as mostly accessible, the only segment in the study corridor. Detailed ADA compliance findings, including specific issues identified and ratings, are provided in Appendix 1.

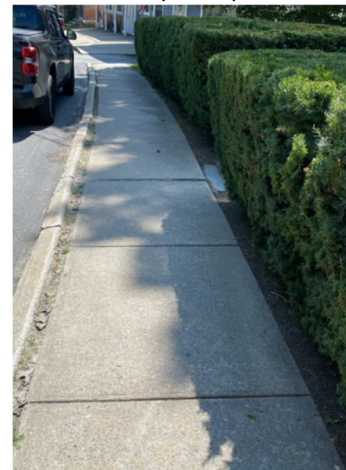
Figure III-2: 13 North St. to E. Main St.

The sidewalk segment from 63 North St. to 13 North St. has been rated as "Not Accessible" due to its narrow width, cracked, and missing panels. The current conditions necessitate a full replacement with a new 5 ft. wide sidewalk to meet ADA standards. The west side of CR 24 from 13 North St. to East Main St. includes a 4 ft. wide sidewalk that widens to over 5 ft. as it nears E. Main St. A driveway between south of 5 Main St. shows signs of deterioration at the sidewalk crossing, with uneven pavement, creating obstacles for individuals with disabilities. Similar conditions were observed at the driveway of the Veterans of Foreign Wars eatery. This segment of the sidewalk is rated as "Partially Accessible" as outside of the noted deficiencies, it is in relatively good shape. The segment from 28 North St. to E. Main St. on the east side of CR 24 has been rated as "Not Accessible" due to minor deficiencies within the sidewalk concrete and utility poles placed in the middle of the sidewalk that restrict the sidewalk width to less than 4 ft. North of 28 North St., the sidewalk diverges onto Pine St. The 900 ft. segment of sidewalk on the east side of CR 24 from E.

Main St. to 28 North St. should be replaced with a new 5 ft. sidewalk, and the utility poles should be relocated to behind the new sidewalk to meet ADA requirements. On the west side of CR 24, the 300 ft. segment between E. Main St. and 13 North St. should be spot repaired where panels are heaving, uneven, exhibit large cracks, or where crossings of driveways are not flush with the pavement. North of 13 North St. (CR 24) the entire sidewalk and curb should be replaced, approximately 1,650 ft. Ideally a 4-5 ft. snow storage buffer would be provided between the sidewalk and the curb. However, there does not appear to be adequate width to accommodate this buffer due to roadside features such as retaining walls, buildings, and the existing topography behind the existing sidewalk.

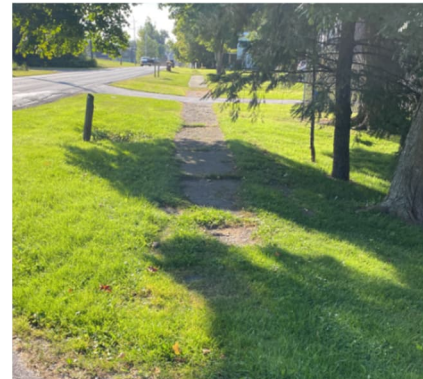
Figure III-3: Existing Sidewalk near Cove Lane intersection

The existing 4-foot-wide sidewalk is located on the west side of the roadway only and exhibits several deficiencies, including panel heaving or missing sections, surface deterioration, and overgrown vegetation. Given the extent of these issues, a complete reconstruction of the sidewalk is necessary. This includes excavation and replacement of the approximately 2,000 ft. of 5 ft. sidewalk, with integrated curb ramps and detectable warning strips at intersections. Reconstruction would not require additional right-of-way acquisitions, as the new sidewalk would be installed in the same location as the existing sidewalk. Minor trimming of overgrown vegetation, including tree branches, may also be required.
