# Lake Shore Drive Pedestrian Connections

Lake Shore Drive Pedestrian Connections

Final Report

Barton & Loguidice, D.P.C.  
10 Airline Drive, Suite 200  
Albany, New York 12205

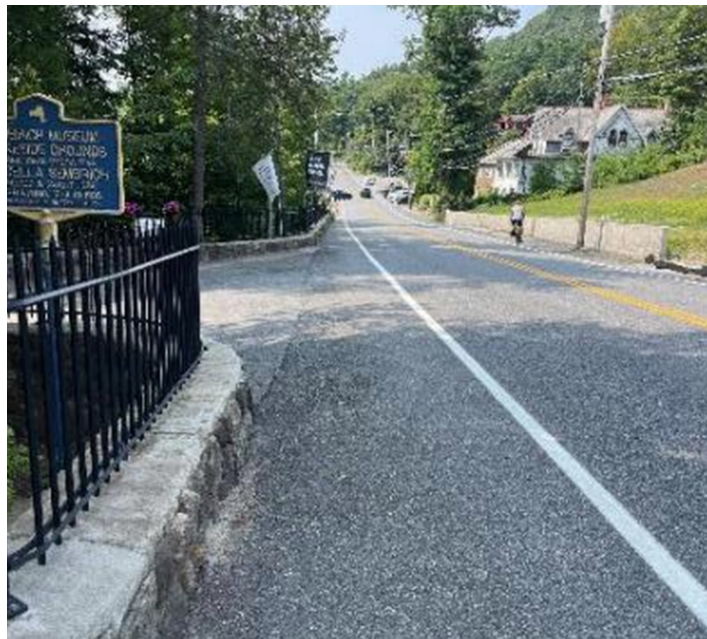
Figure 2 - Roadside conditions along the corridor, showing retaining walls on both sides of the roadway, a driveway, and utility poles on the west side.

The corridor transitions between residential and commercial land uses, with multiple retaining walls located approximately 5 to 7 feet from the outer pavement edge. Numerous driveways, parking areas, and building frontages are situated directly adjacent to the roadway. Sidewalks are absent on both sides of Lake Shore Drive.

Utility poles are predominantly located along the west side of the corridor and are generally situated within the roadway clear zone, with offsets varying from approximately 5 to 8 feet from the pavement edge. Additional obstructions beyond the shoulders include property fences, drainage structures, business signage, mature trees, guide rail, and landscaping features.

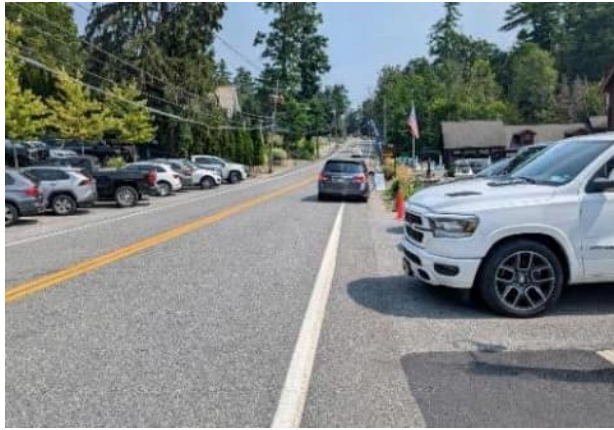
Figure 3 - Roadside conditions along the corridor, showing parking lots adjacent to corridor.

Pedestrian activity along the corridor is frequent, particularly near Chic's Marina and the Algonquin Restaurant. Both businesses are located on the east side of the roadway, with their primary parking lots situated on the west side. Patrons also use parallel or angled parking directly adjacent to Lake Shore Drive.

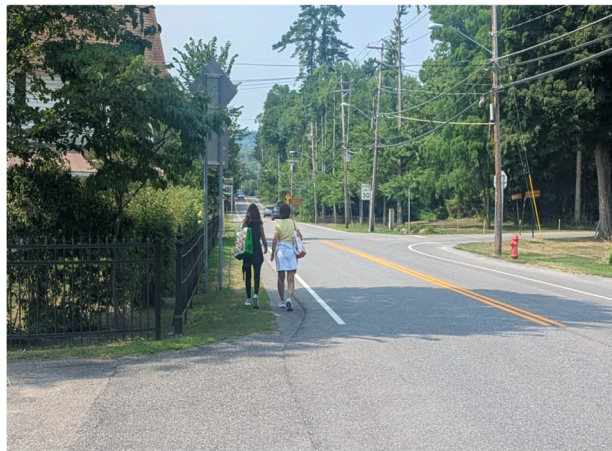
Figure 4 - Pedestrians walking on the east side of the corridor.

Sight distance for pedestrians is often limited by parked vehicles adjacent to the roadway. Pedestrians were observed walking along the east shoulder, where no designated sidewalks, crosswalks, or pedestrian warning signs are currently provided.

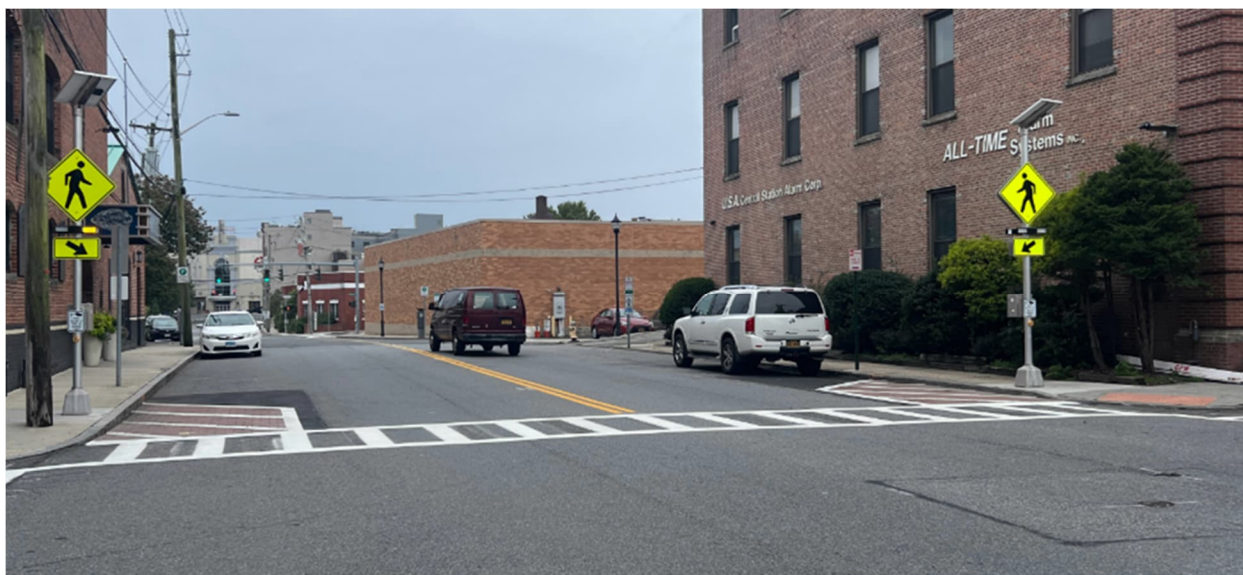
Figure 7 – RRFB's installed on a B&L Project on Abendroth Ave. in Port Chester, NY.

Rectangular Rapid Flashing Beacons (RRFBs) should also be considered at each crossing location. RRFBs enhance crossing visibility and encourage driver yielding when installed at a crosswalk. The push button activated rapid flashing beacons are mounted below the pedestrian crossing sign (W11-2) and above the diagonal downward arrow plaque on both sides of the crosswalk to alert drivers that there is a pedestrian that wants to cross the roadway (see Figure7).

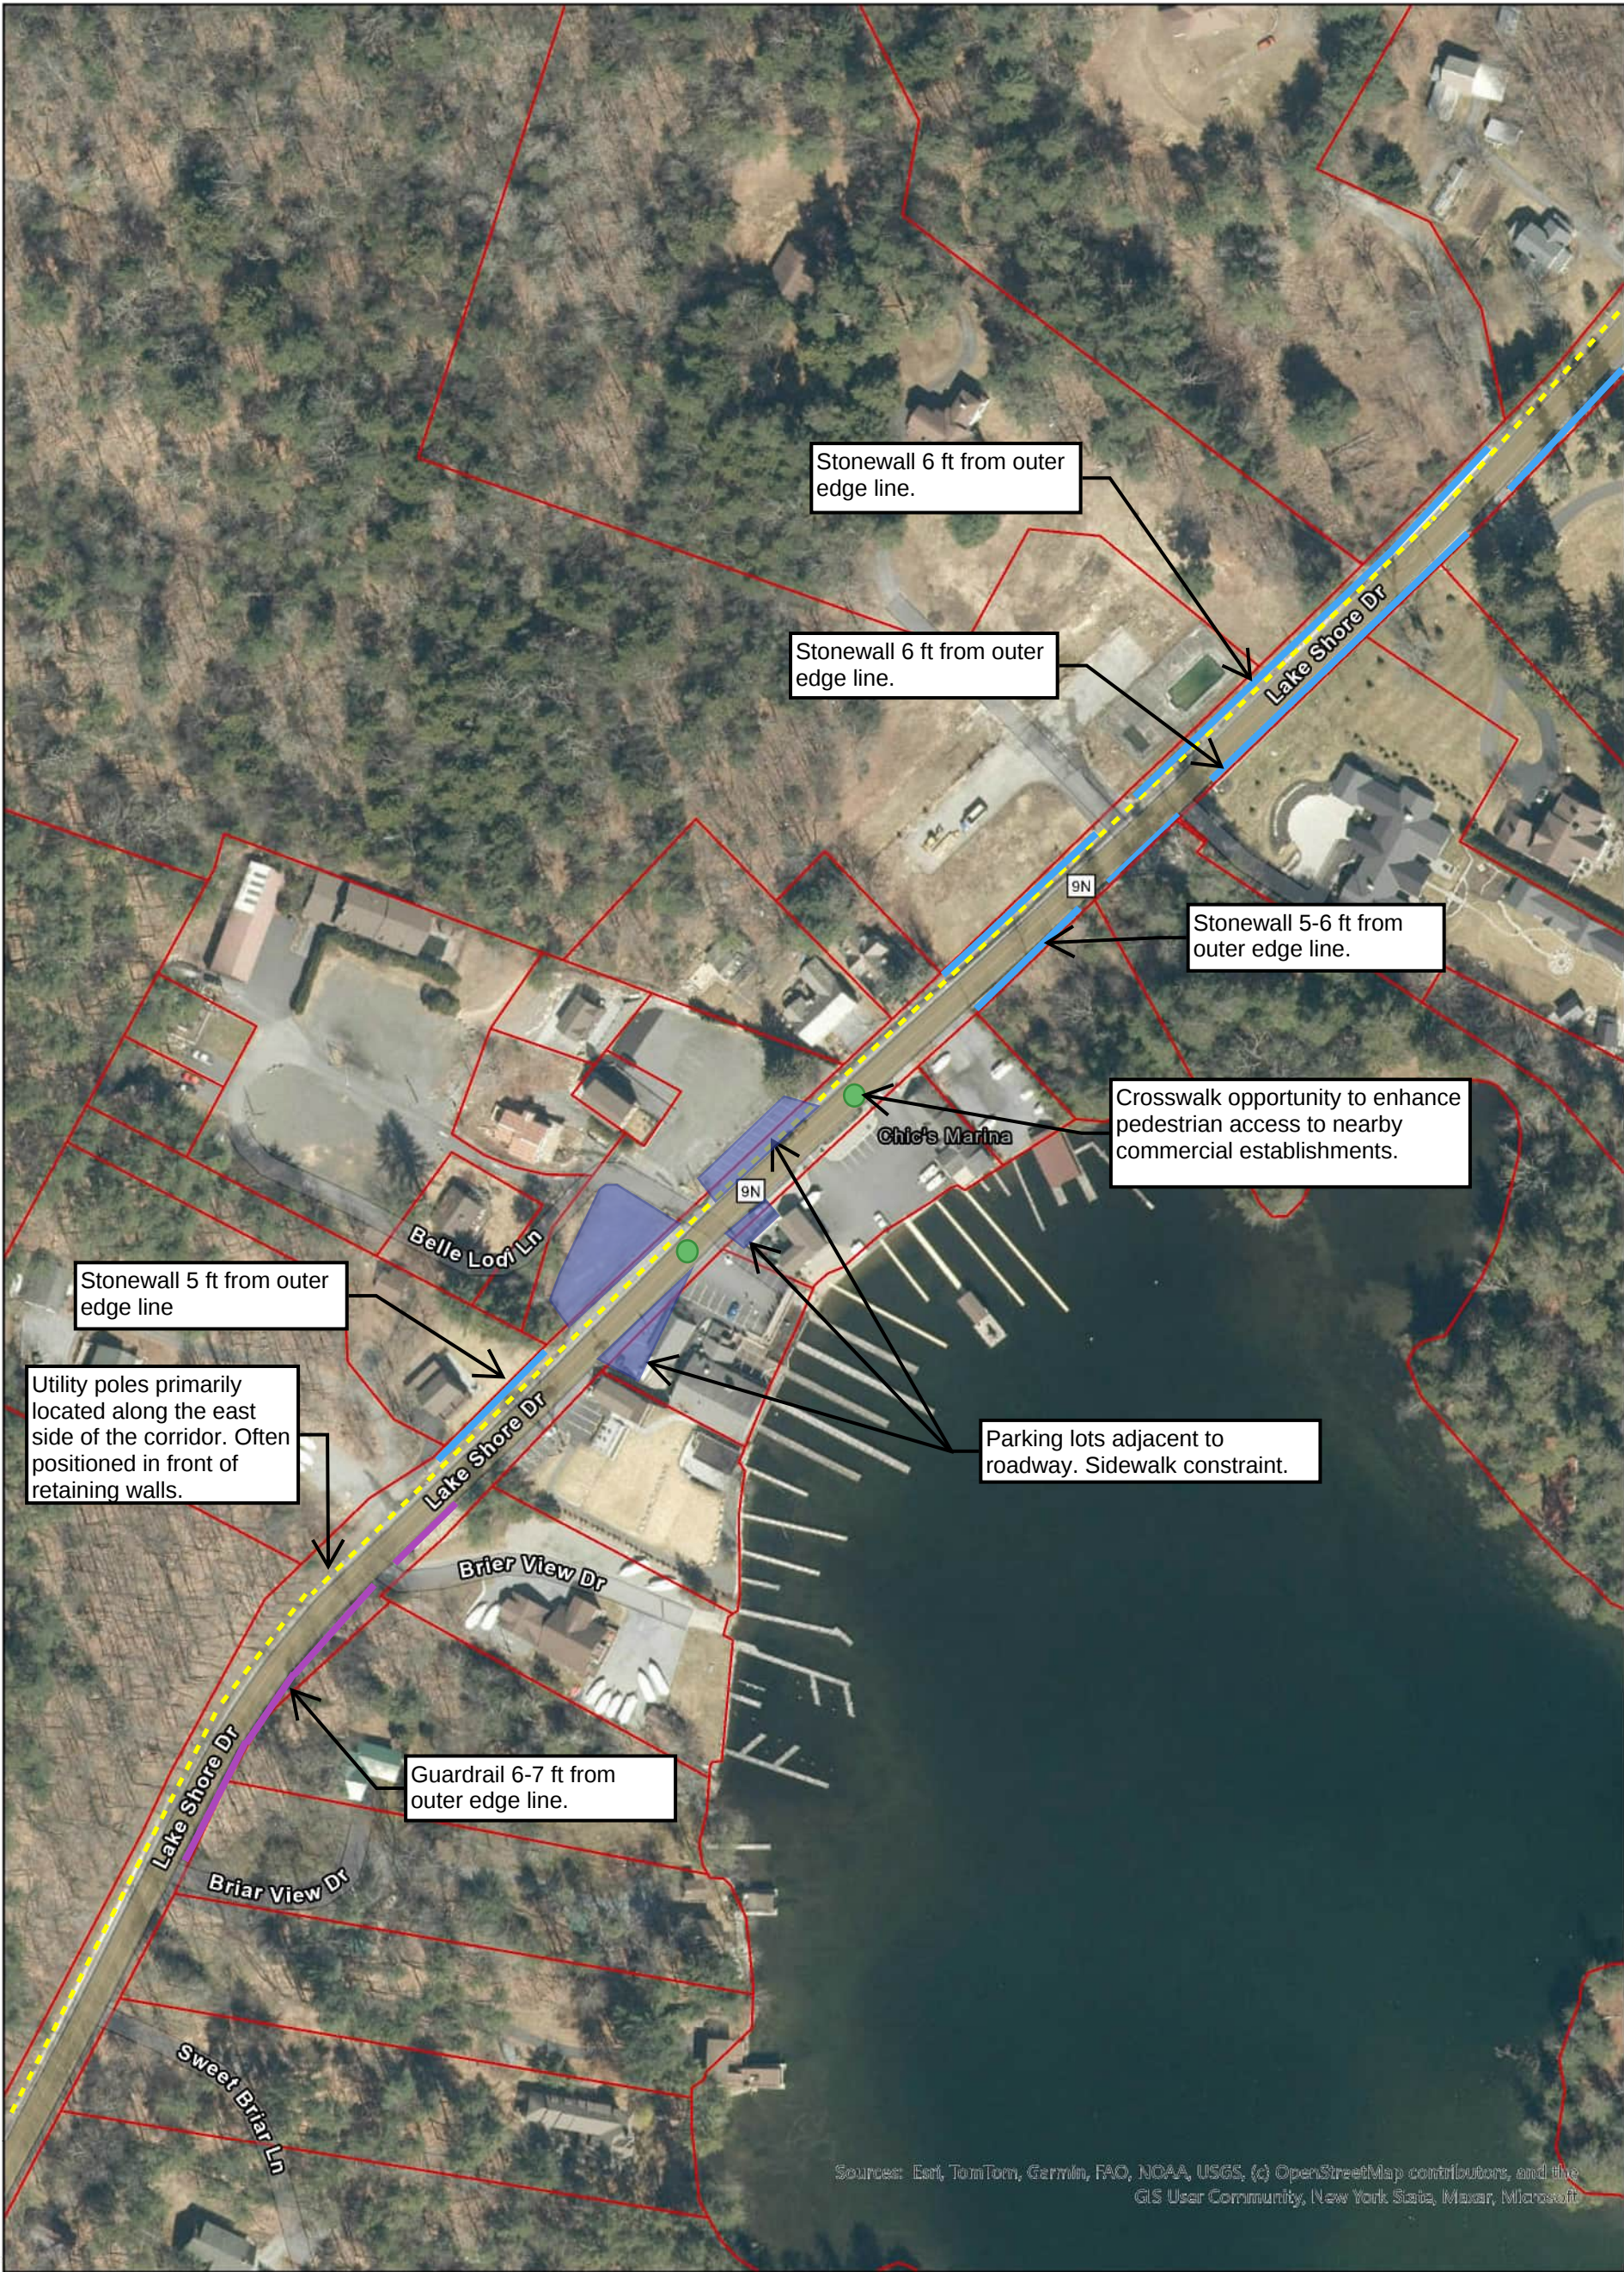
## APPENDIX A - MAPPING OF EXISTING CONDITIONS

- Guardrail Constraint
- Wall/Fence Constraint
- Utility Poles Constraint
- Parking Lot Constraint
- ROW
- Crosswalk Opportunity

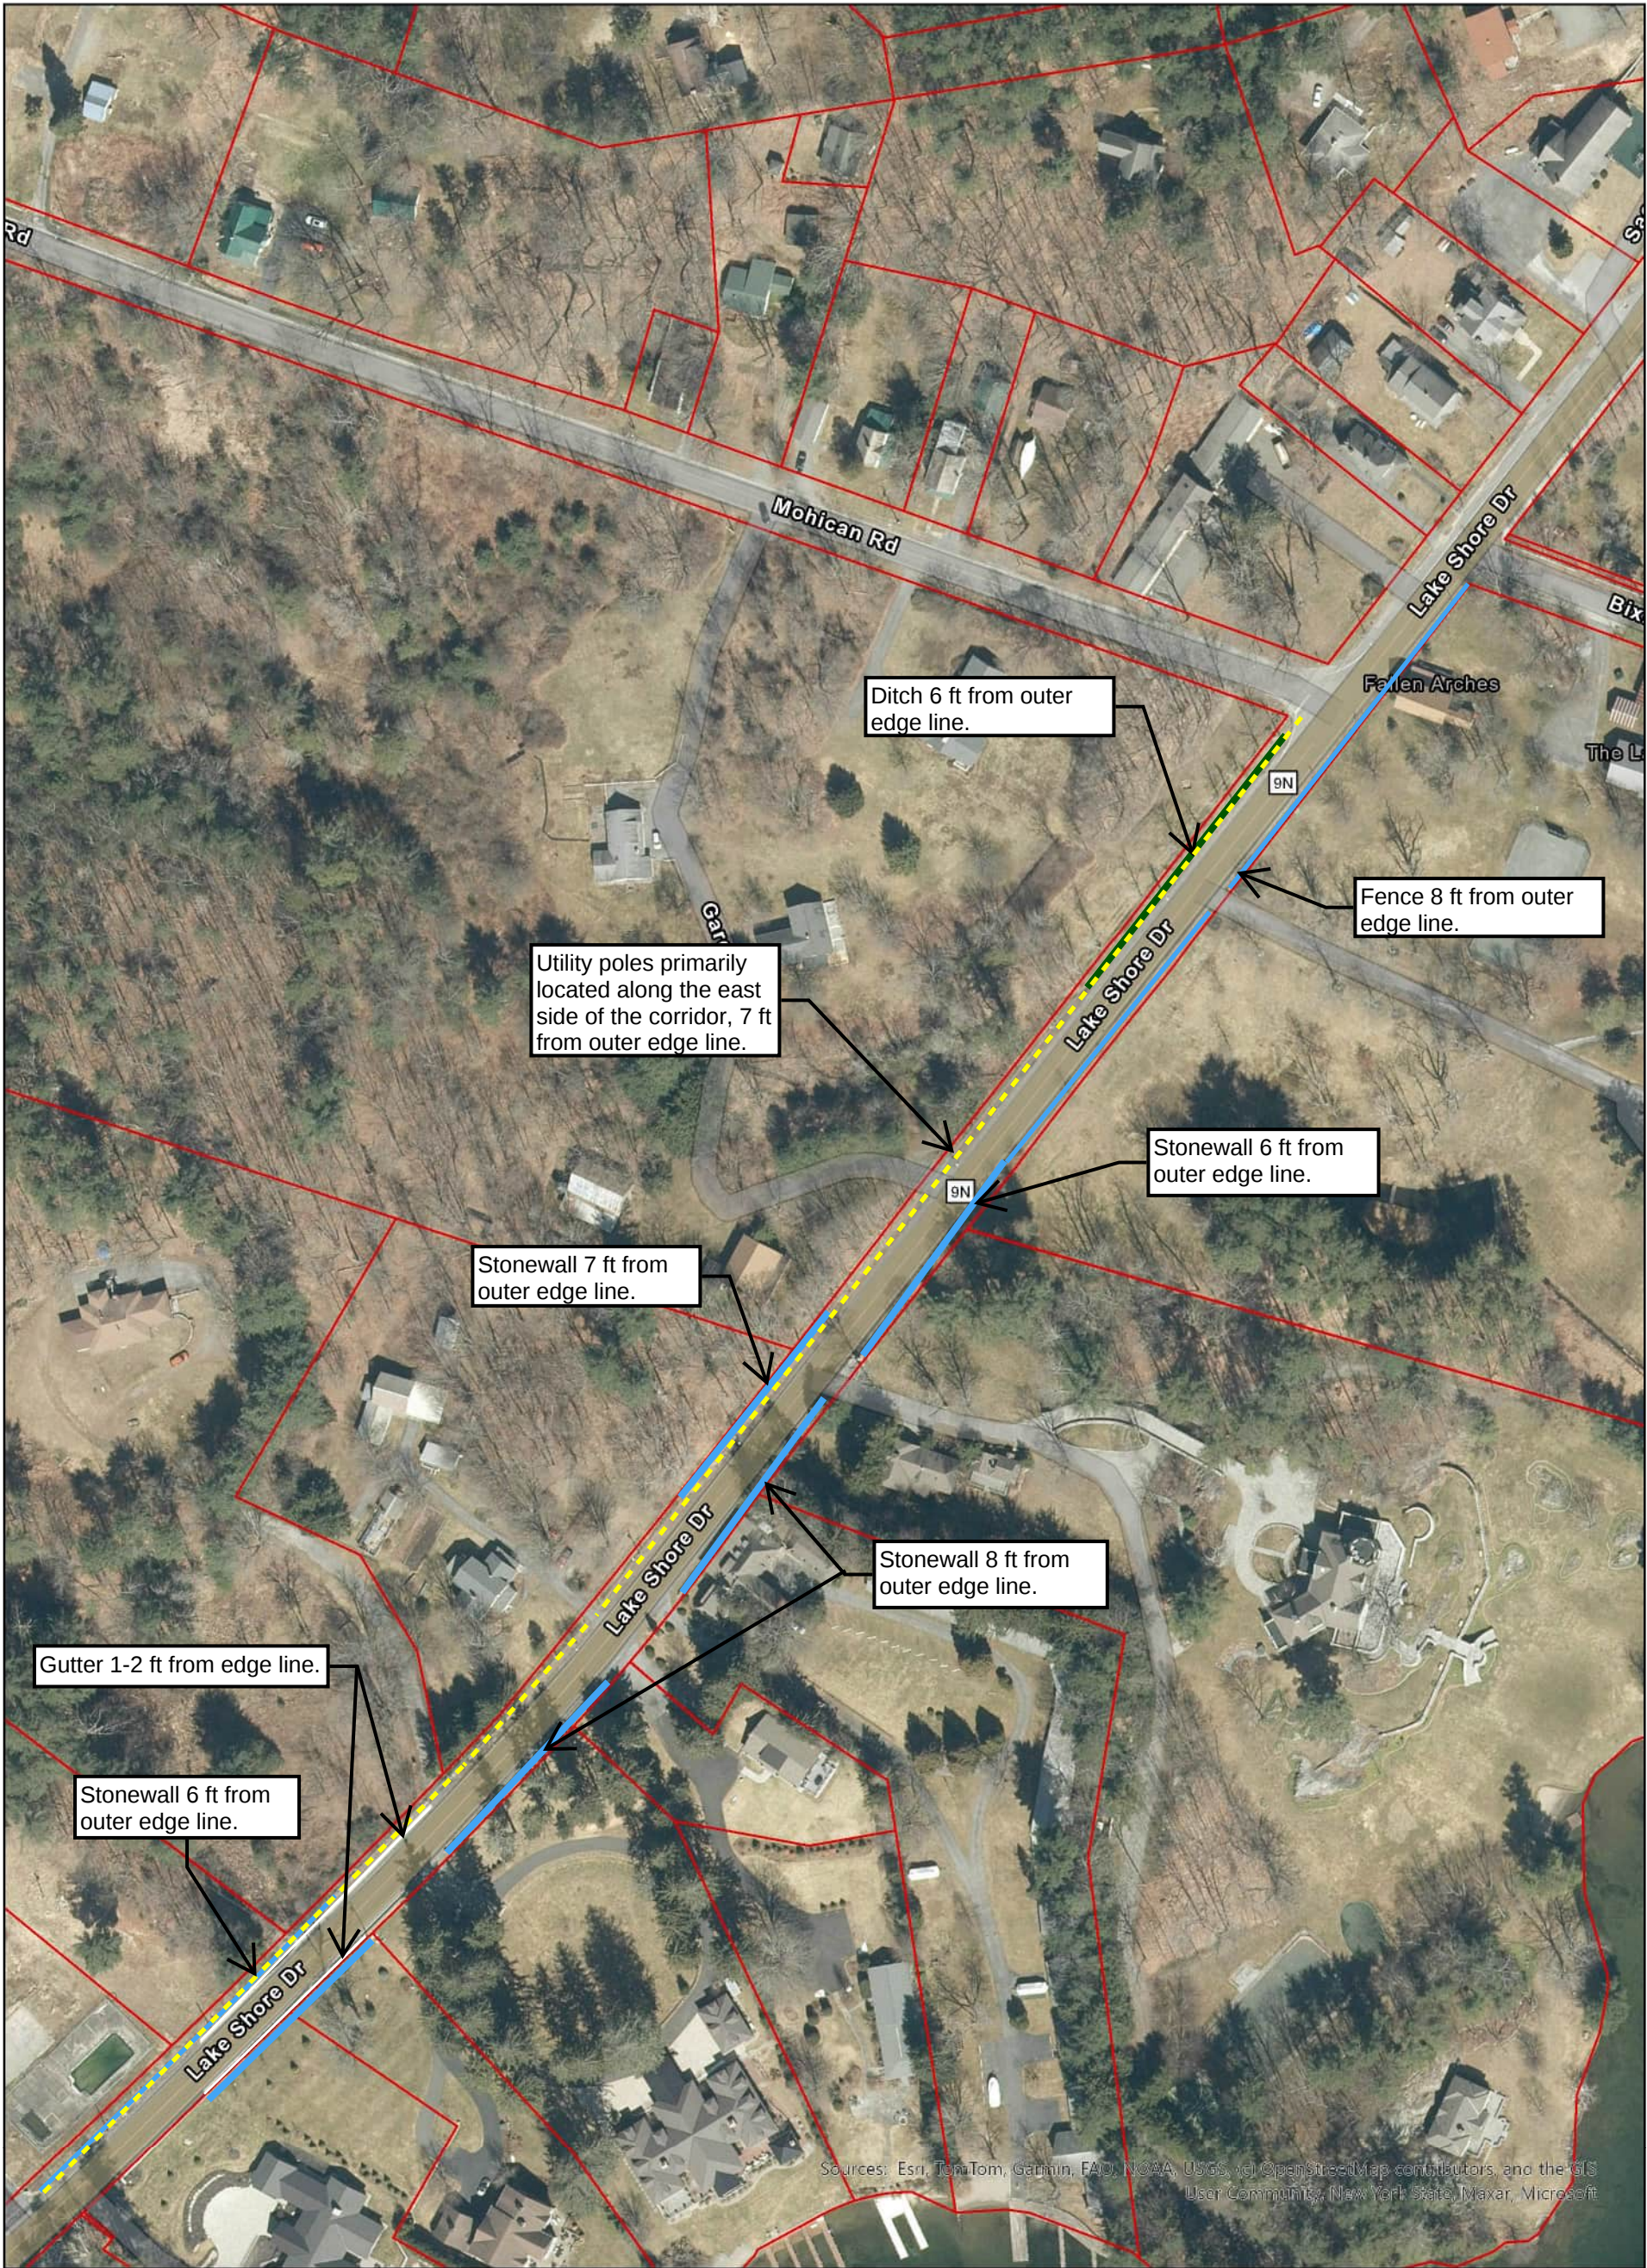
- Wall/Fence Constraint
- Ditch Constraint
- Utility Poles Constraint
- ROW
- Crosswalk Opportunity

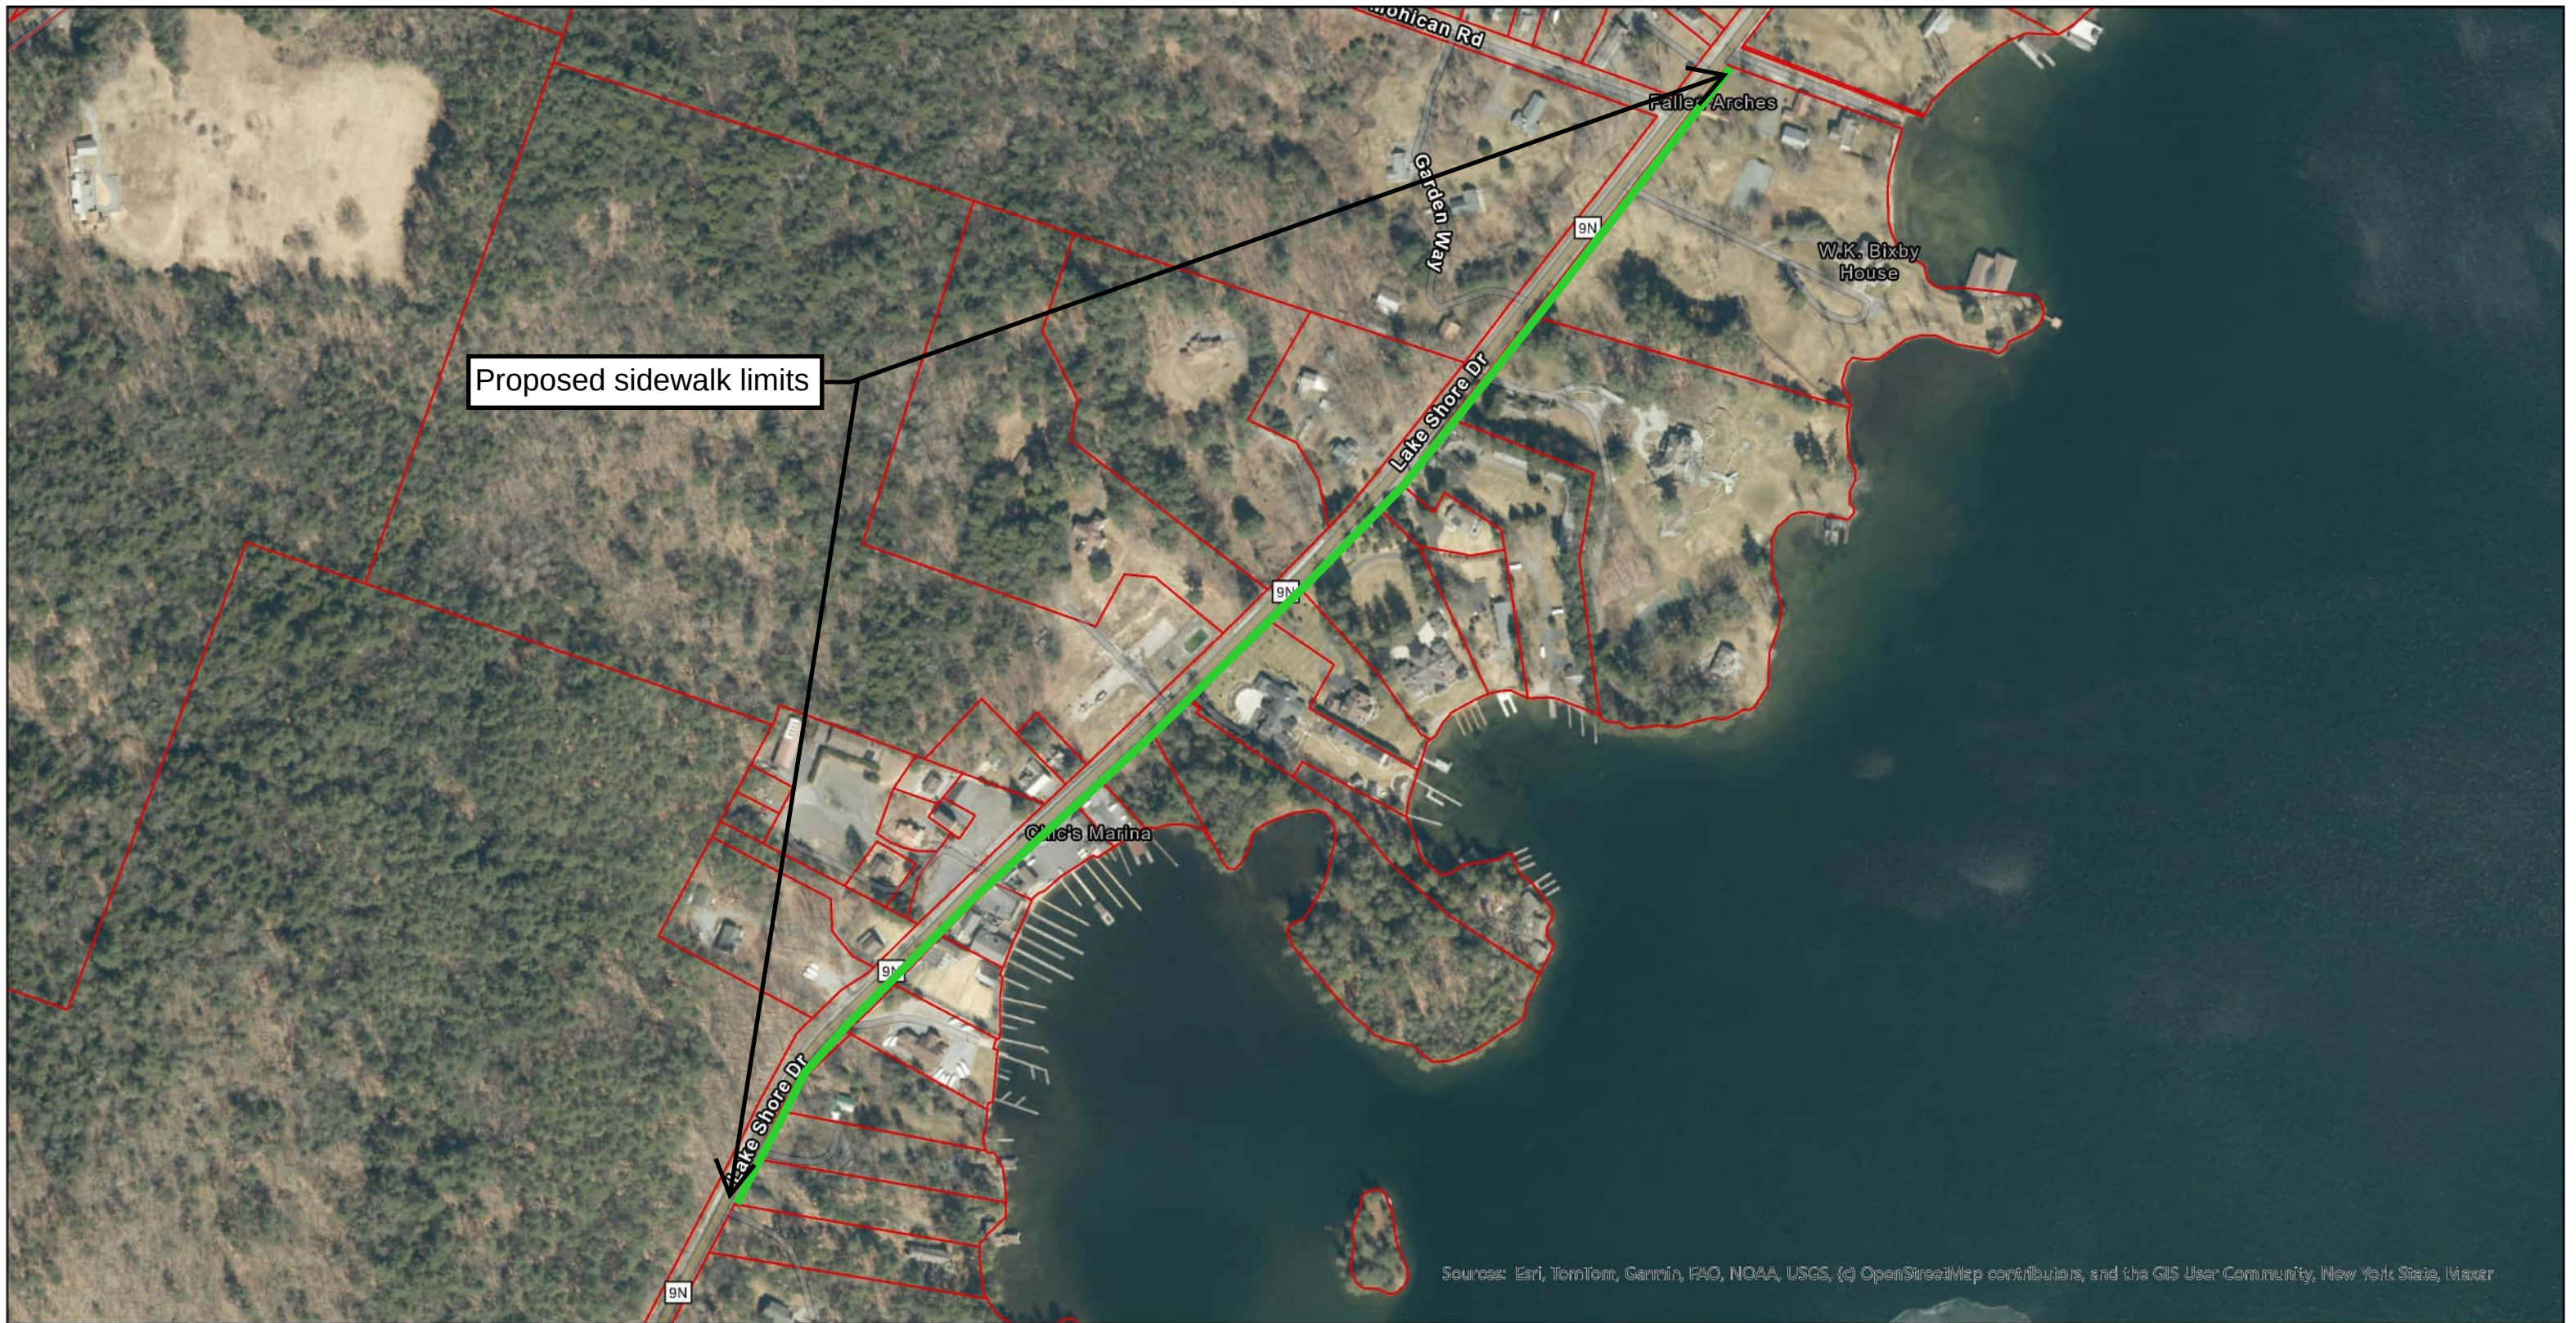
Figure  
3  
Project  
1896.013.001  
09/29/2025

Proposed sidewalk limits

**Town of Bolton**  
**Lake Shore Drive Pedestrian Connections**  
**Existing Conditions Opportunities & Constraints**
