Harrison Avenue/Main Street Intersection Evaluation

Draft Report

**Barton
& Loguidice**

**Adirondack | Glens Falls Transportation
Council**

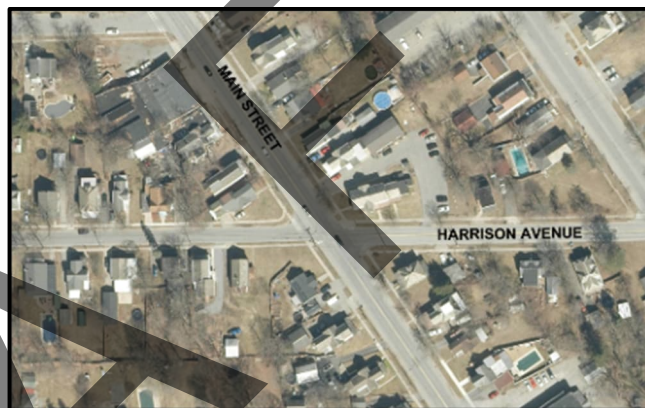
Figure 2-1: Harrison Avenue/Main Street Intersection

The Harrison Avenue/Main Street intersection is a four-way intersection with stop control on the minor street approaches (Harrison Avenue) and uncontrolled on Main Street. Both roadways are owned and maintained by the Village of South Glens Falls and are subject to a Village-wide speed limit of 30 miles per hour (mph). The observed 85th percentile speed was 35 mph.

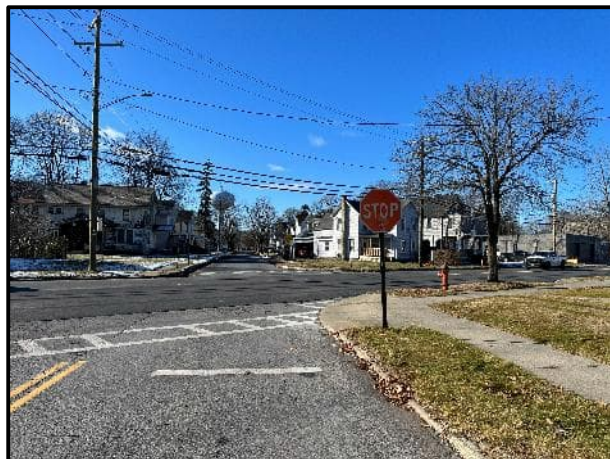
Figure 2-2: Looking west on Harrison Avenue

Sidewalks are present along both Harrison Avenue and Main Street, providing pedestrian access to schools, residences, and businesses within the corridor, including Stewart's Gas Station to the north, Oliver W. Winch Middle School and Harrison Elementary School to the east, and nearby other commercial properties and apartment buildings. The general setting within the immediate vicinity of the intersection is residential with single and multi-family homes. The curb ramps at the intersection are not ADA compliant; lacking detectable warning pads, the ramps are not flush with the pavement at three of the four ramps.

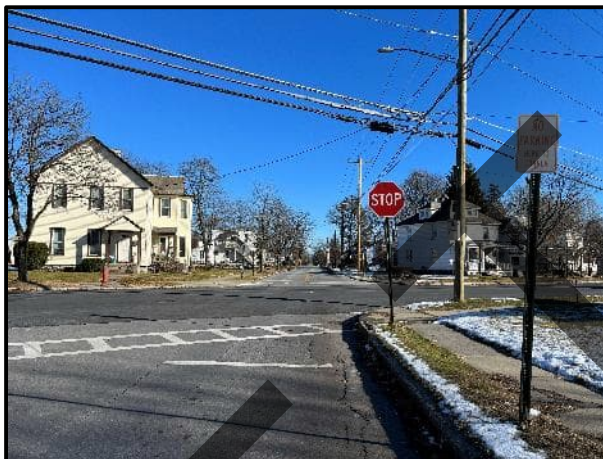
Figure 2-3: Looking east on Harrison Avenue

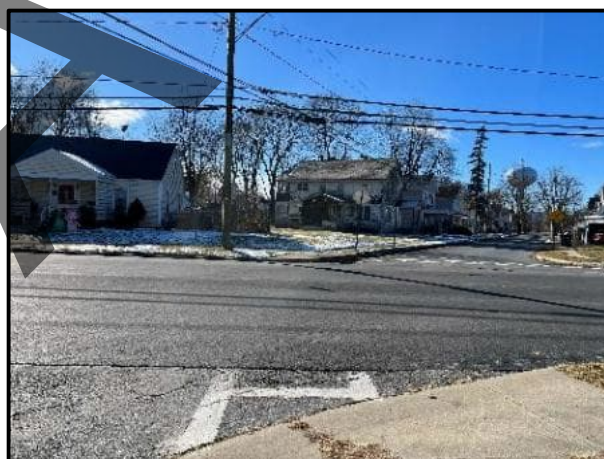
During the site visit, existing crosswalk markings on Main Street were observed to be faded and not continuous across the street, as shown in Figure 2-4. However, these same crosswalk markings were repainted in January or February. "No Parking" signs are installed on Harrison Avenue approximately 10 feet from the "Stop" sign. On Main Street, pedestrian warning signs with diagonal downward-pointing arrows are installed in advance of each marked crosswalk, consistent with the 2023 Manual on Uniform Traffic Control Devices (MUTCD) shown in Figure 2-5 and 2-6. "No Parking" signs are not installed on either side of Main Street approaching the intersection.

Figure 2-4: Crosswalk on Main Street

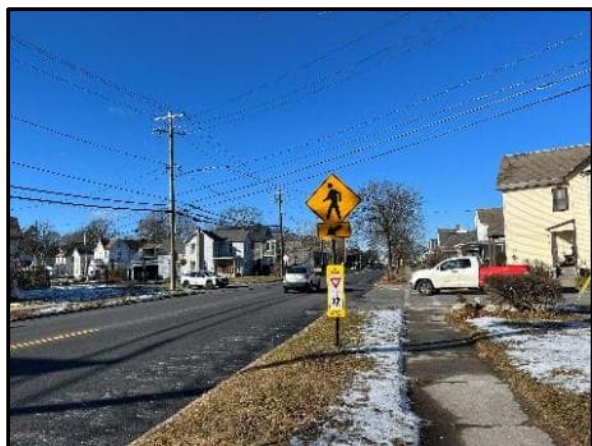
Figure 2-5: Pedestrian warning sign installed for northbound traffic on Main Street

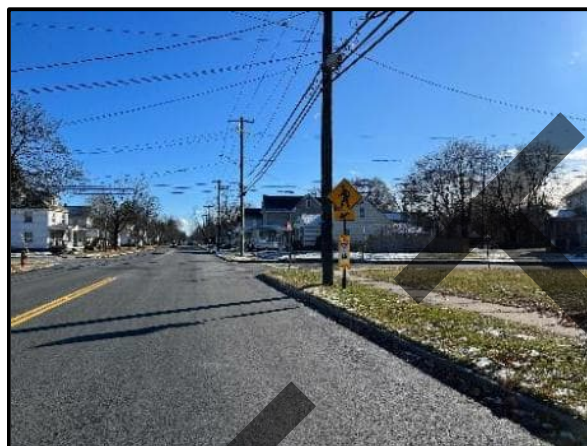
Figure 2-6: Pedestrian warning sign installed for southbound traffic on Main Street

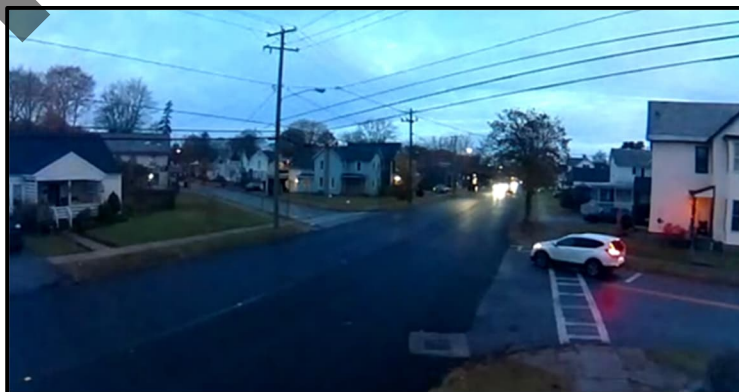
1. Vehicles traveling eastbound or westbound on Harrison Avenue frequently stop beyond the stop bar, often stopping on the crosswalk. While this positioning improves sight distance for drivers, it obstructs pedestrian access to the sidewalk and crossing area (see Figure 3-1).

Figure 3-1 Cars stopping on crosswalk

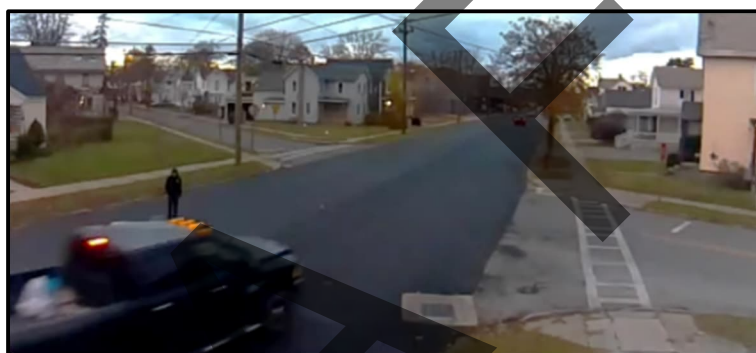
- Field observations indicated that vehicles rarely yield to pedestrians despite the presence of a crosswalk. A crossing guard is provided during school hours to assist students, but this support is limited to specific times, typically from 7:00-7:30 AM and 2:00-2:30 PM, and is not available during evenings, weekends, or non-school days. A summary of the interview with the crossing guard is in section 4 below. While vehicles are required to yield to pedestrians when they are crossing at an intersection in an unmarked crosswalk, that requirement may not be apparent to all drivers (see Figure 3-2). It should be noted that when field work by B&L staff was first performed, there were no crosswalk markings across Main St. The crosswalk markings were added in the winter of 2026 and have since improved driver compliance in yielding to pedestrians.

Figure 3-2 Car failing to yield to a pedestrian

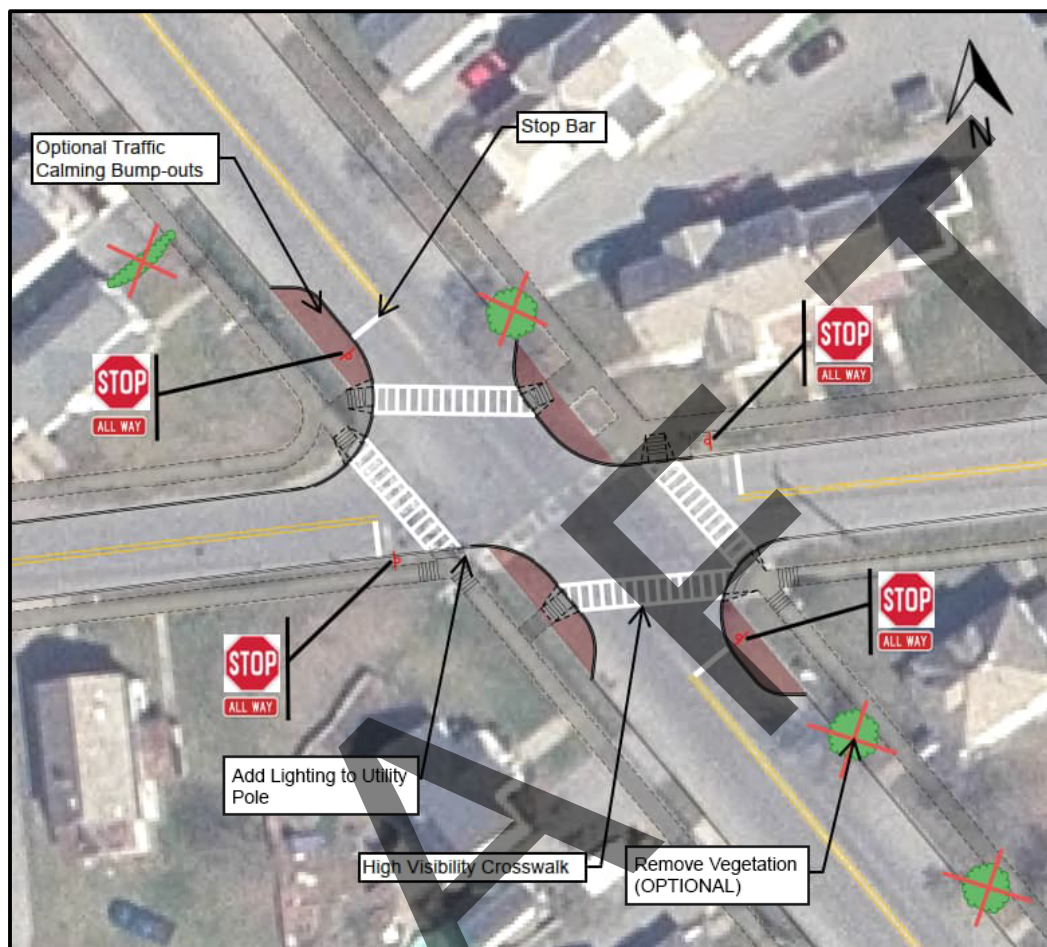
These enhancements, as shown in Figure 5-1, are further detailed in section 5.3. Important to note about this intersection is that the existing diagonal crosswalk is replaced in Figure 5-1 with a standardized four crosswalk layout, this is further discussed in section 5.3.1.

Figure 5-1 All Way Stop Control Alternative

To increase driver awareness of the crossing locations, high-visibility crosswalks should be installed on Main Street and Harrison Avenue as indicated in Figure 5-1 above. The crosswalk should be "NYSDOT Type LS" that includes parallel stripes and ladder bars to enhance visibility as depicted in Figure 5-2. The pavement markings should be Epoxy paint with glass beads for retro-reflectivity or retro-reflective thermoplastic pavement markings.

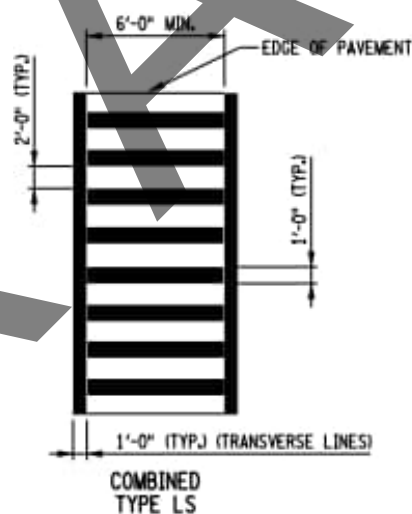
Figure 5-2: High Visibility Crosswalk Stripping

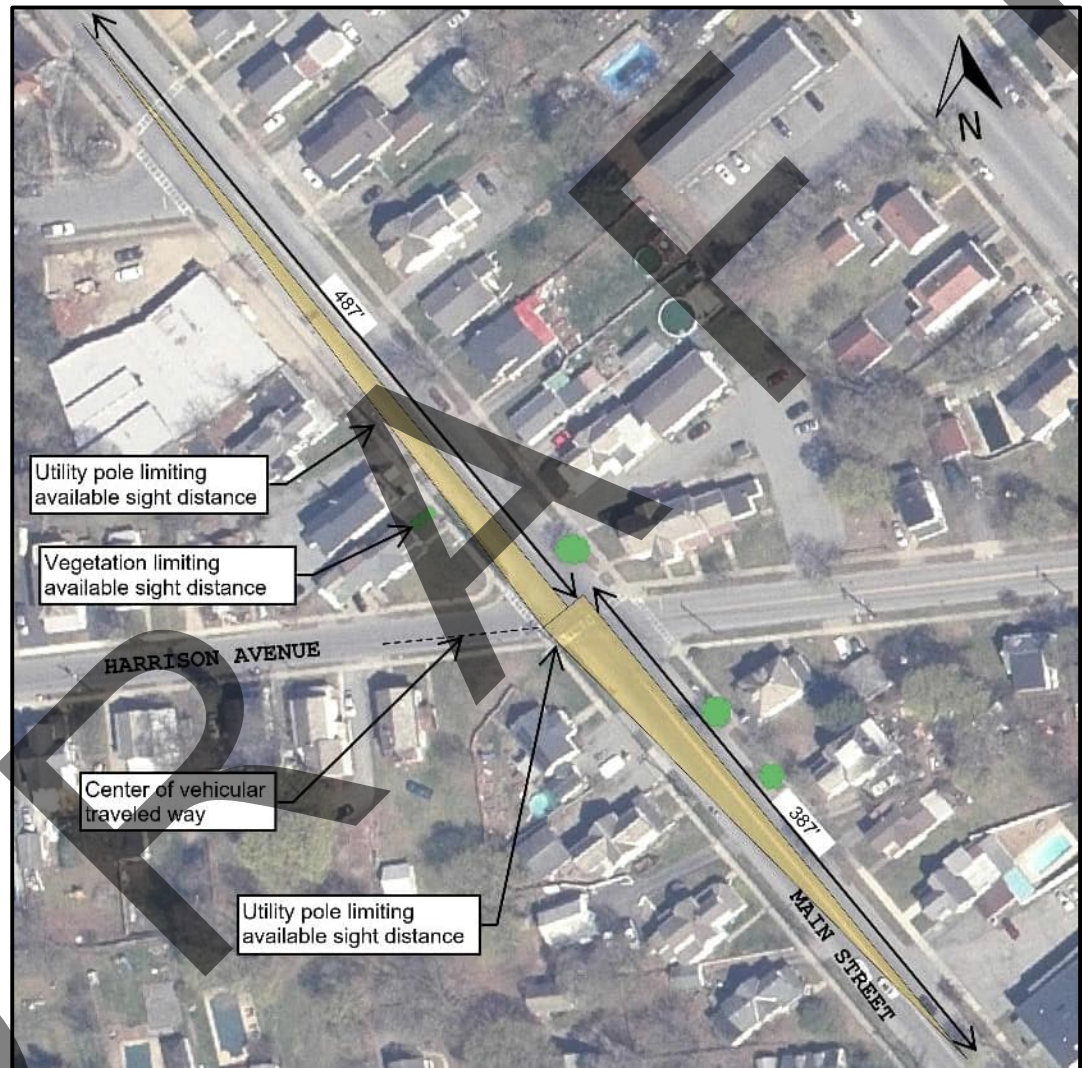
Sight distance limitations at the intersection are primarily caused by vegetation and a utility pole on the eastbound Harrison Avenue approach. Vehicles turning left from this approach experience restricted visibility to the right due to the pole, which should be relocated to meet minimum sight distance requirements. Coordination with the utility owner will be required, and relocation costs are typically borne by the utility.

Figure 5-3: Harrison Avenue eastbound sight distances

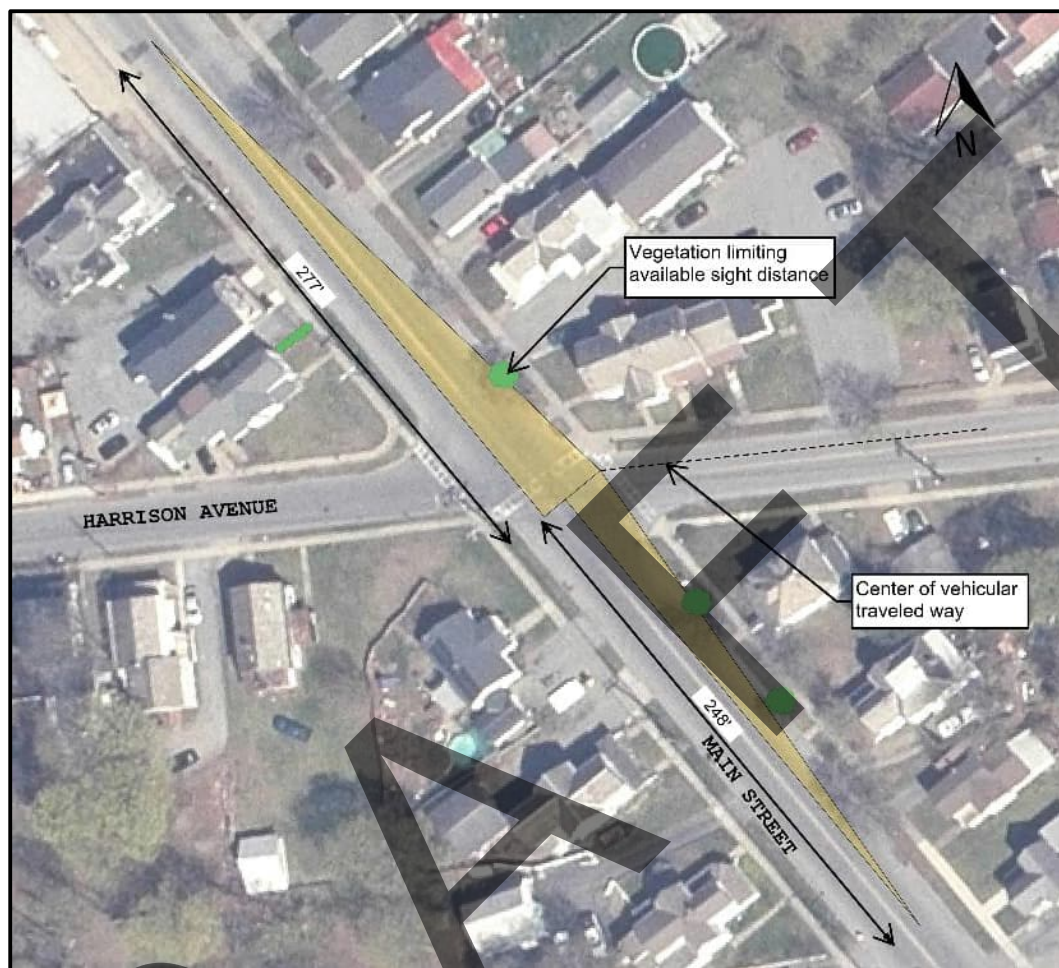
In addition, vegetation and trees located between the curb and sidewalk within approximately 250 feet of the intersection (Figure 5-4) restrict sight distance for vehicles on the westbound Harrison Avenue approach. Removal or trimming of this vegetation is recommended to improve visibility for both left- and right-turning movements onto Main Street.

Figure 5-4: Harrison Avenue westbound sight distances

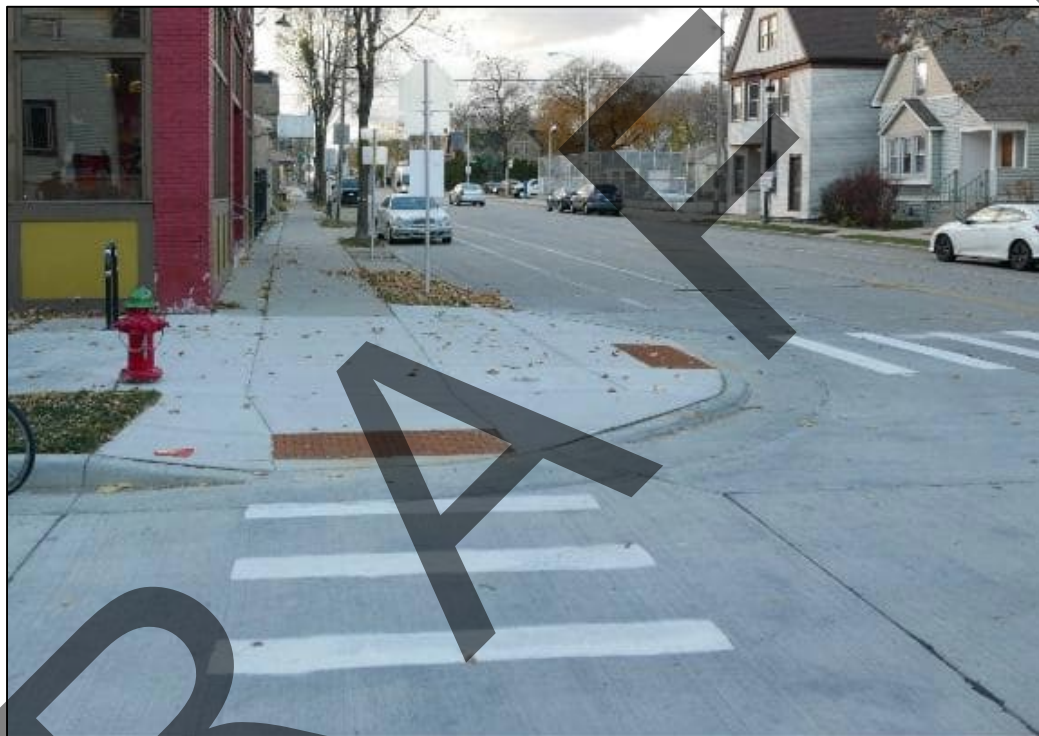
This treatment can reduce pedestrian crossing distances, improve pedestrian visibility, and provide traffic calming benefits by narrowing the roadway at the intersection, thereby enhancing overall pedestrian safety. At this intersection, curb extensions could be installed on Main Street as shown in Figure 5-1 above, allowing the pedestrian to be more visible to drivers, especially if the parking lane is occupied. An example photo of a typical Bump Out/Curb Extension at an intersection with a parking lane is provided in Figure 5-5

Figure 5-5 Traffic Calming Bump Outs

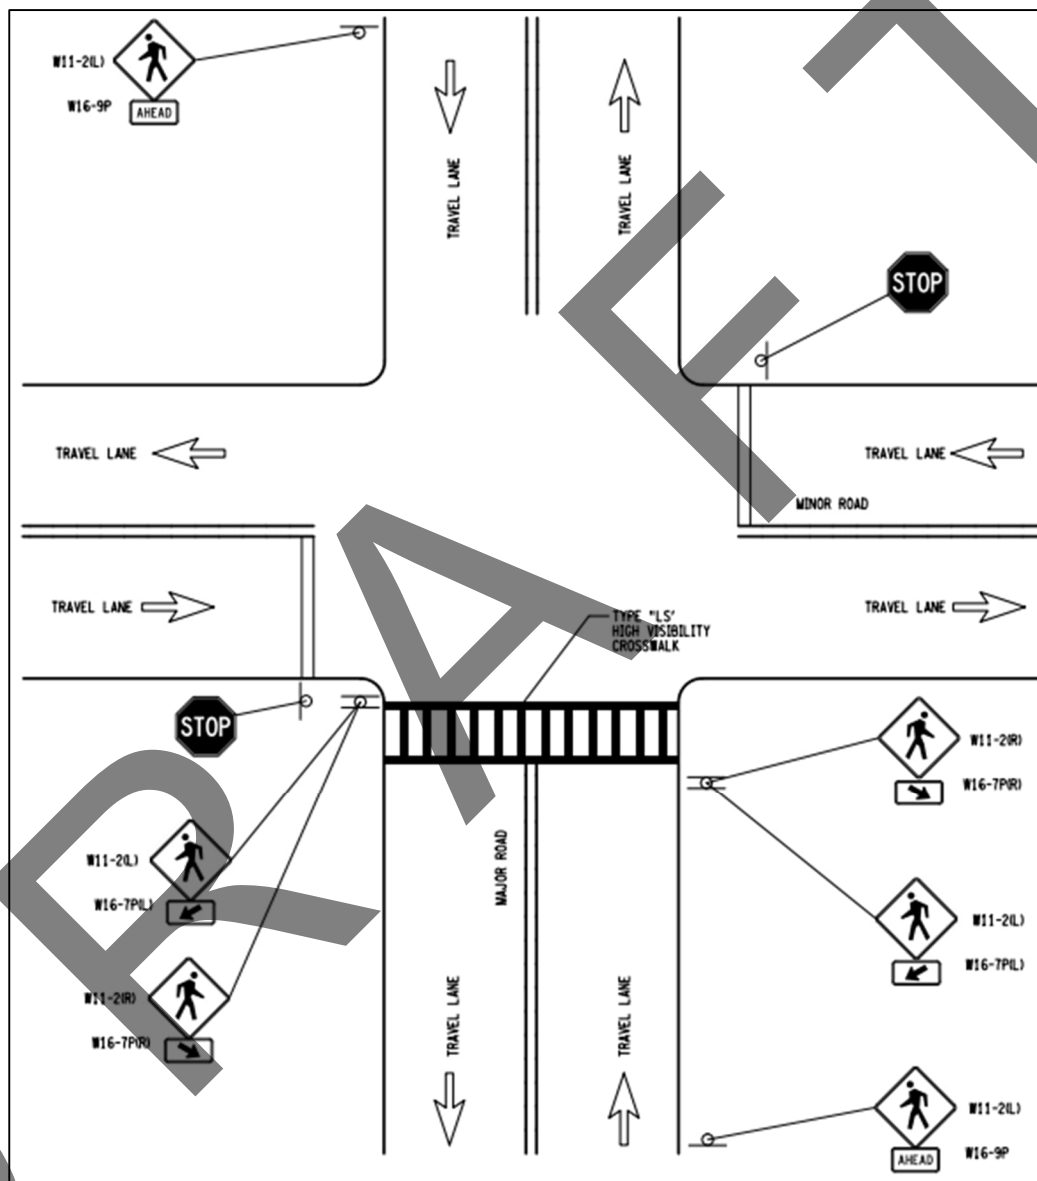
If AWSC is not implemented, advance pedestrian warning signs should be installed on Main Street in accordance with MUTCD guidance for uncontrolled crosswalks (Figure 5-6). Fluorescent yellow-green signage is recommended for enhanced visibility and should include retroreflective signpost striping to improve driver awareness.

Figure 5-6: Sign plan for Uncontrolled Crosswalks at Intersections

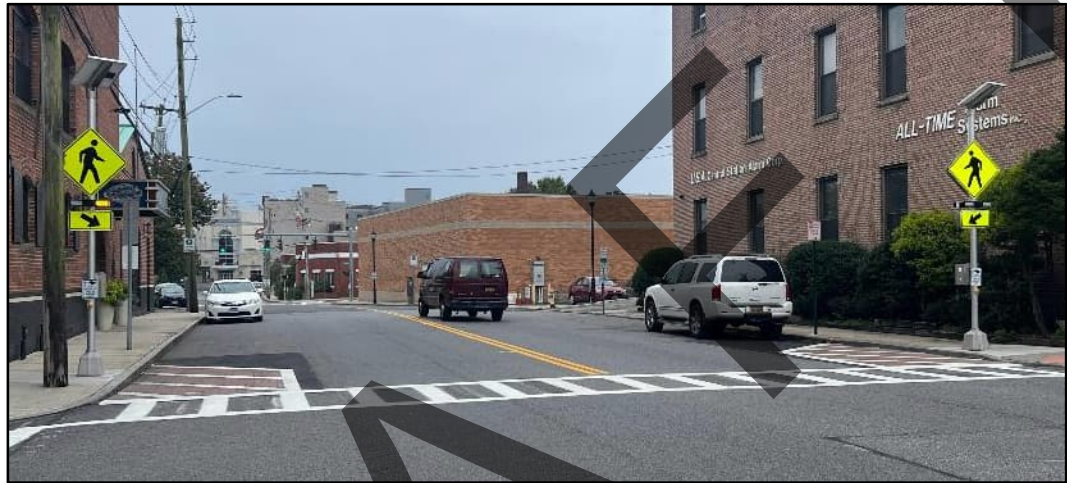
Rectangular Rapid Flashing Beacons (RRFBs) may be considered to enhance driver yielding behavior at uncontrolled crosswalks. RRFBs consist of high-intensity, rapidly flashing yellow beacons mounted on pedestrian warning signs and activated by push button. RRFBs are not appropriate for use at stop-controlled approaches and therefore would only be applicable if AWSC is not implemented.

Figure 5-7: Typical RRFB Installation at an Intersection

For this location, four RRFB assemblies are recommended on the east and west sides of Main Street, at each crossing location. Each assembly should include dual-sided signage and beacon units to provide visibility to both directions of traffic. Advance warning signs should also be installed as described in Section 5.3.6.

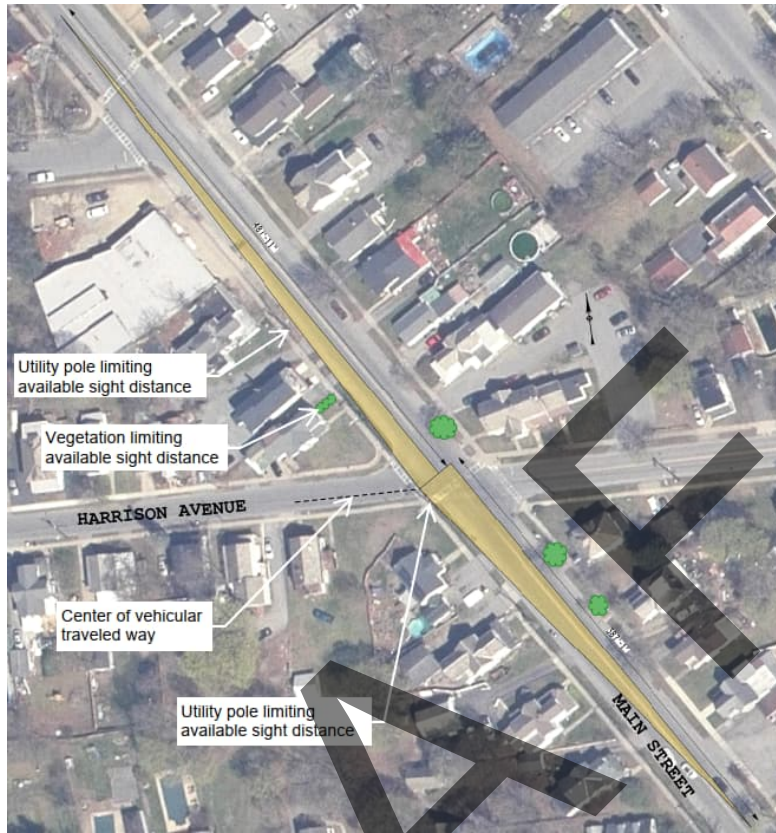
Figure 1 – Intersection sight distance – Harrison Avenue (Eastbound)

Figures 1 and 2 illustrate the sight triangles for vehicles approaching from Harrison Ave. As shown in Figure 1, vehicles on the eastbound Harrison Ave. approach making left turns and looking to the right experience sight distances below the recommended minimum due to a utility pole that limits the available line of sight. Additionally, Figure 2 indicates that, in the absence of tree trimming or vegetation removal, available sight distance is restricted for vehicles turning left and right from the westbound Harrison Avenue approach onto Main St.

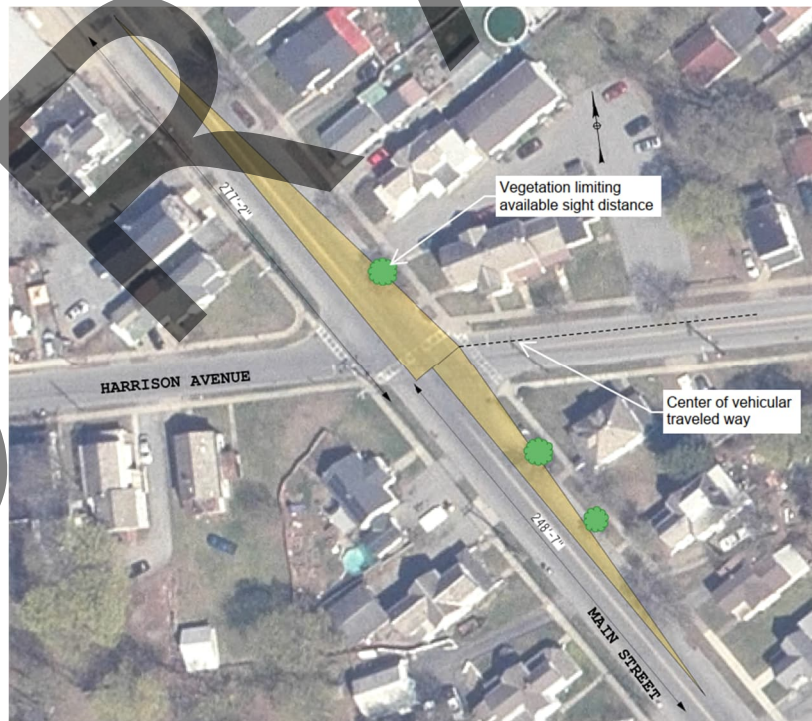
Figure 2 – Intersection sight distance – Harrison Avenue (Westbound)

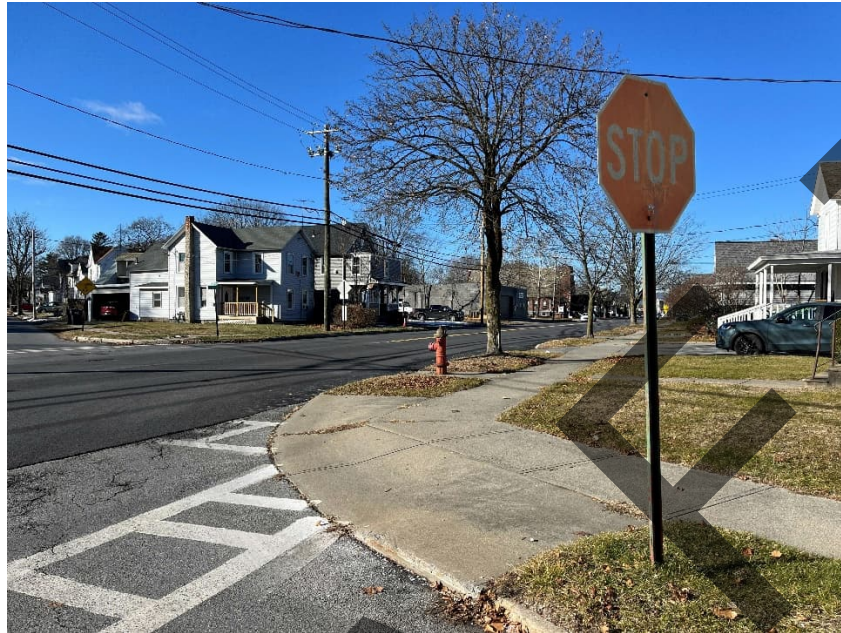
Figure 3 – Vegetation limiting intersection sight distance

Several movements from the Harrison Ave. approaches exhibit sight distances below the recommended minimum. These deficiencies are primarily the result of fixed roadside features, including utility poles, as well as vegetation located along the Main St. right-of-way.

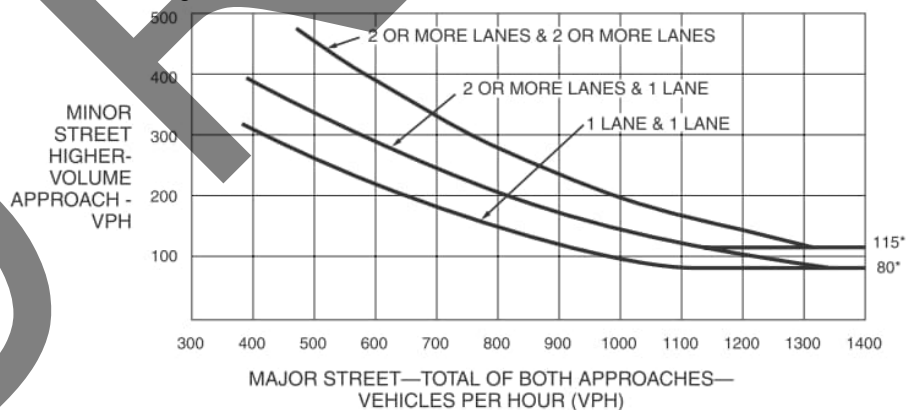
Warrant 2, the four-hour vehicular volume warrant, states that the need for a traffic signal shall be considered if for each of any 4 hours of an average day, the plotted points representing the vehicles per hour on the major street (total of both approaches) and the corresponding vehicles per hour on the higher-volume minor-street approach (one direction only) all fall above the applicable curve in Figure 1 for the existing combination of approach lanes.

Figure 1 - Warrant 2, Four-Hour Vehicular Volume

*Note: 115 vph applies as the lower threshold volume for a minor-street approach with two or more lanes and 80 vph applies as the lower threshold volume for a minor-street approach with one lane.

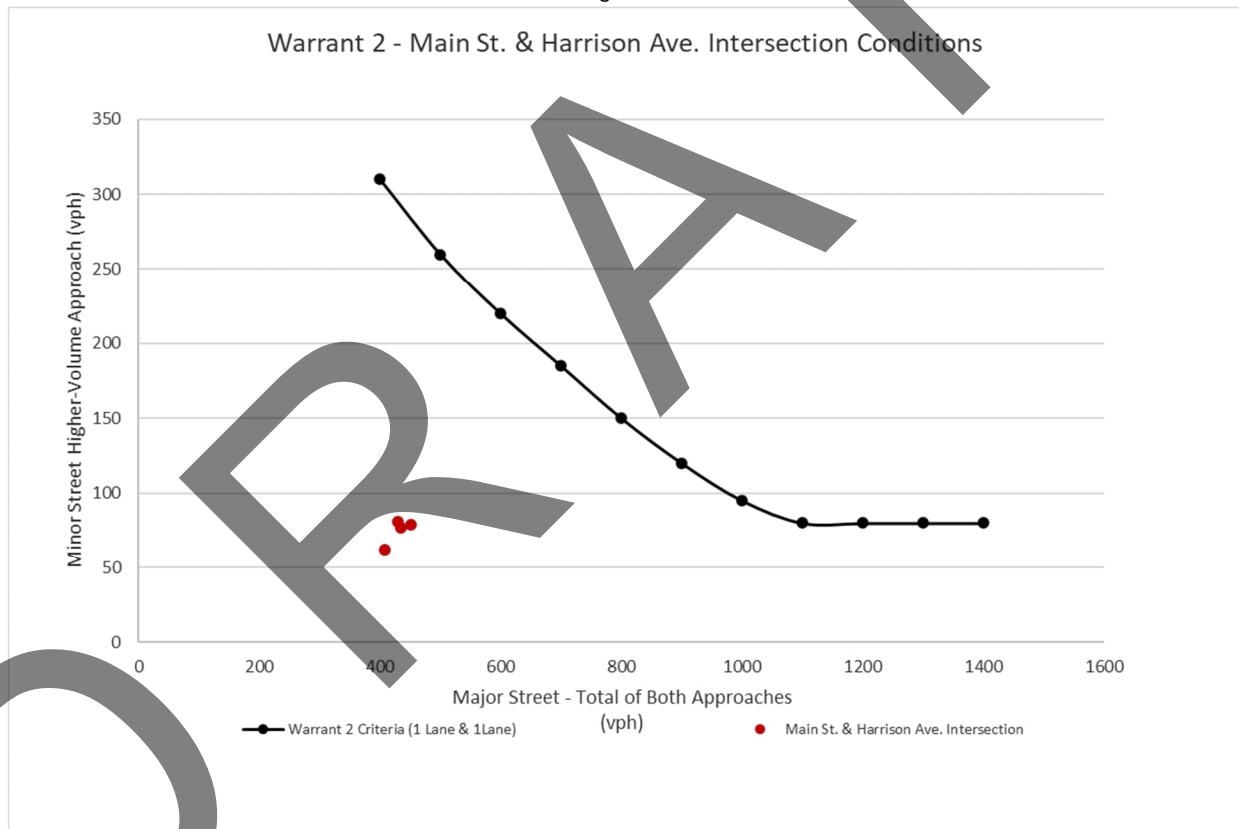
Figure 2

These peak volumes are plotted against the "1 lane & 1 lane" curve of Figure 1 in the following figure:

From Figure 2, it can be seen that the plotted points representing the proposed vehicular volumes fall below the applicable curve. Therefore, Warrant 2 is not satisfied.

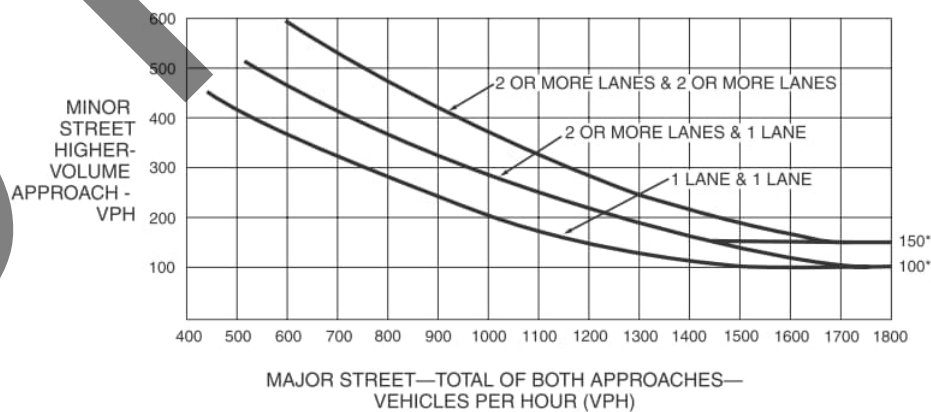
- B. The plotted point representing the vehicles per hour on the major street (total of both approaches) and the corresponding vehicles per hour on the higher-volume minor-street approach (one direction only) for 1 hour (any four consecutive 15-minute periods) of an average day falls above the applicable curve in Figure 3 for the existing combination of approach lanes.

Figure 3 - Warrant 3, Peak Hour

*Note: 150 vph applies as the lower threshold volume for a minor-street approach with two or more lanes and 100 vph applies as the lower threshold volume for a minor-street approach with one lane.

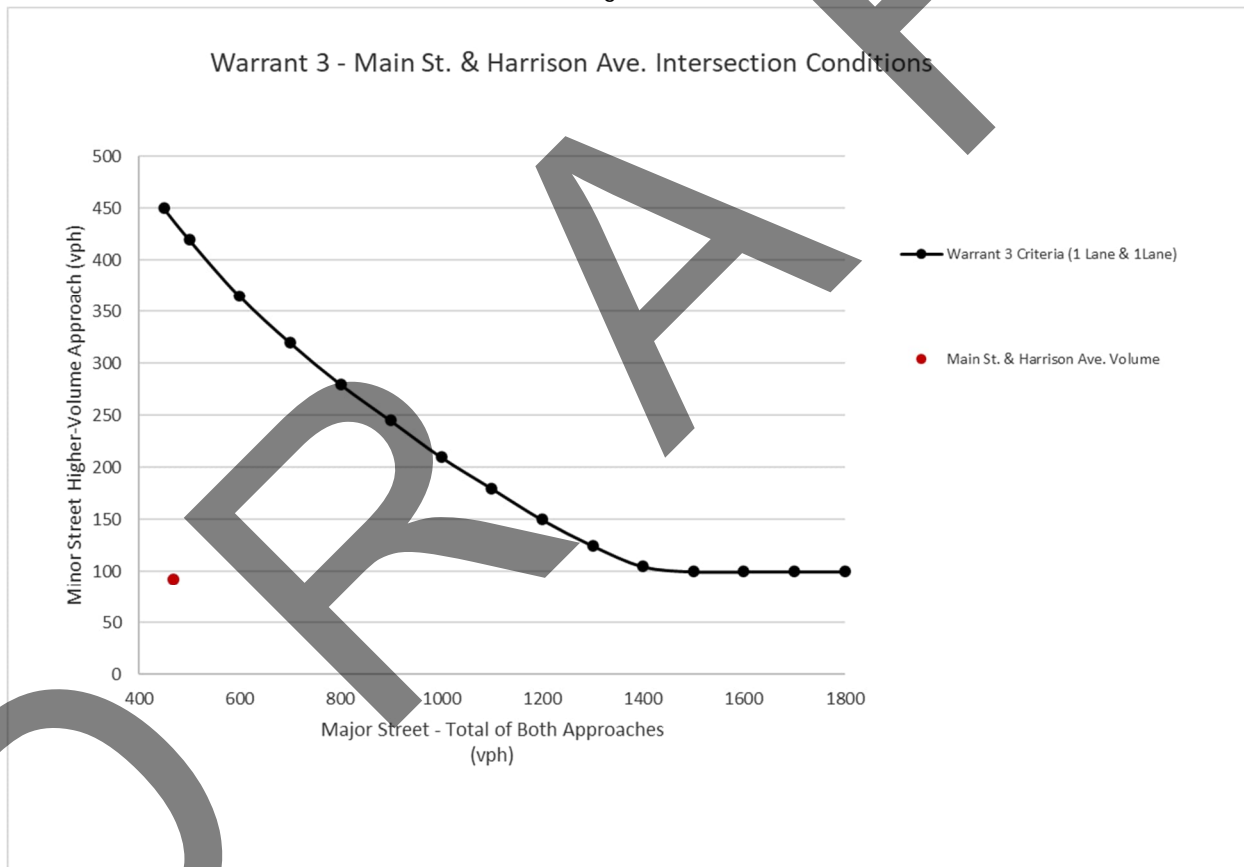
The peak hour occurs in afternoon as shown in Table 4 above. These peak volumes were measured against the criteria set in Warrant 3-A as well as the "1 & 1 lane" curve of Figure 4 as shown below.

By comparison, the volumes shown in Table 4 do not satisfy Signal Warrant 3-A.2. Signal Warrant 3-B is also not satisfied, as depicted in Figure 4 where the vehicles per hour on the major street approaches and minor street critical approach falls below the "1 lane & 1 lane" curve. Therefore, Warrant 3 is not satisfied.

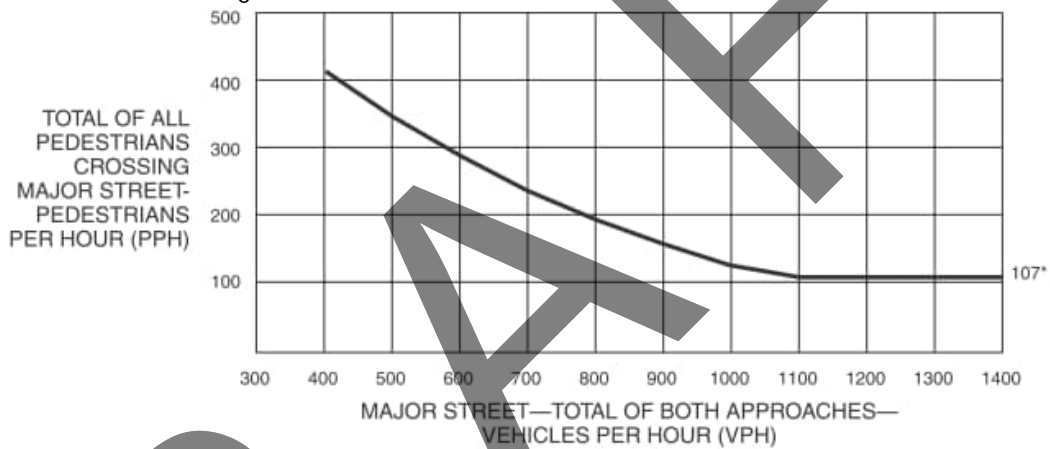
- A. For each of any 4 hours of an average day, the plotted points representing the vehicles per hour on the major street (total of both approaches) and the corresponding pedestrians per hour crossing the major street (total of all crossings) all fall above the curve in Figure 5; or

Figure 5 - Warrant 4, Pedestrian Four-Hour Volume

*Note: 107 pph applies as the lower threshold volume.

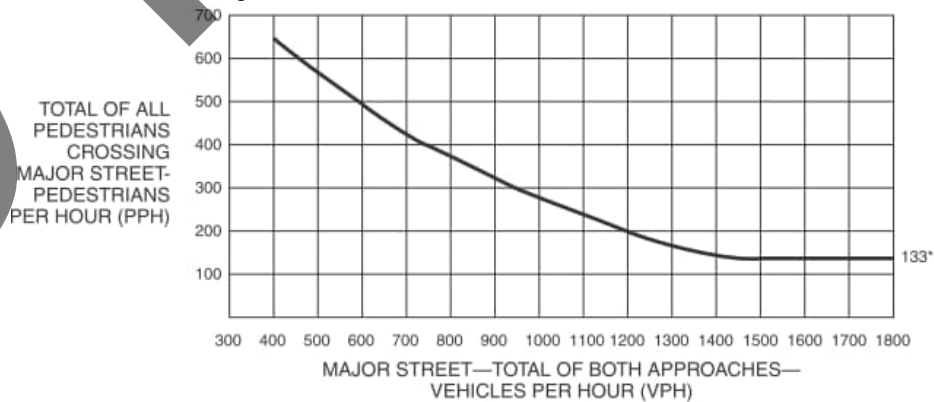
- B. For 1 hour (any four consecutive 15-minute periods) of an average day, the plotted point representing the vehicles per hour on the major street (total of both approaches) and the corresponding pedestrians per hour crossing the major street (total of all crossings) falls above the curve in Figure 6.

Figure 6 - Warrant 4, Pedestrian Peak Hour

*Note: 133 pph applies as the lower threshold volume.
