VILLAGE OF SOUTH GLENS FALLS

Route 9 Corridor
Adaptive Signal Control Technologies

FEASIBILITY STUDY

akrf
Barton & Loguidice

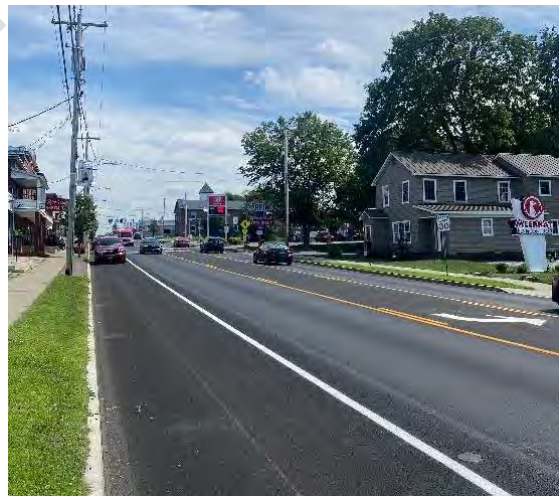
Route 9 Looking South Near 2nd St.

Route 9 is classified as an Urban Principal Arterial throughout the corridor. Along Main Street, the Annual Average Daily Traffic (AADT) is 18,522 vehicles per day (vpd), based on 2022 NYSDOT data. The posted speed limit is 30 miles per hour (mph) and the recorded 85th percentile speed for this segment is approximately 31 mph. The typical cross-section from River Street to Saratoga Avenue includes two 14-foot-wide travel lanes, an 11-foot-wide center two-way left-turn lane which transitions to a dedicated left-turn lane at signalized intersections, and a 9-foot-wide parking lane on the east side. No shoulders are present along Main Street aside from the parking lane. Sidewalks are present on both sides of the corridor, with an approximate 3-foot buffer area between the edge of the roadway and the sidewalk. There are no

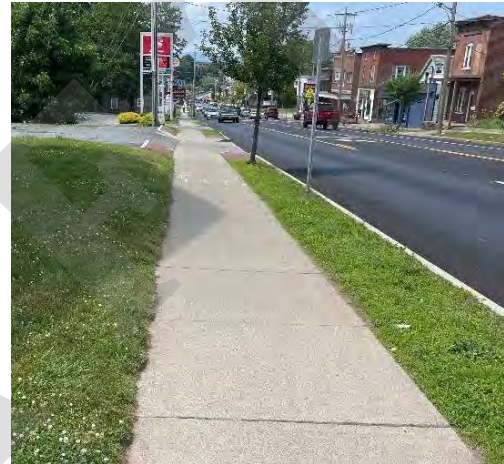
Typical Roadside Condition Near 3rd St.

The corridor transitions between residential and commercial land uses throughout, with multiple driveways and building frontages located close to the roadway. In many areas, the sidewalk is directly adjacent to buildings or fenced property lines. Utility poles are primarily located along the east side of the corridor and are often positioned immediately behind the sidewalk. Additional obstructions beyond the sidewalk include mature trees, traffic control and business signage, and landscaping features. Several drainage structures, including catch basins and manholes, are in conflict areas, such as directly in front of curb ramps or within marked crosswalks. There is also a cemetery that is located adjacent to the sidewalk on the Saratoga Avenue segment between Harrison Avenue and New Street.

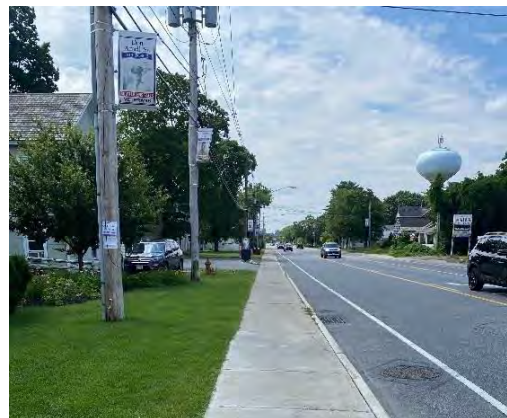
Existing Sidewalk Adjacent to Stewarts

Sidewalks are present along both sides of the Route 9 corridor. On the Saratoga Avenue segment, the east side includes sidewalk for the whole length, approximately 5,300 feet of sidewalk extending from the Feeder Dam Road intersection to the Main Street intersection. The west side has about 3,670 feet of sidewalk, with a gap from Feeder Dam Road to Beach Road. On the Main Street segment, north of the Main Street intersection, sidewalks continue on both sides of the road for approximately 2,400 feet to the Glen Street Bridge.

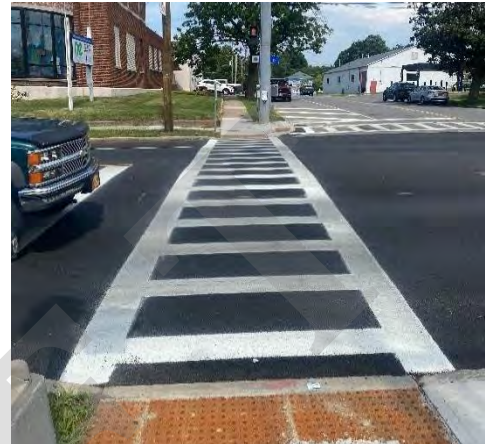
Pedestrian Crossing at 3rd St.

The survey identified a total of five midblock (between intersections and not signal controlled) pedestrian crossings across Main Street/Saratoga Avenue within the study area. At intersections controlled by standard three-color traffic signals, 15 marked crosswalks were identified. An additional five crosswalks were found at intersections with flashing traffic signals and 14 more crosswalks were located where sidewalks intersect with crossing points (driveways/ side streets) along the corridor, bringing the total number of crosswalks to 34.

All midblock and intersection crossings were equipped with ADA-compliant curb ramps. All crosswalks were marked with pavement striping, and curb ramps were provided on both ends. However, several of the crosswalk markings were faded and in need of repainting which is typical of heavily travelled roadways such as Route 9.

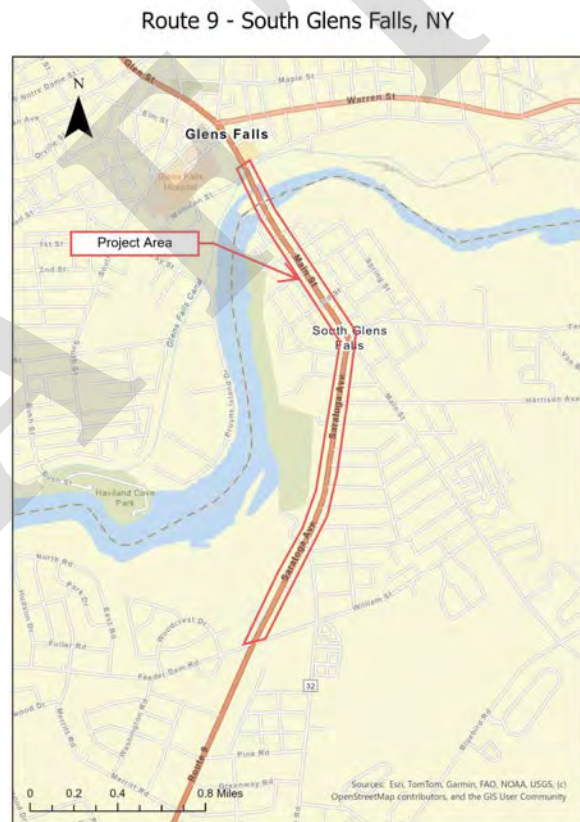
Figure 1- Project Area Map

On behalf of the Village of South Glens Falls and the Adirondack/Glens Falls Transportation Council (A/GFTC), Barton & Loguidice, in collaboration with AKRF, has prepared this Technical Memorandum to evaluate improvement opportunities along Route 9 within the Village of South Glens Falls, NY. The study area extends from Mohican Street/ Oakland Avenue to Feeder Dam Road/ William Street and encompasses two main segments: Main Street to the north and Saratoga Avenue to the south, which intersect at 5th Street. Land use along the corridor includes a mix of commercial properties, civic institutions, and residential areas. The corridor also serves as a primary business district and is frequently used by pedestrians and cyclists. This memorandum provides an overall assessment of the corridor's conditions and provides recommendations to enhance safety, accessibility, and mobility, including installing continuous ADA-compliant sidewalks, improving pedestrian crossings with high-visibility markings and Rectangular Rapid Flashing Beacons (RRFBs), adding curb extension, and providing dedicated bicycle facilities where feasible.

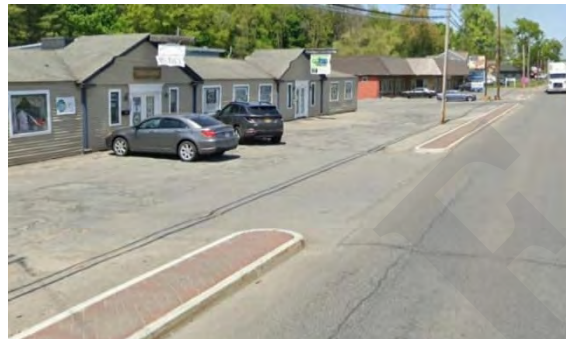
Figure 2. Segment between Feeder Dam Road and Beach Road

Install an ADA-compliant sidewalk that connects to the existing curb ramps at each end of the segment between Feeder Dam Road and Beach Road along the west side of Saratoga Avenue. This corridor currently lacks a continuous sidewalk, creating a gap in pedestrian connectivity. The proposed improvement would involve constructing a 5 ft. wide sidewalk along the roadway, with a 3 ft. buffer to enhance pedestrian safety and provide space for snow storage. The design would maintain the existing roadway dimensions and curblines and repurpose the driveway islands to accommodate the sidewalk.

Although the proposed sidewalk and buffer space generally fits within the existing right-of-way, temporary construction easements will likely be required for grading activities and driveway restoration. Based on the available ROW mapping from GIS, the ROW appears to be sufficient to install a sidewalk in this location without acquiring property. Utility poles are generally 4-5 ft. from the edge of the driveway island and will not be a constraint as there is adequate clearance to meet ADA standards (4 ft. min). However, some mailboxes, signage, and trees would need to be relocated or removed to accommodate the design.

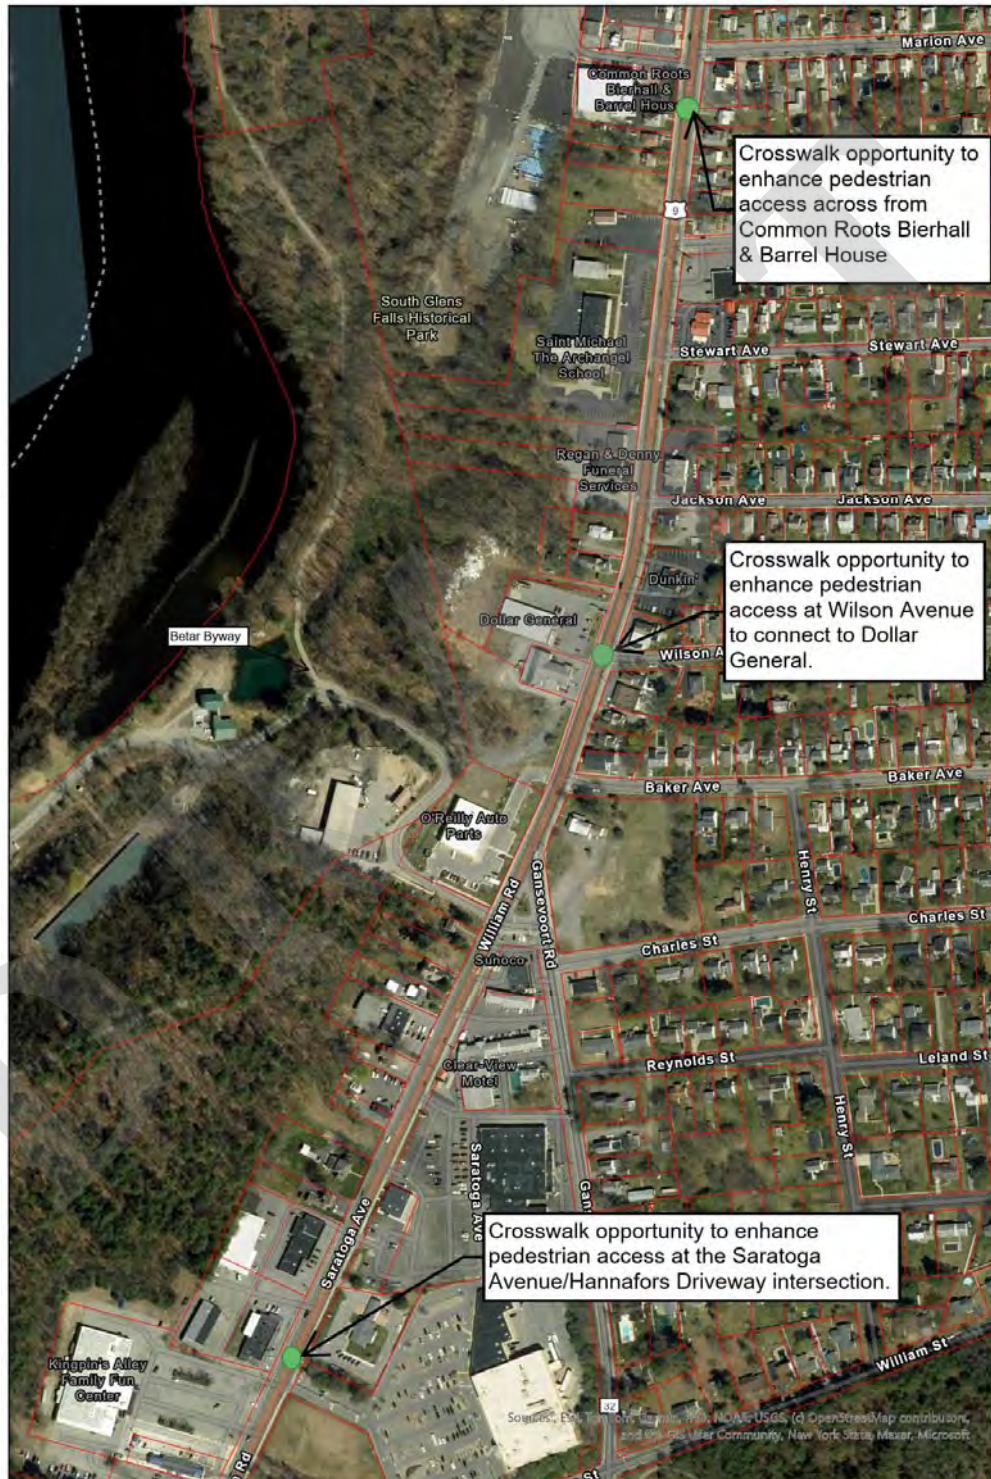
Figure 3. Recommended Locations for Crosswalk Installation

The installation of new crosswalk markings will improve driver awareness of pedestrian activity and provide clearly defined crossing points. All crosswalks should use highly visible ladder-bar pavement markings with epoxy paint or thermoplastic with glass beads for retro-reflectivity.

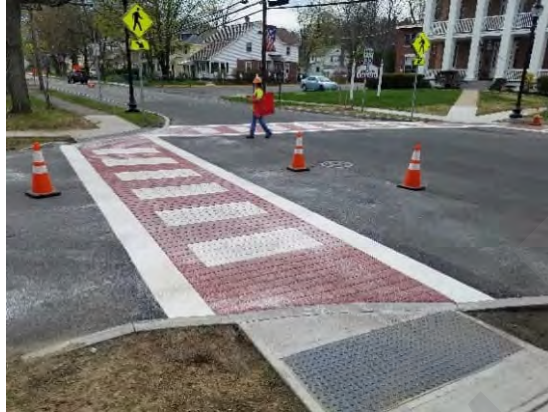
Figure 4. Imprinted Thermoplastic Crosswalks. Source: Harbour Roads and Ennis-Flint

An alternative treatment may include imprinted asphalt thermoplastic surface treatments, which heat and stamp the asphalt pavement with a contrasting color and pattern to provide a durable and visually prominent crossing (see Figure 4).

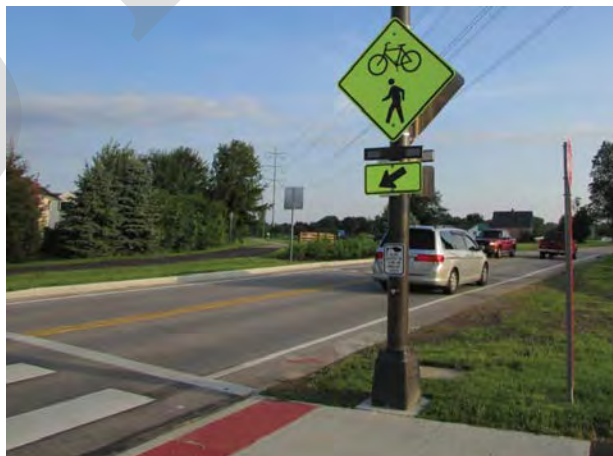
Figure 5. RRFBs Used at a Crossing. Source: FHWA

To enhance pedestrian safety, (RRFBs) should be installed at the proposed and existing crosswalk locations along Saratoga Avenue and the existing midblock on Main Street. According to FHWA, RRFBs are particularly effective at multilane crossings with posted speeds under 40 mph and moderate-to-high traffic volumes, which align with conditions in this corridor. Saratoga Avenue consists of two travel lanes and one two-way left-turn lane (TWTL), with an AADT of 17,682 vehicles per day and an 85th percentile speed of approximately 38 mph. These factors pose a challenge to pedestrians crossing at Saratoga Avenue. RRFBs will enhance visibility and encourage driver yielding at these locations. Push button activated rapid flashing beacons are mounted on both sides of the crosswalk below the pedestrian crossing sign and above the diagonal downward arrow plaque to alert drivers that there is a pedestrian that wants to cross the roadway (see Figure 5).

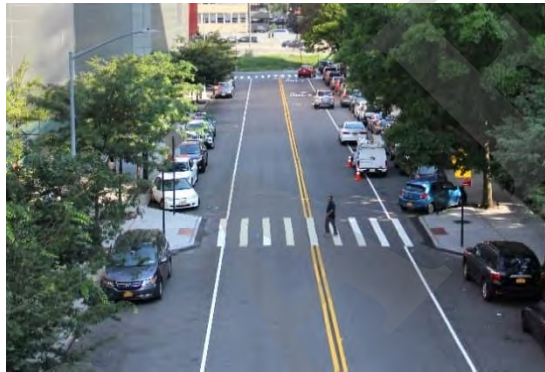
Figure 6. Mid-Block Curb Extension. Source: NYC Street Design Manual

Curb extensions, or bumpouts, extend the sidewalk or curb line into the roadway at intersections or midblock locations to enhance pedestrian safety, reduce crossing distances for pedestrians, and calm traffic. They are generally recommended at intersections with full-time parking lanes and can also be used at midblock crossings (see Figure 6).

For this project, a bumpout is recommended at the existing midblock crossing on the east side of Main Street within the existing parking lane. Sight distance for pedestrians is currently limited by parked vehicles. If a bumpout is not installed, a "No Parking" signs should be established on the east side of Main Street within 20 ft. from the crosswalk. This will help ensure adequate sight distance for both drivers and pedestrians. Bumpouts are not recommended on the west side of Main Street or along Saratoga Avenue due to the absence of parking lanes and adequate shoulder width.

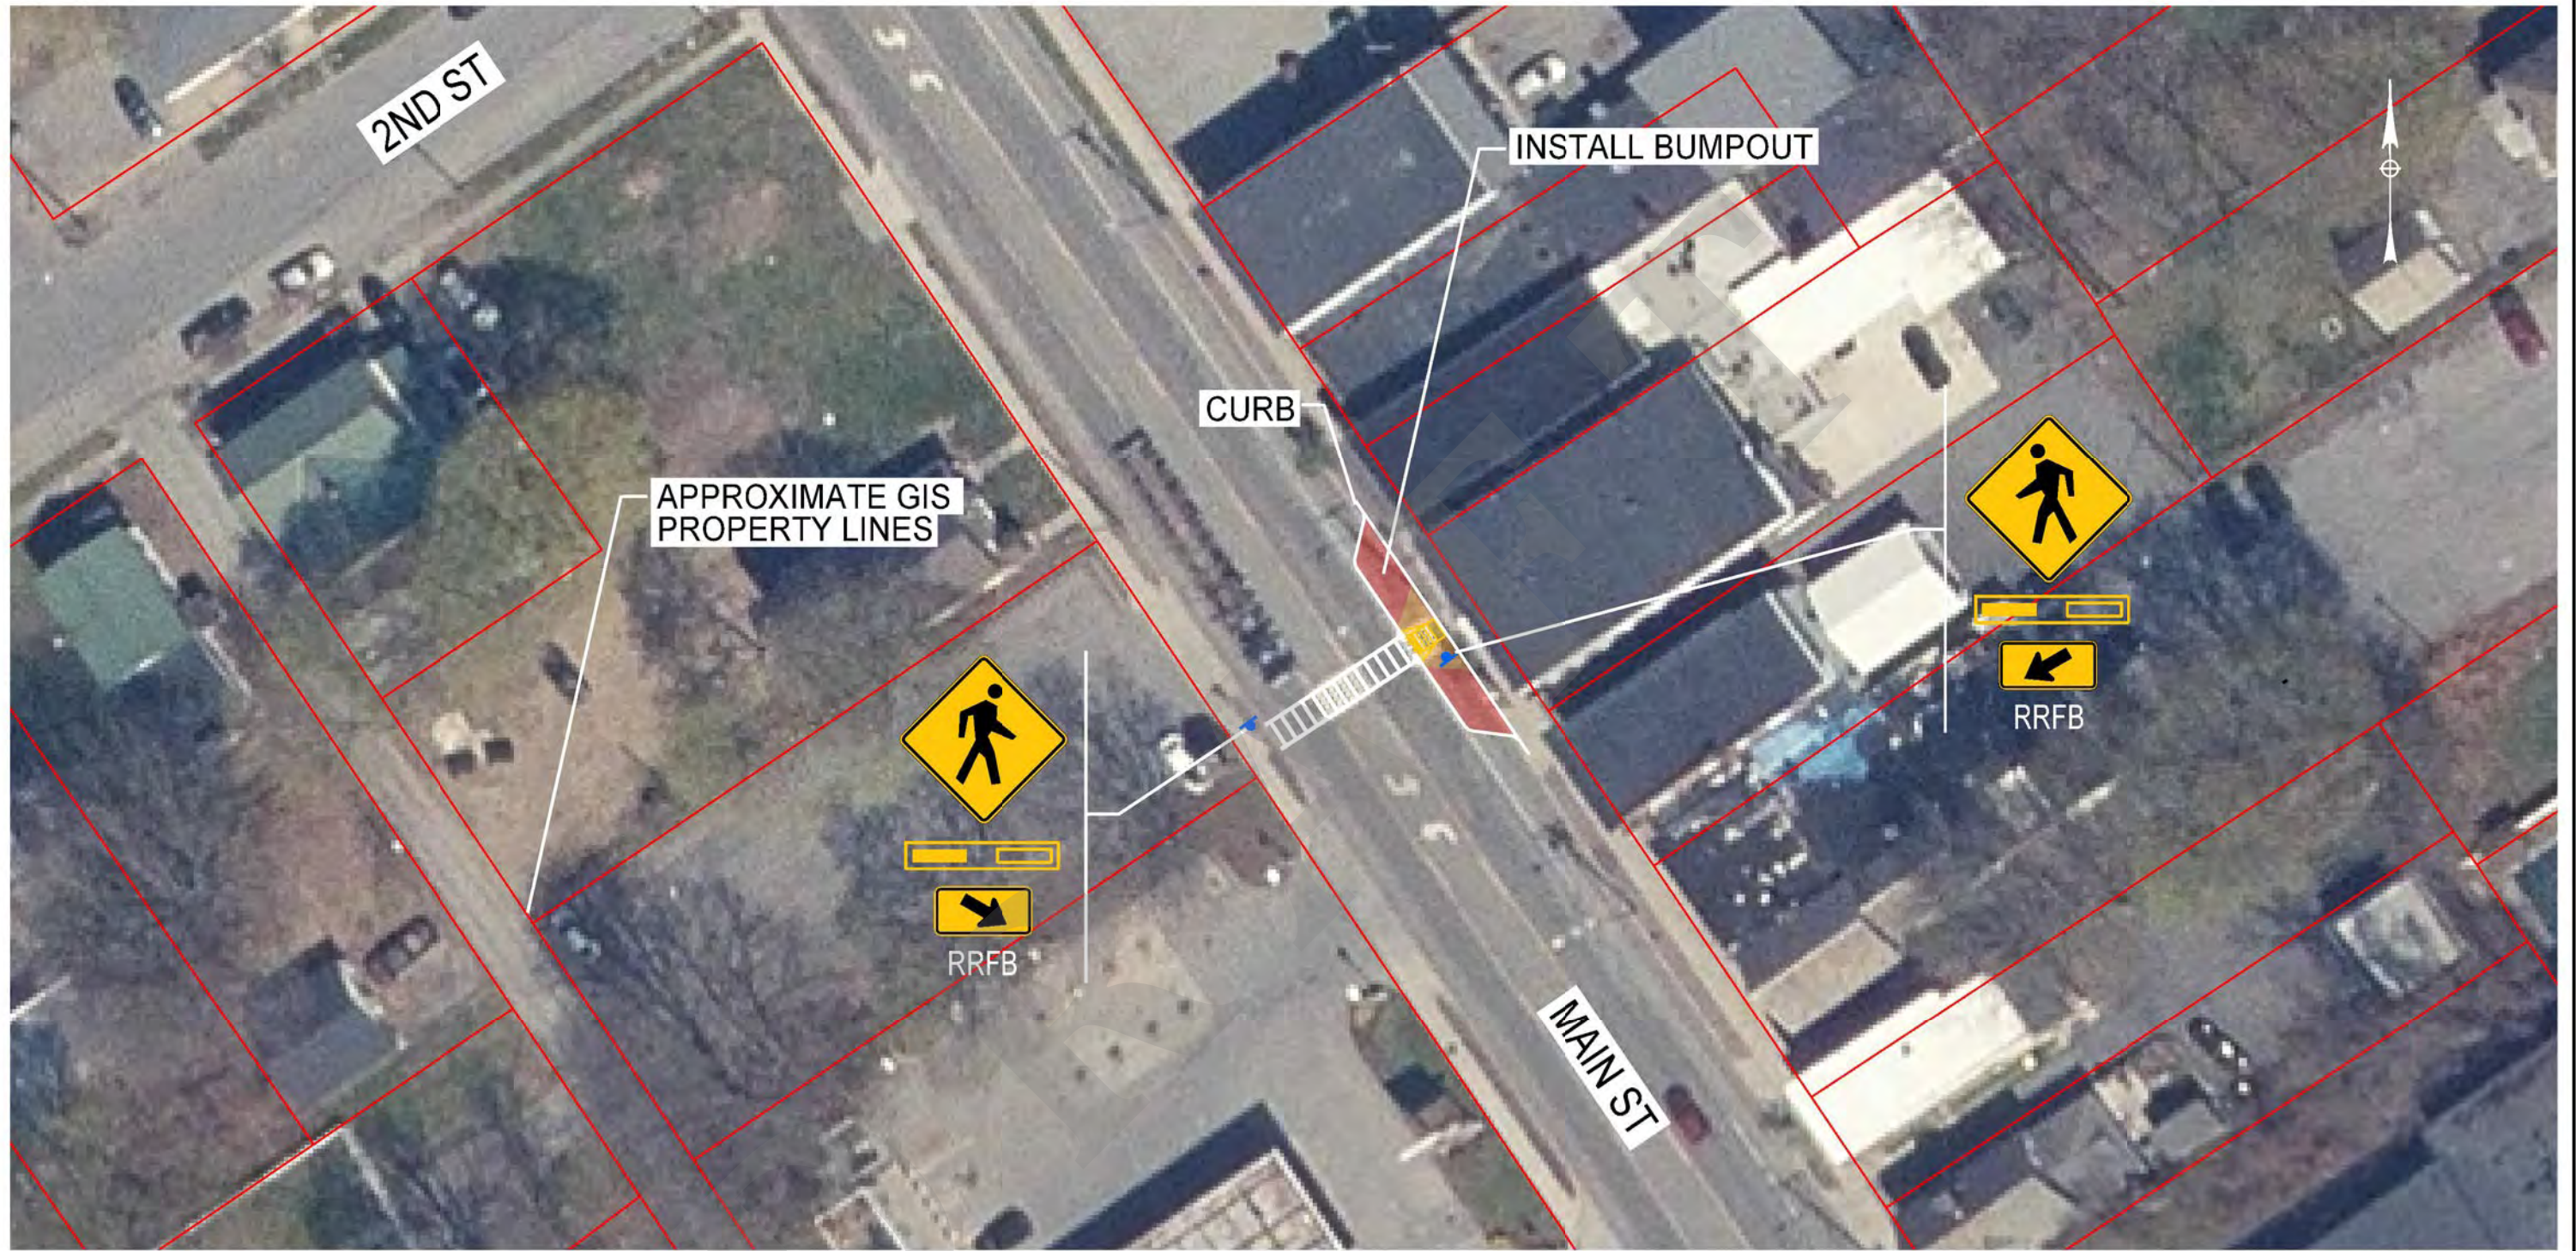
CONCEPT 2 - MID-BLOCK CROSSING, RRFB, AND BUMPOUT LAYOUT ON MAIN ST
OPTION WITH CURB BUMPOUT

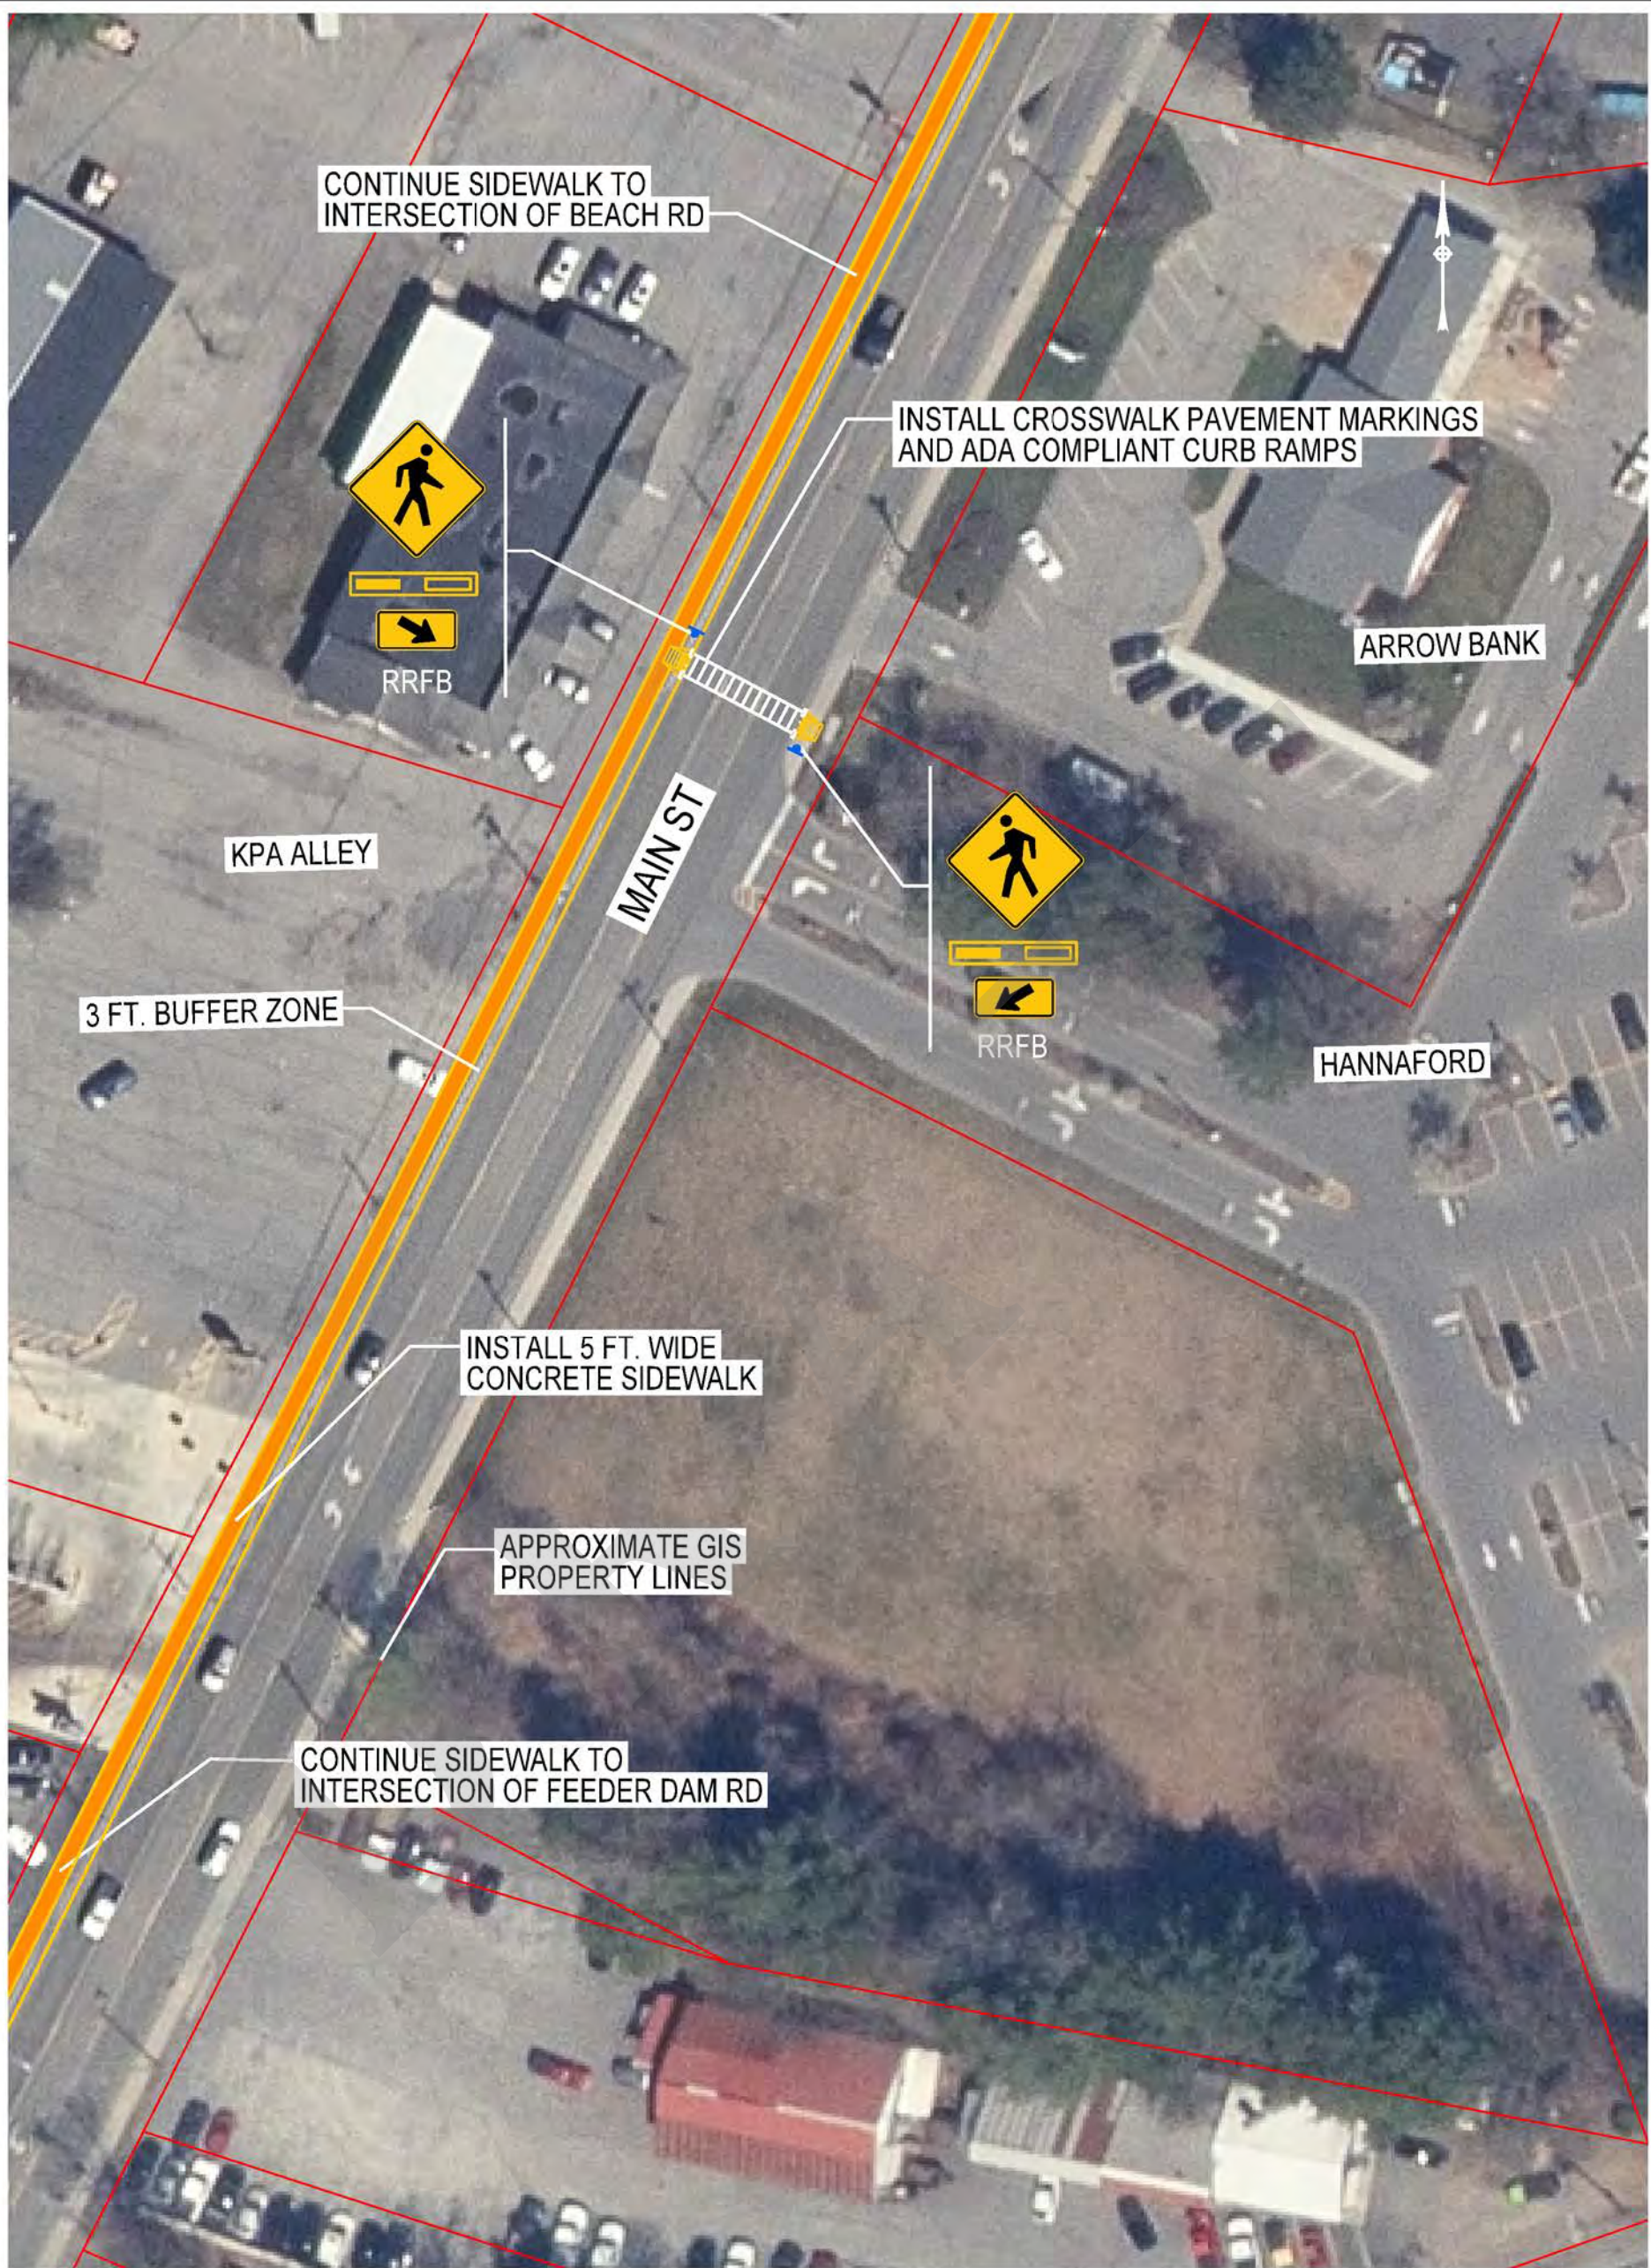
**CONCEPT 3 - SIDEWALK, CROSSWALK AND RRFB
LAYOUT ON SARATOGA AVE**

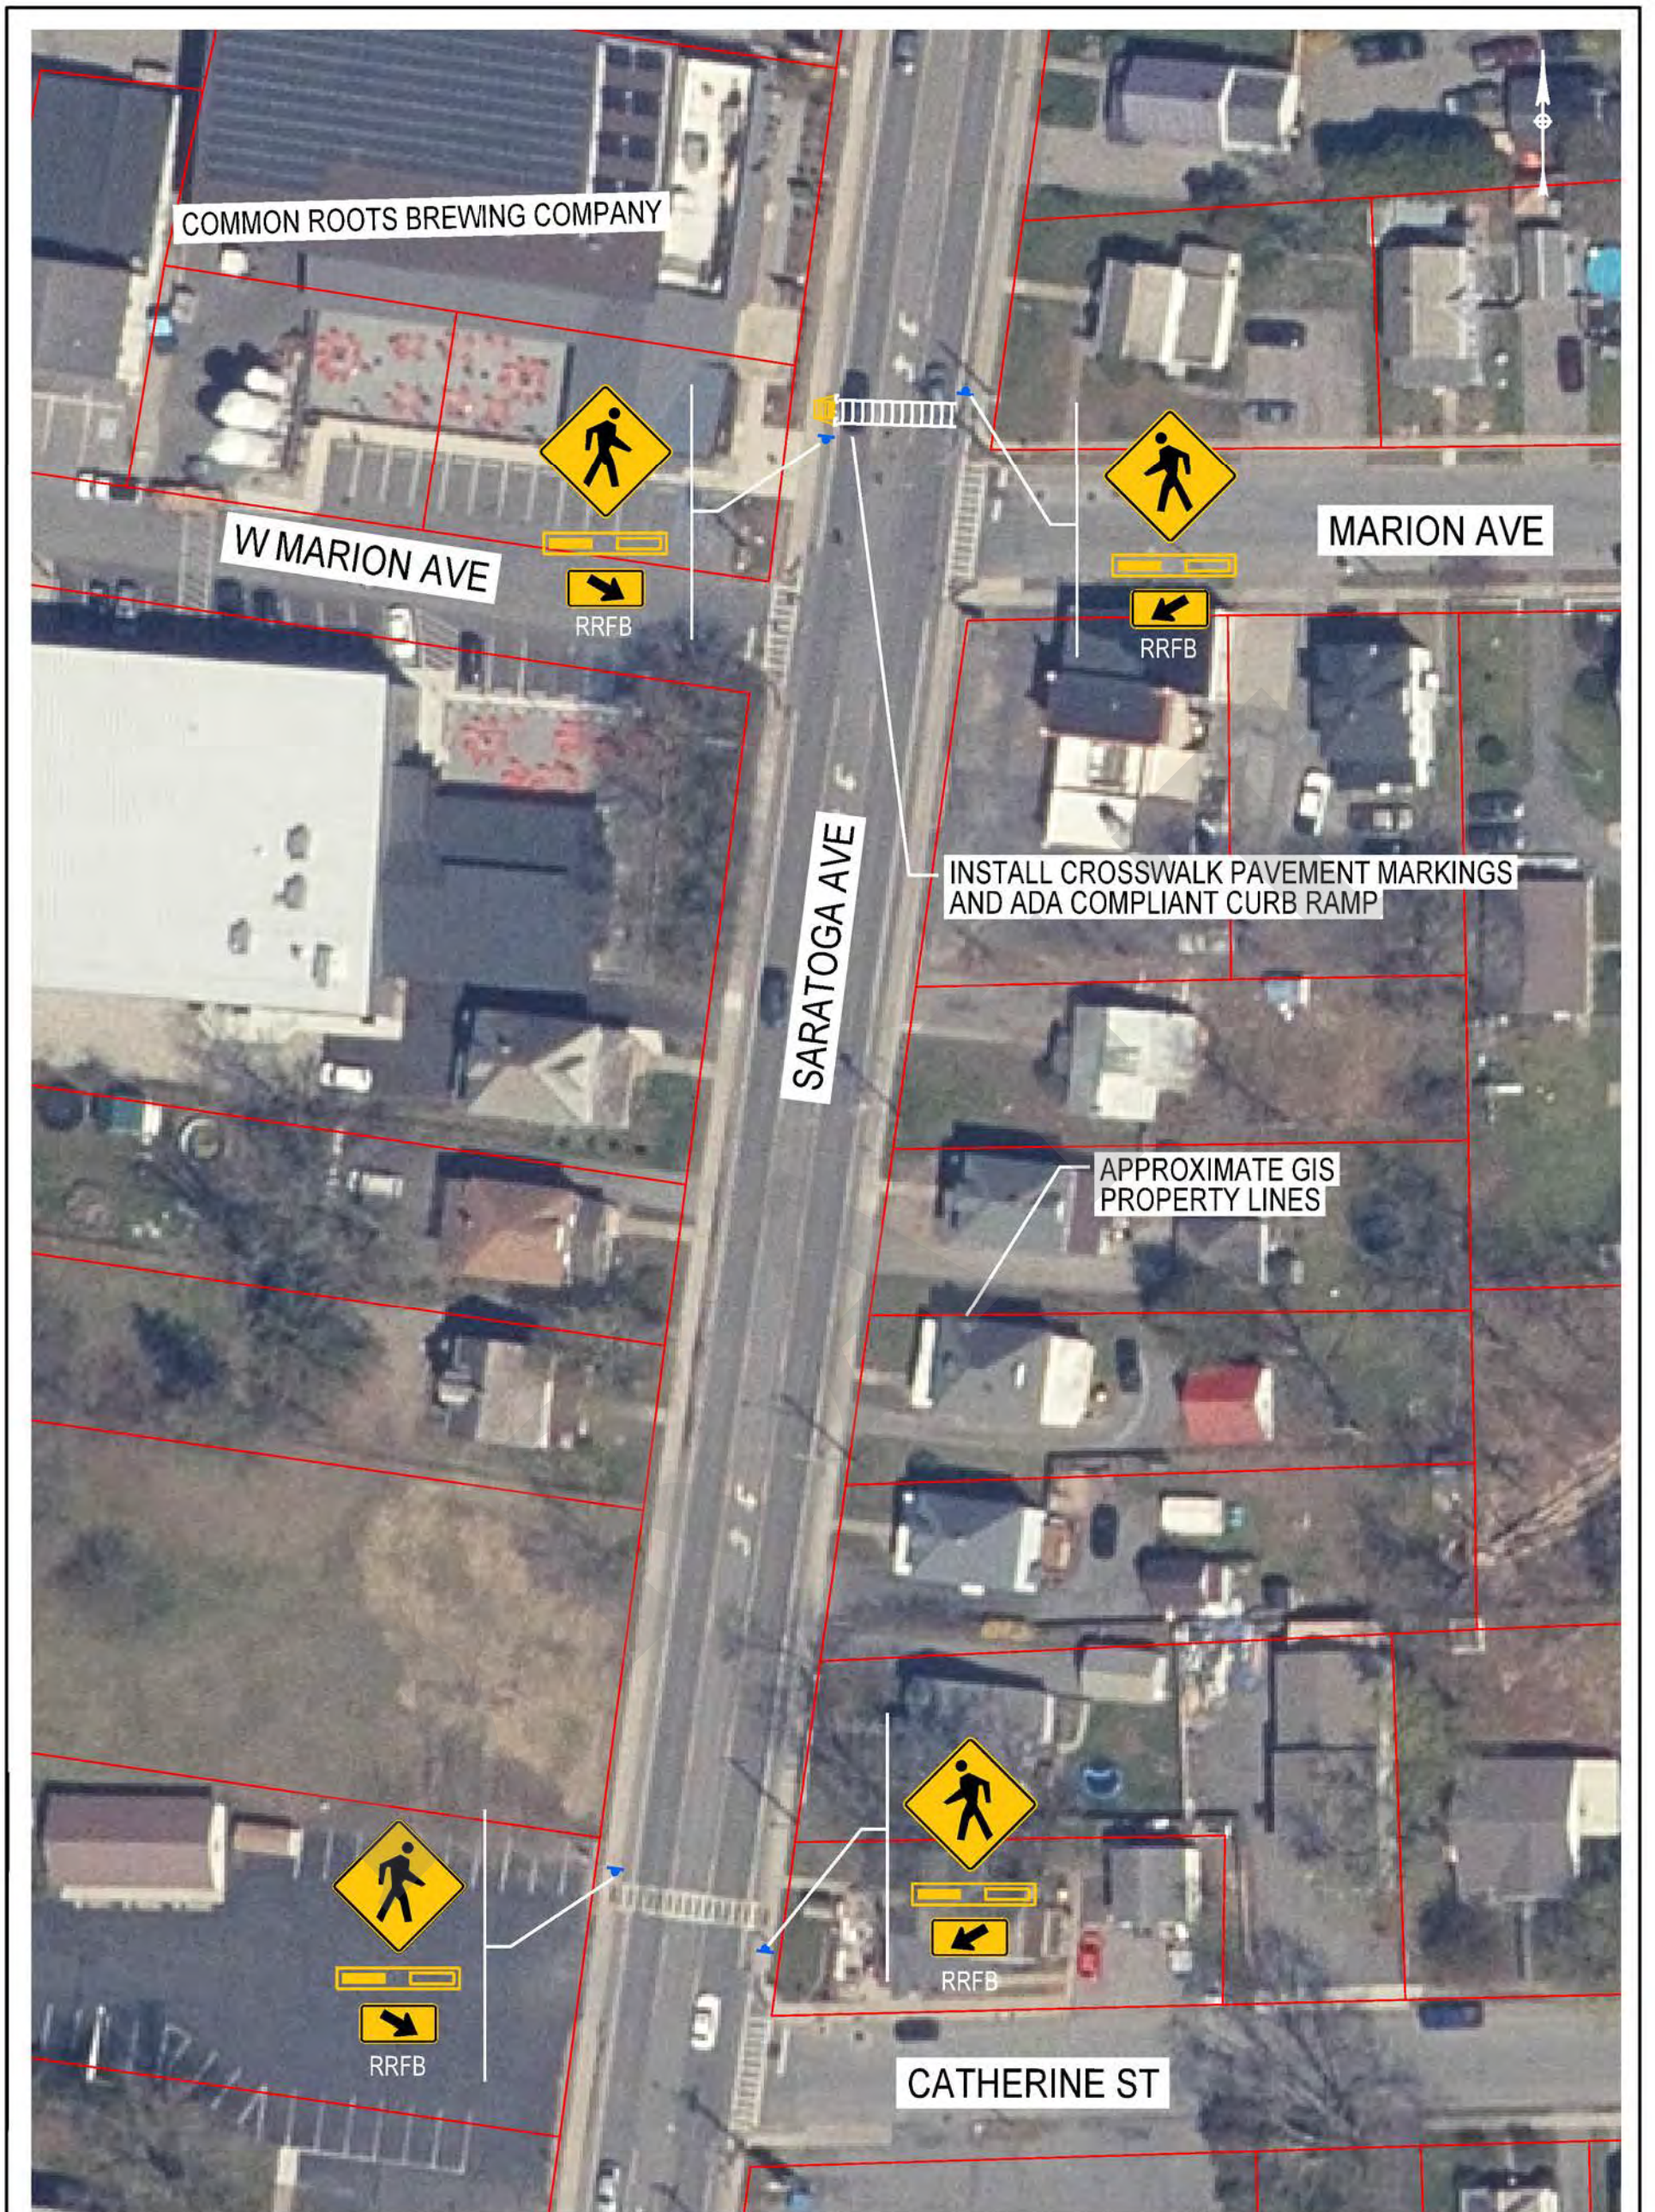
**CONCEPT 4 - CROSSWALK AND RRFB
LAYOUT ON SARATOGA AVE**

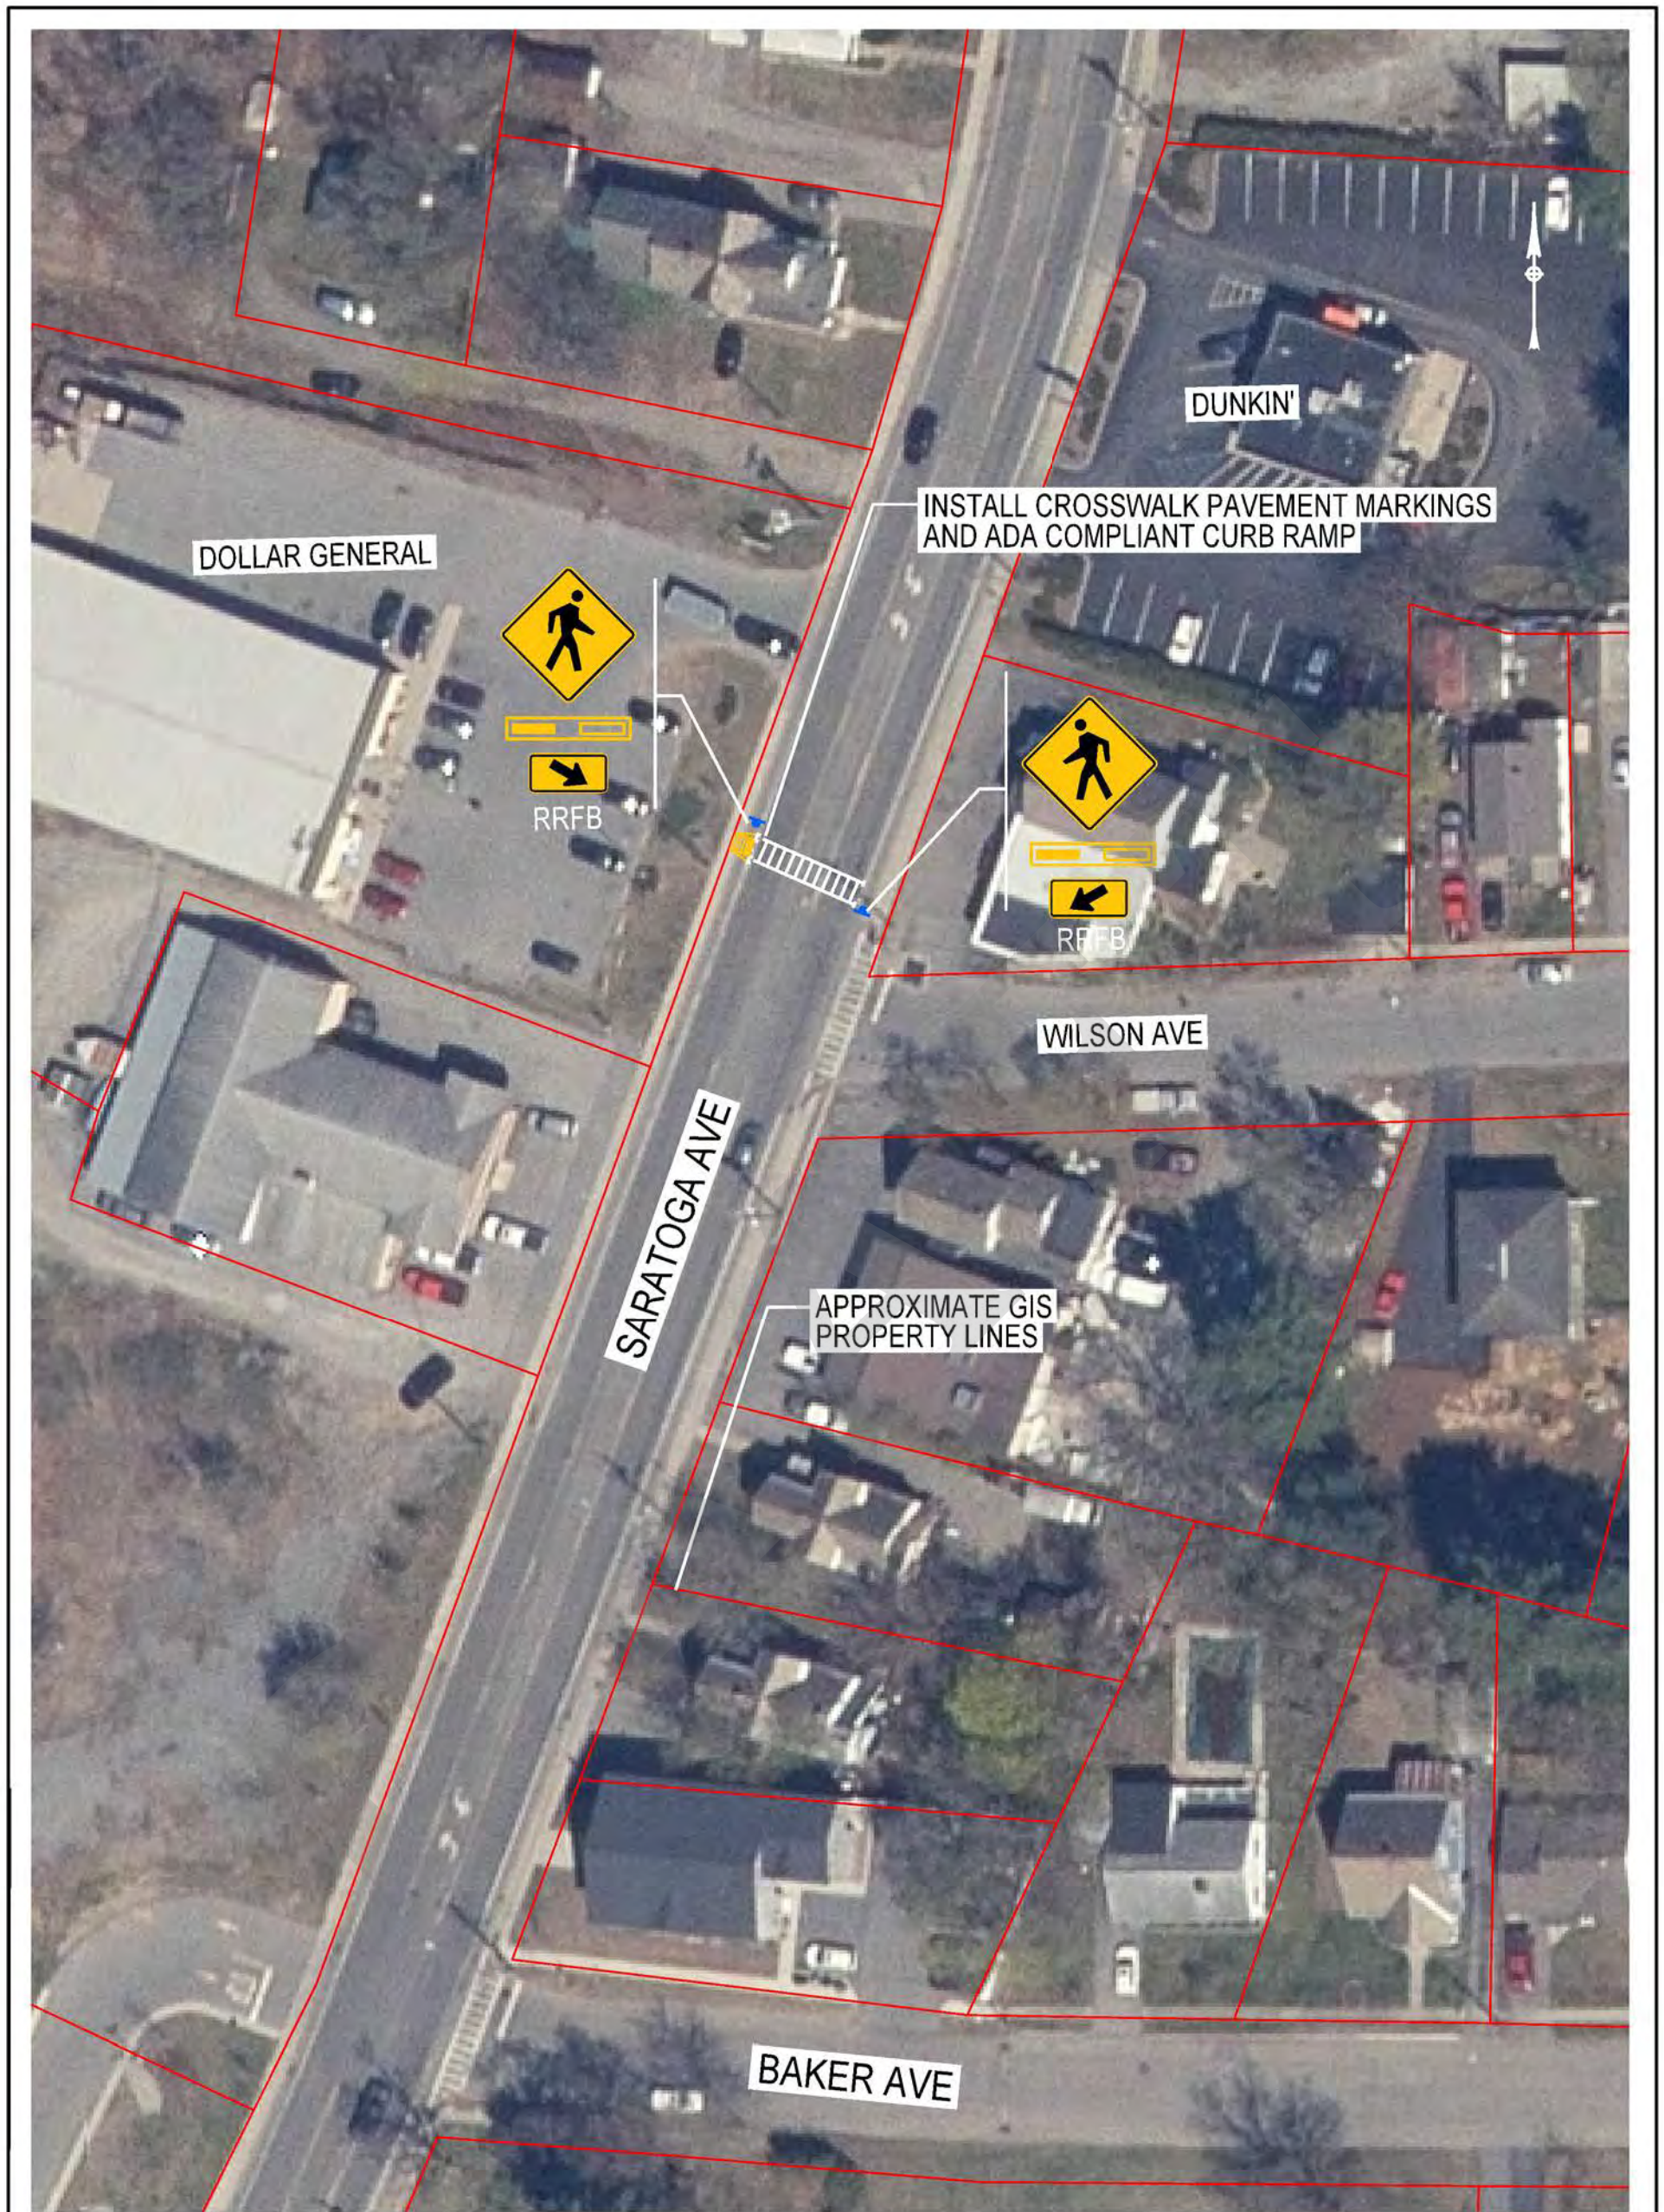
CONCEPT 5 - CROSSWALK AND RRFB
LAYOUT ON SARATOGA AVE

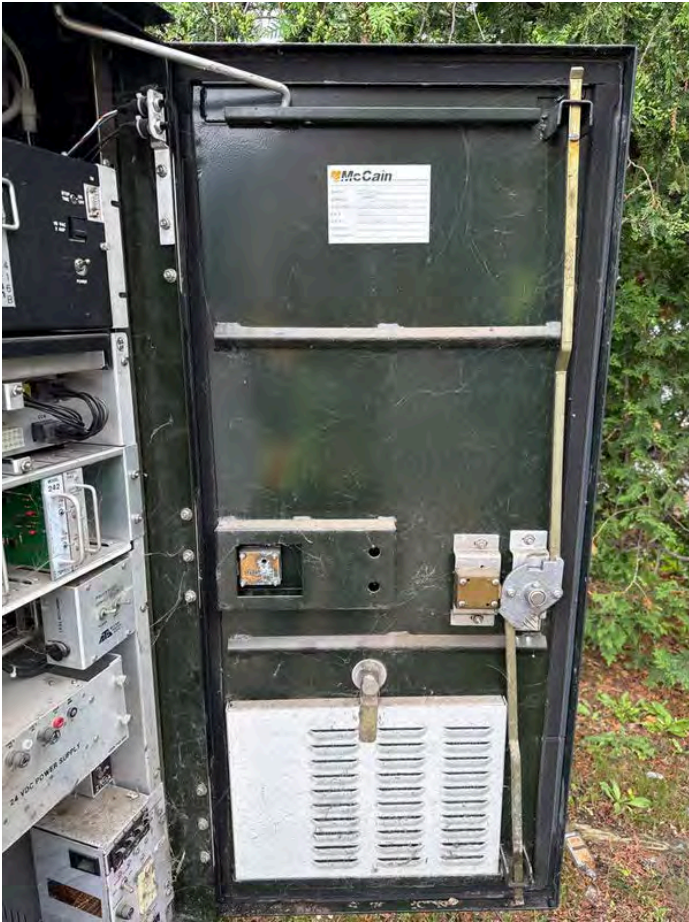
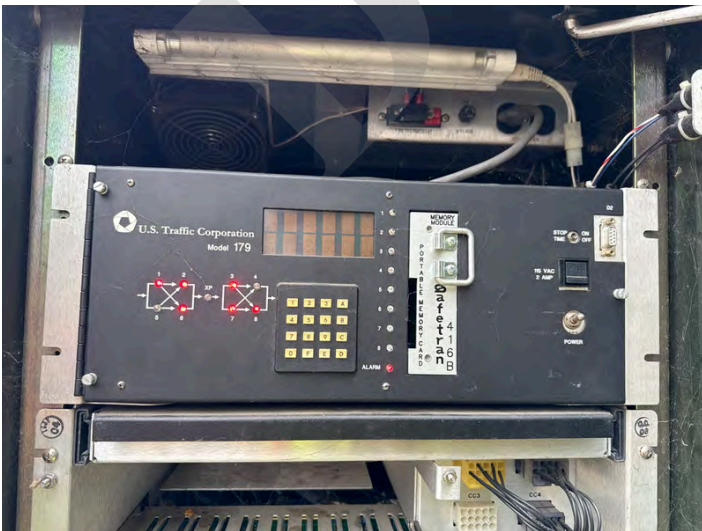
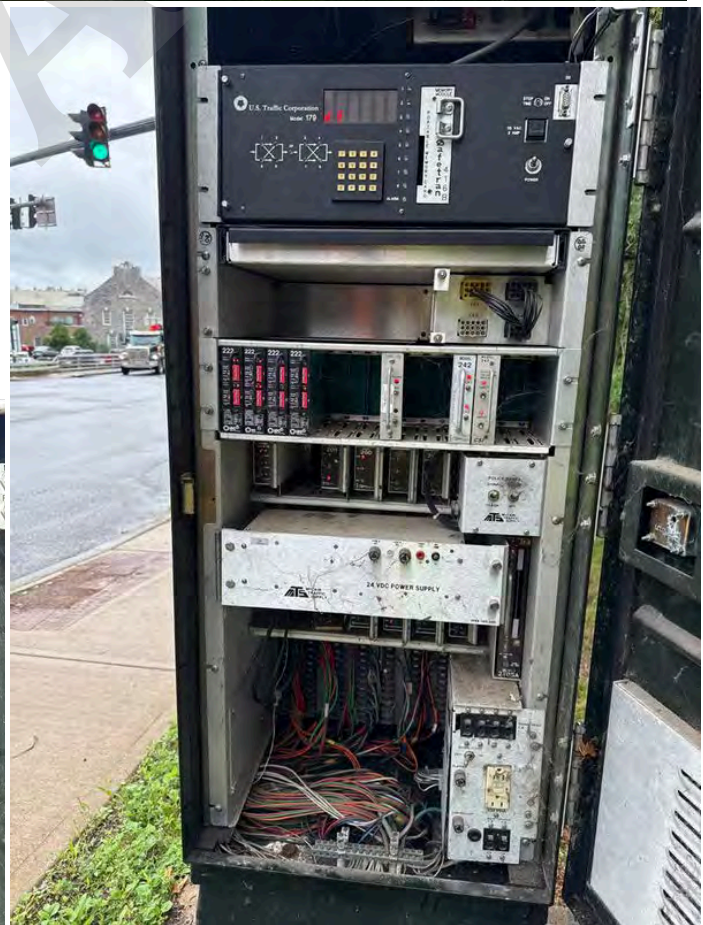
Year of Controller/Cabinet Assembly	
Conflict Monitor Model/Size	EDI 210SA
Load Switches Installed/Type	9 installed
Backpanel Size	14 position
Controller Type	179
Controller Make	U.S. Traffic Corp
Controller Model	179
Cabinet Type	330
Cabinet Mount	Ground
Cabinet Door	Single, Police
Signal Coordination	No
Type of Coordination	
Overall Cabinet Rating	
Cabinet Notes	Only detector working is microwave
Cabinet Photos
