VILLAGE OF SOUTH GLENS FALLS

Route 9 Corridor
Adaptive Signal Control Technologies

FEASIBILITY STUDY

akrf
Barton & Loguidice

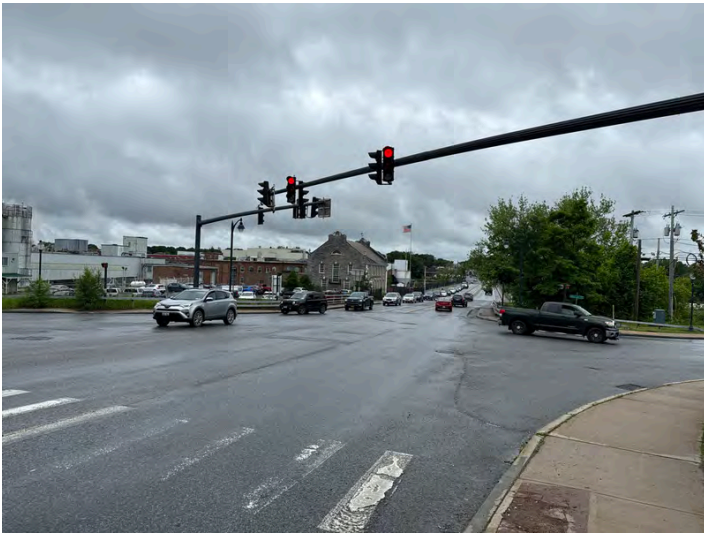
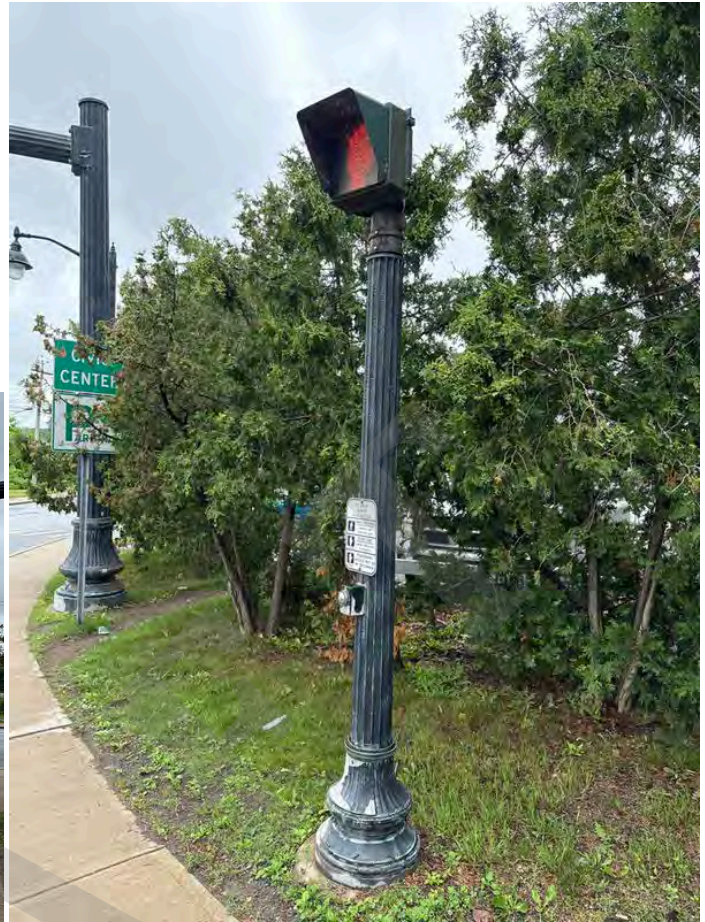
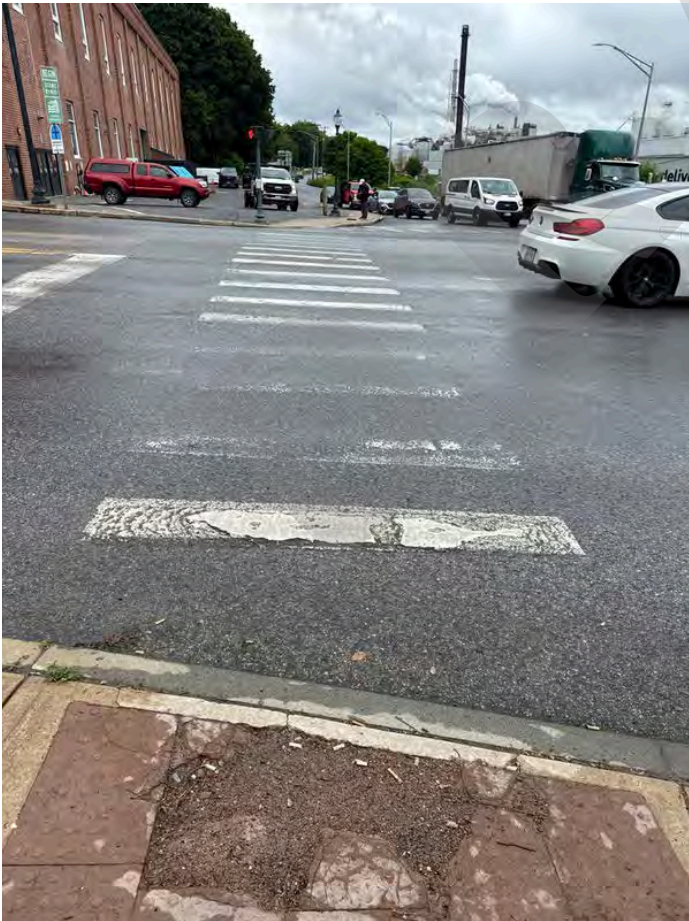
Photos

Route 9 and Mohican Street/ Oakland Avenue

Year of Signal Installation	
Overall Condition	Good
Poles	Mast
Span Type	N/A
Signal Heads	12", LED
Maintenance Record Notes

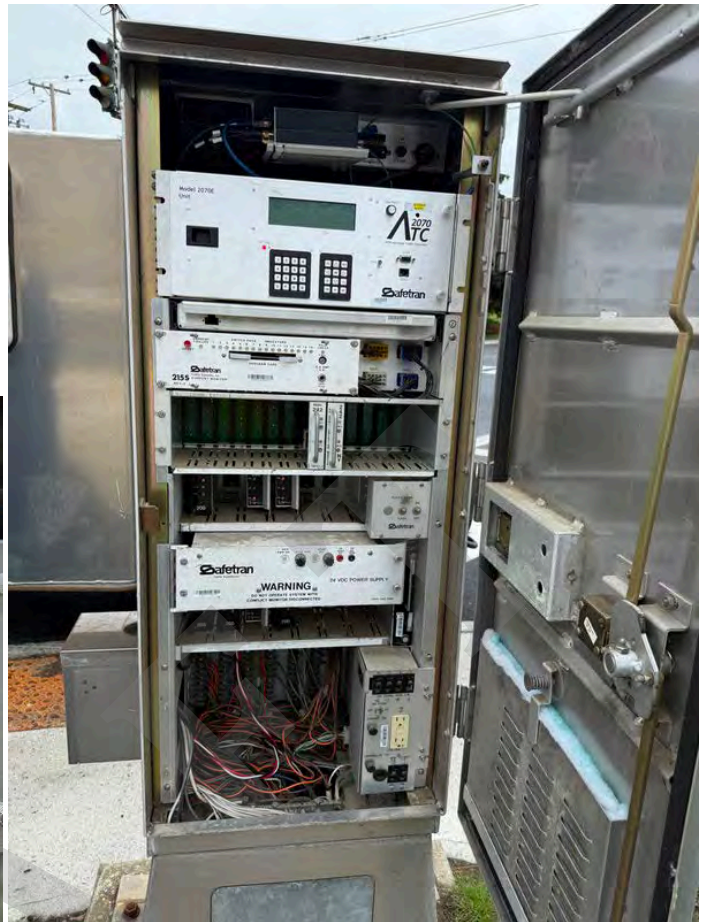
Year of Controller/Cabinet Assembly	
Conflict Monitor Model/Size	
Load Switches Installed/Type	8 installed
Backpanel Size	14 position
Controller Type	2070
Controller Make	Safetran ATC
Controller Model	2070E
Cabinet Type	330
Cabinet Mount	Ground
Cabinet Door	Single, Police
Signal Coordination	No
Type of Coordination	
Overall Cabinet Rating	
Cabinet Notes	Modem present for communication
Cabinet Photos

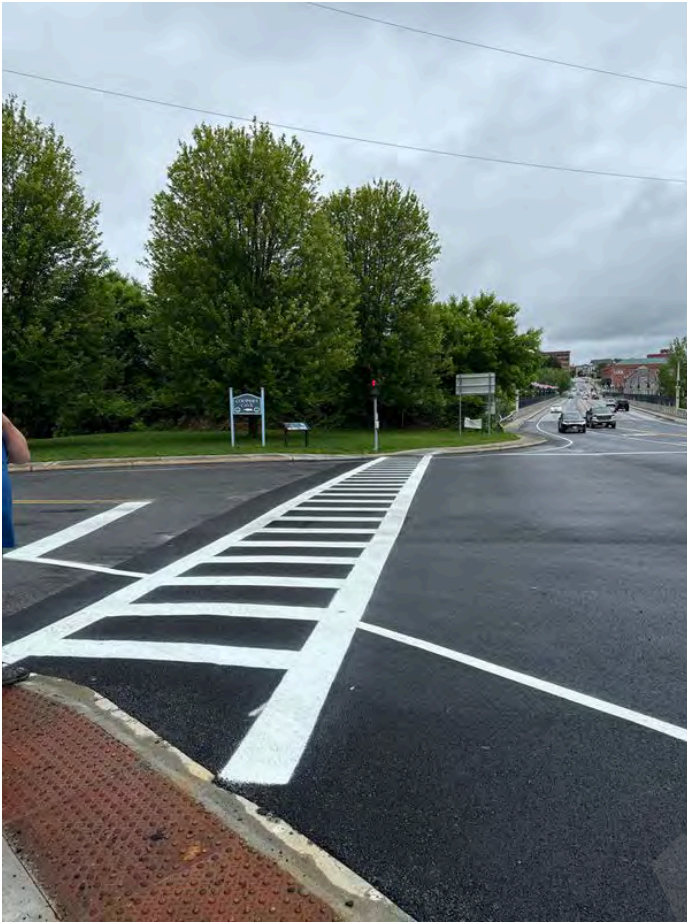
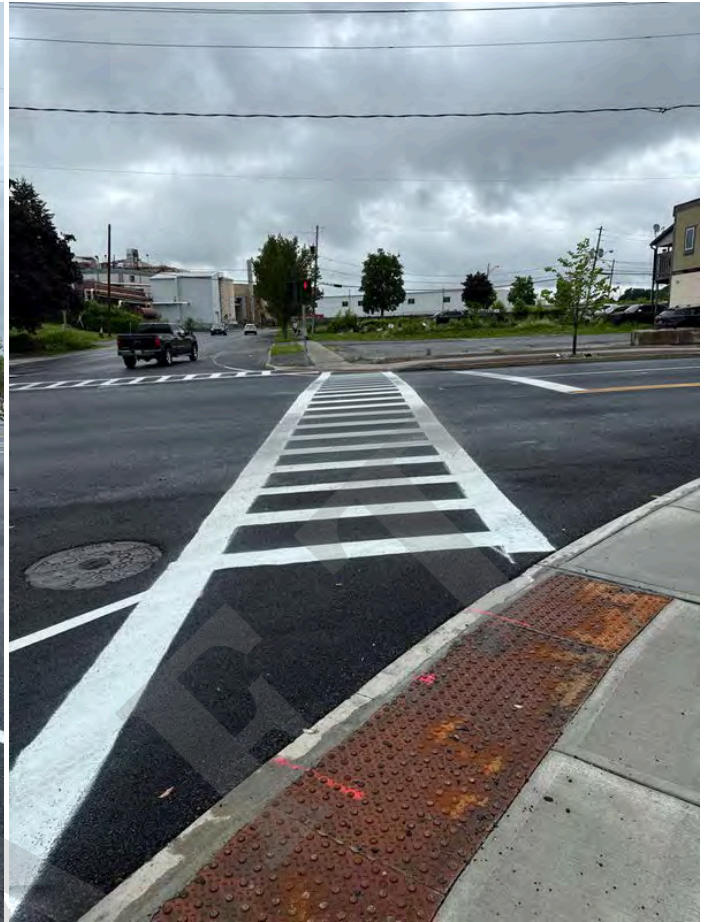
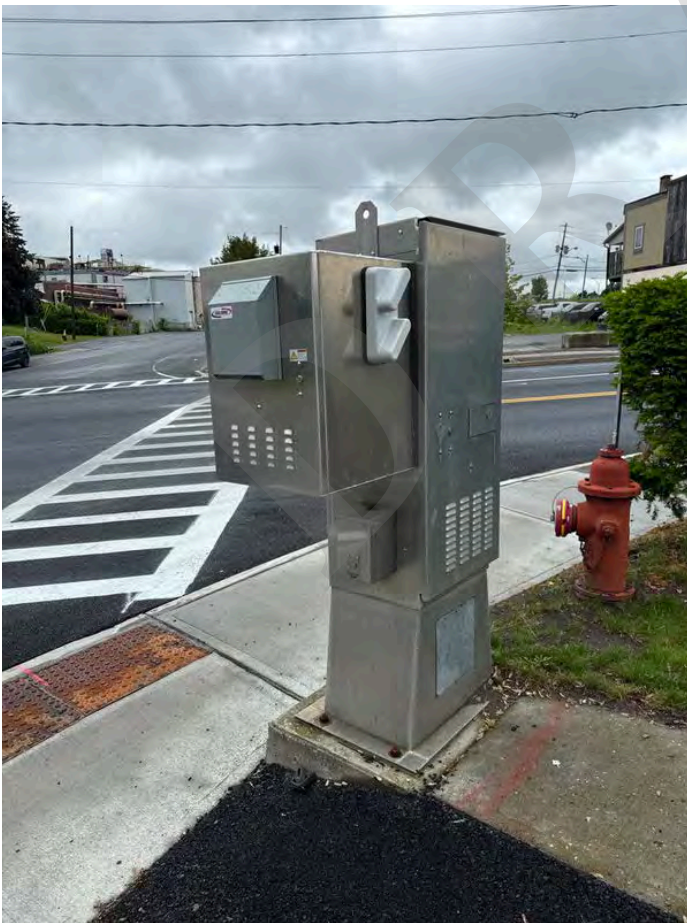
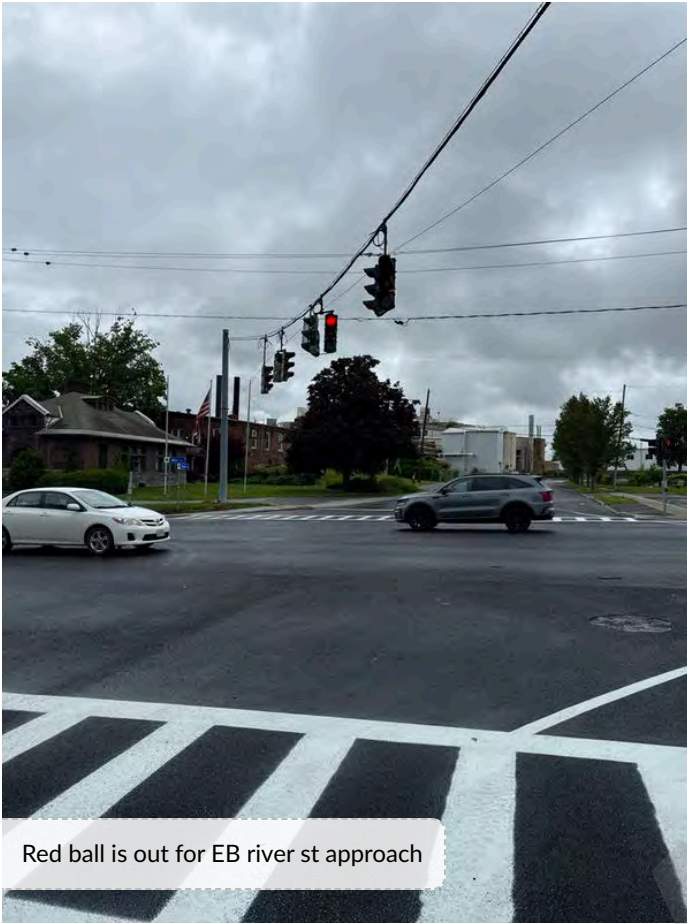
Photos

Main Street and River Street

Two Signal Faces per Approach?	Yes
Proper Use of Signal Heads?	Yes
Proper Size Vehicle Displays?	Yes
8' min seperation of signals?	Yes
Post/Poles 2' min off curb?	Yes
Proper Timing/Clearance (Vehicle)?	
Proper Timing/Clearance (Ped)?	
Adequate Visibility?	
Both signals <120/180' from stop bar?	Yes
Atleast one signal >40' from stop bar?	Yes
MUTCD Compliant?	Yes
Notes

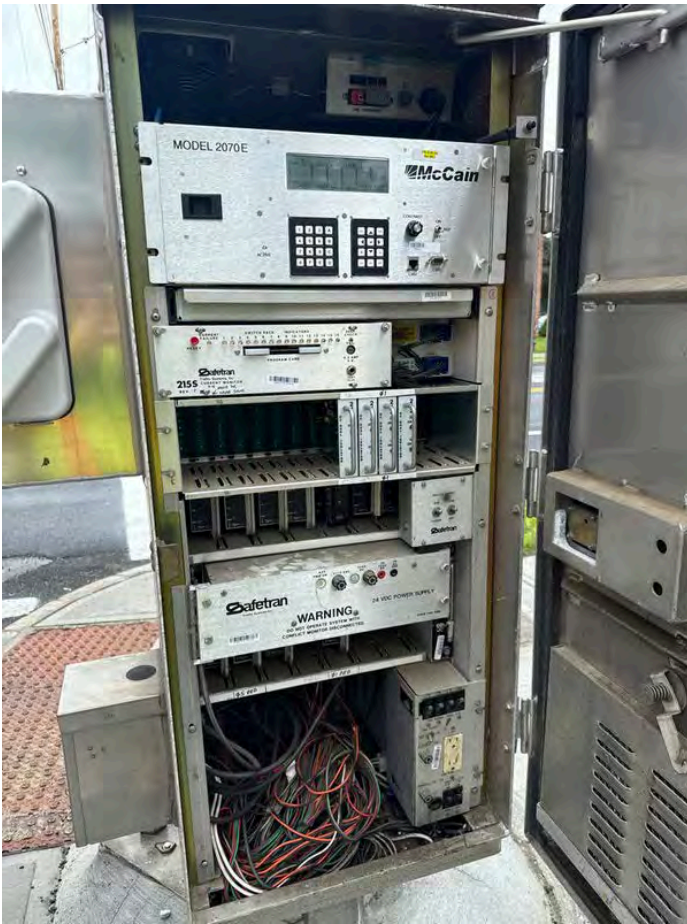
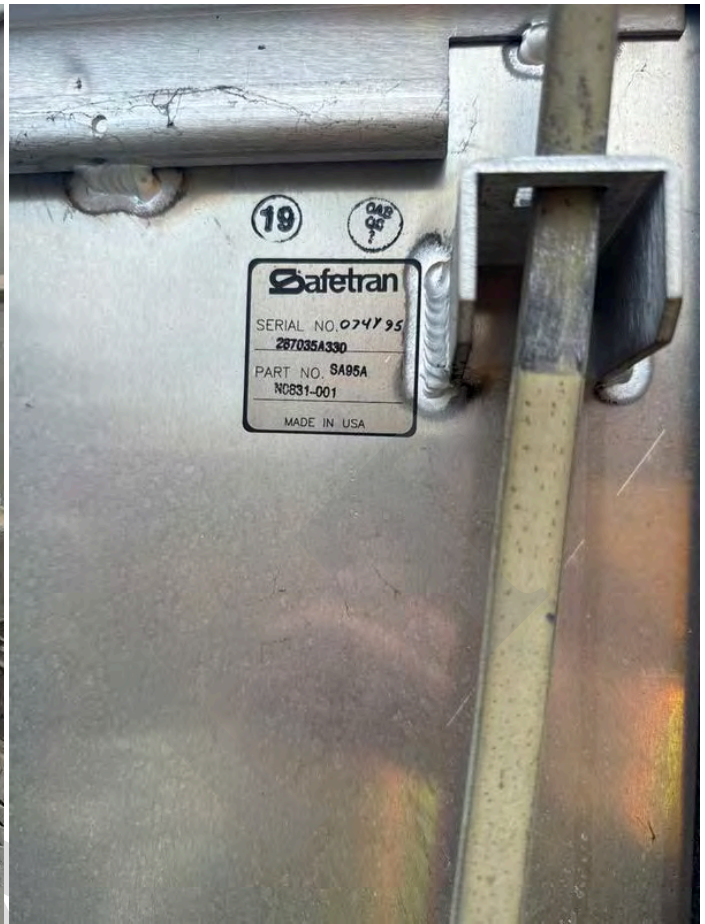
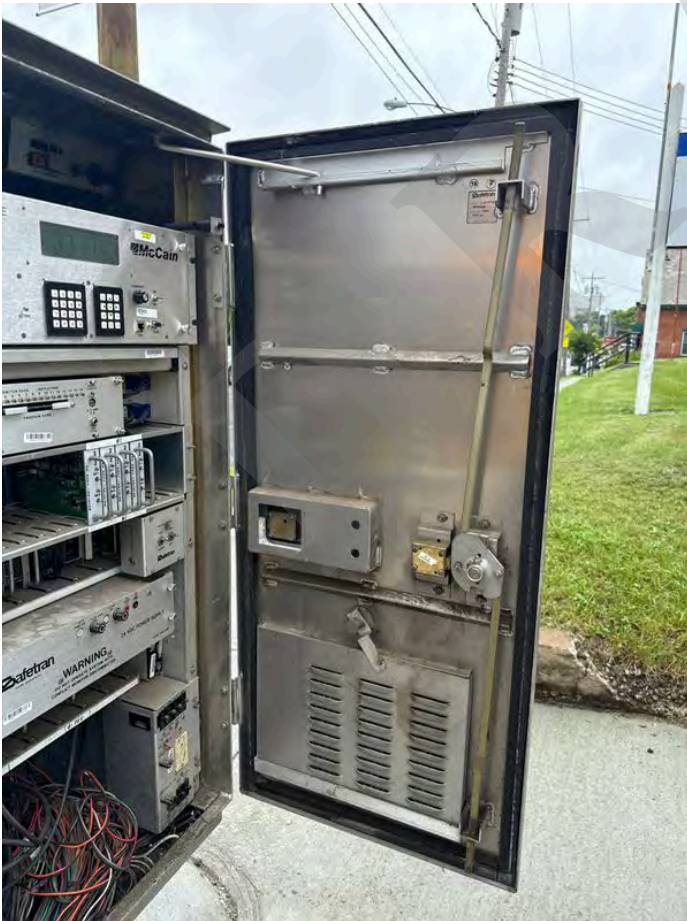
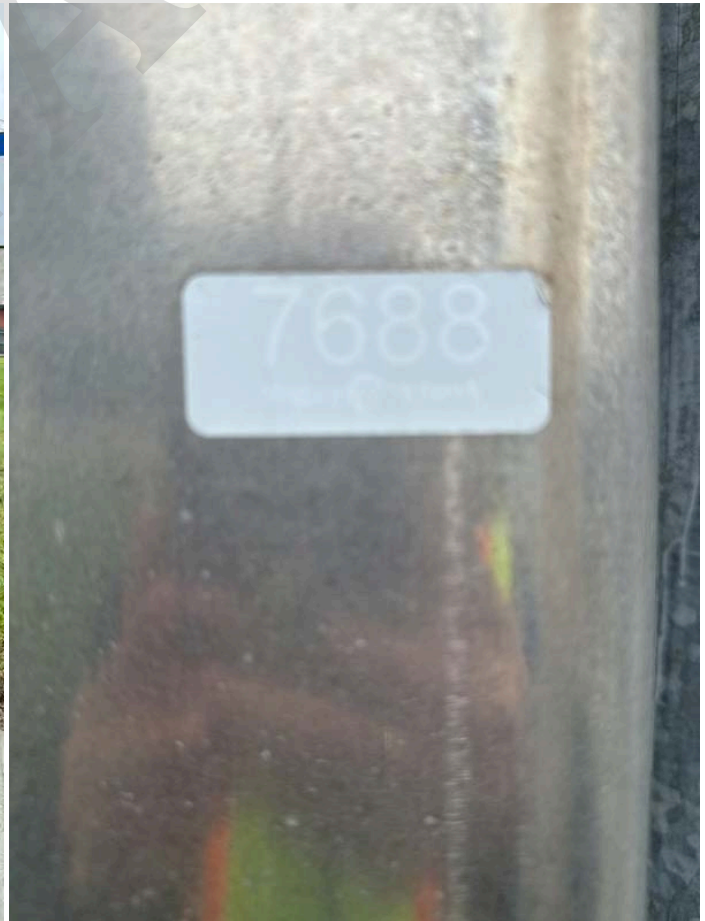
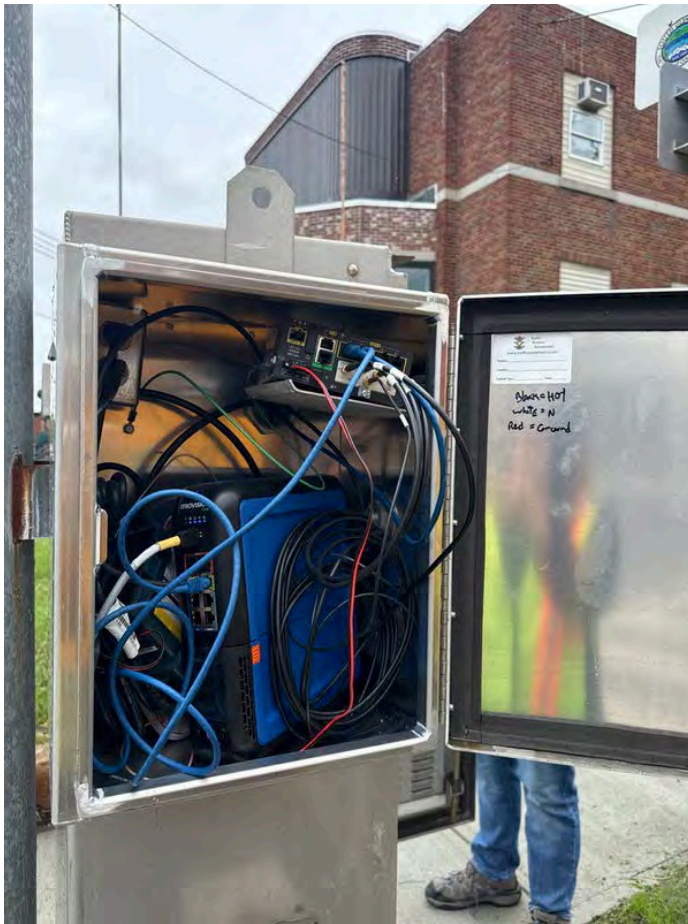
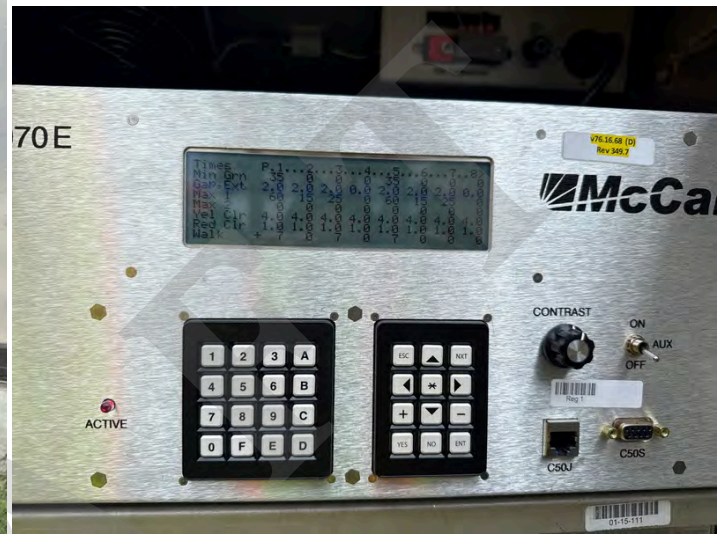
Year of Controller/Cabinet Assembly	
Conflict Monitor Model/Size	
Load Switches Installed/Type	11 installed
Backpanel Size	14 position
Controller Type	2070
Controller Make	McCain
Controller Model	2070E
Cabinet Type	330
Cabinet Mount	Side of Pole
Cabinet Door	Single, Police, Aux Cabinet
Signal Coordination	No
Type of Coordination	
Overall Cabinet Rating	
Cabinet Notes	Modem for Communication
Cabinet Photos

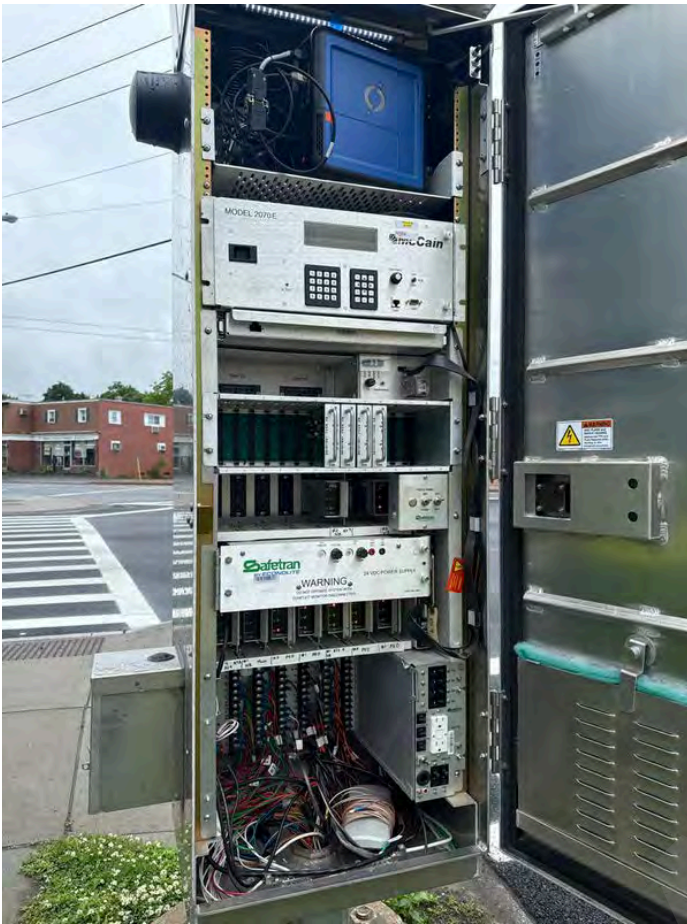
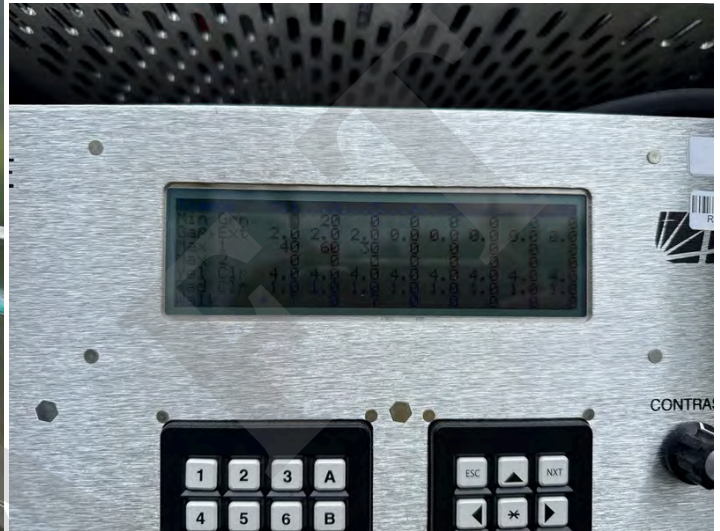
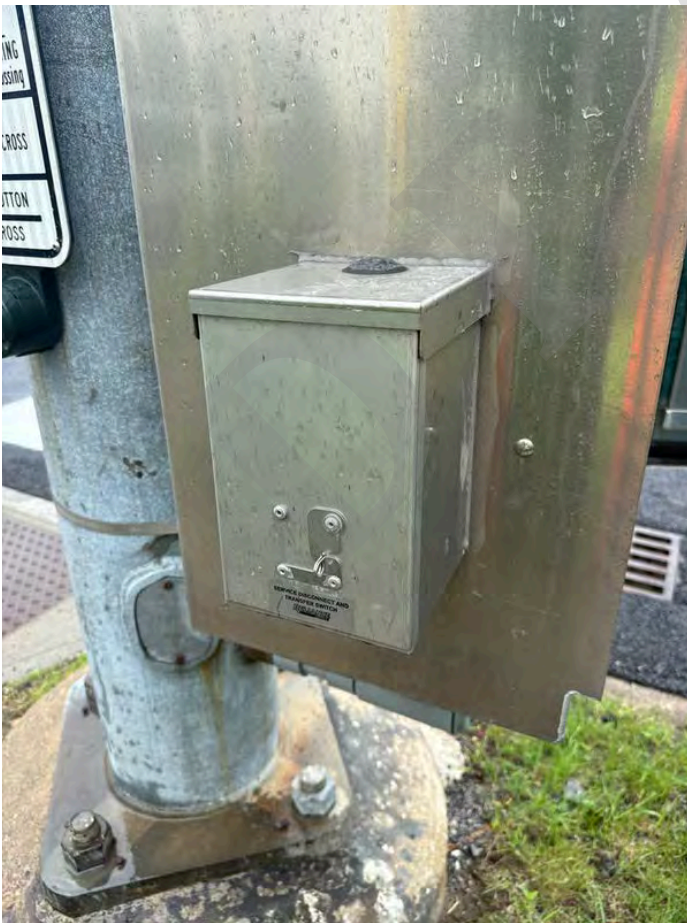
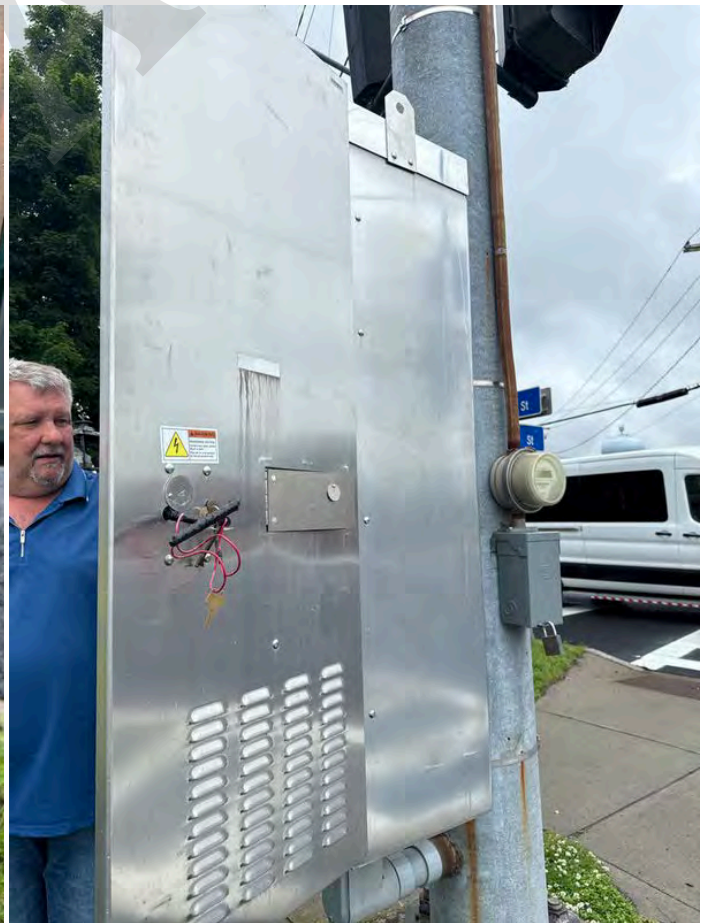
Route 9/Main Street and Saratoga Avenue and 5th Street

Year of Controller/Cabinet Assembly	
Conflict Monitor Model/Size	
Load Switches Installed/Type	9 installed
Backpanel Size	14 position
Controller Type	2070
Controller Make	McCain
Controller Model	2070E
Cabinet Type	330
Cabinet Mount	Side of Pole
Cabinet Door	Single, Police
Signal Coordination	
Type of Coordination	
Overall Cabinet Rating	
Cabinet Notes	
Cabinet Photos

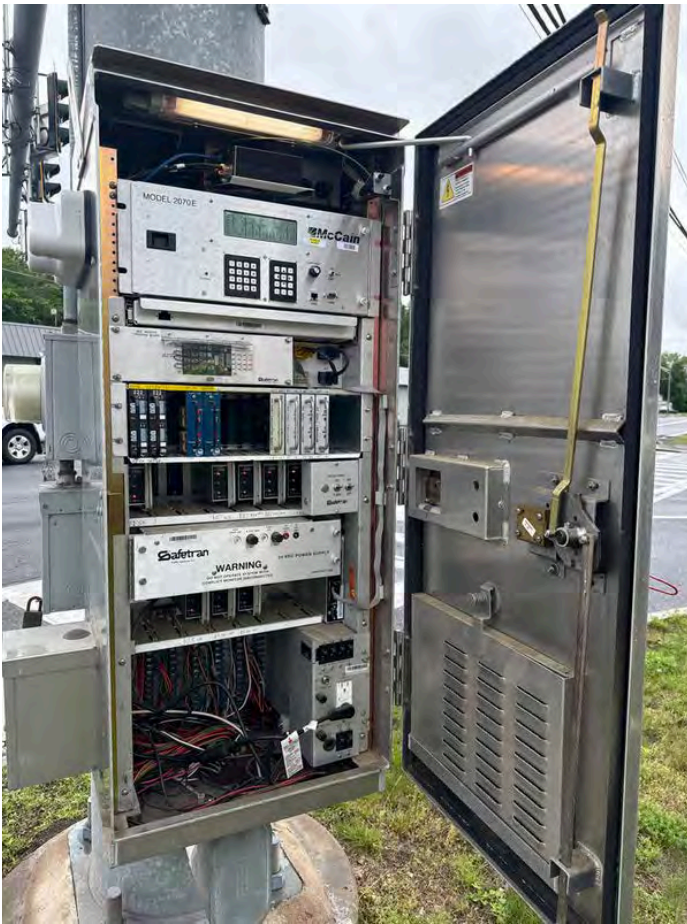
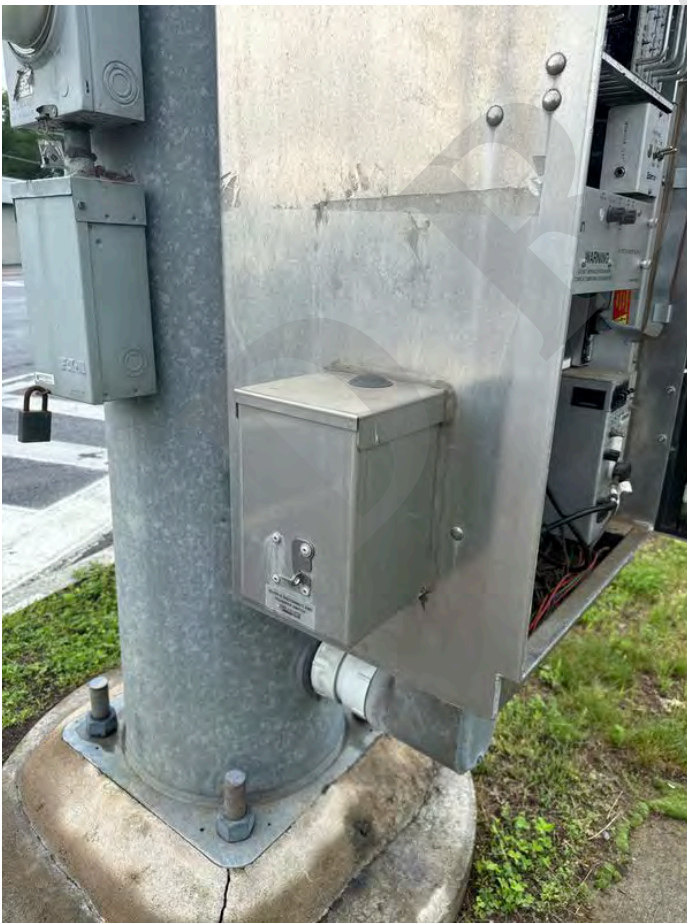
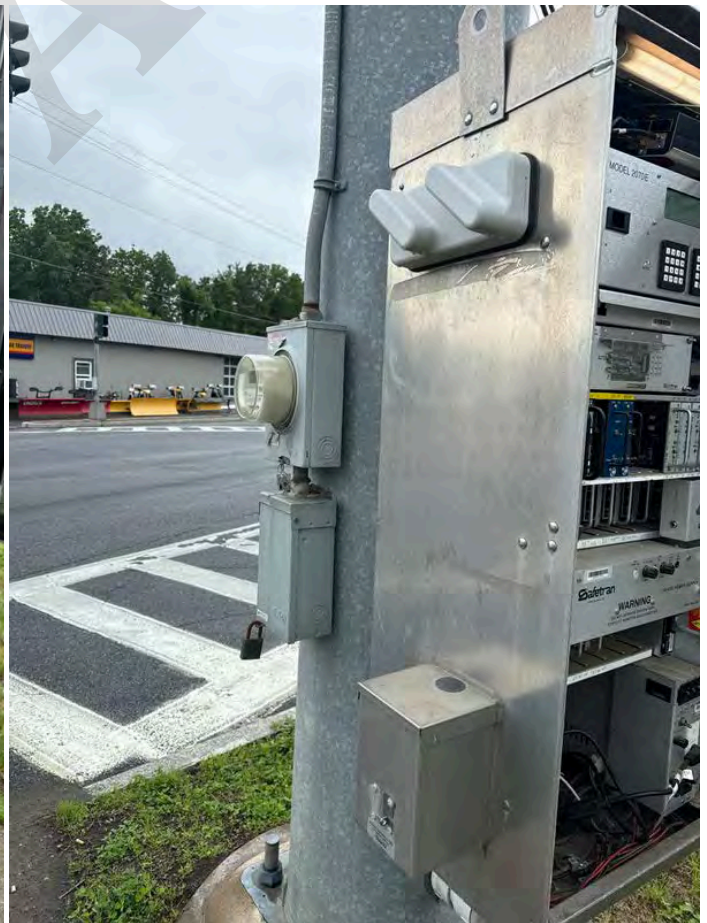
Route 9 and Feeder Dam Rd and William St

Year of Controller/Cabinet Assembly	
Conflict Monitor Model/Size	
Load Switches Installed/Type	
Backpanel Size	
Controller Type	2070
Controller Make	McCain
Controller Model	
Cabinet Type	
Cabinet Mount	Side of Pole
Cabinet Door	Single, Police
Signal Coordination	
Type of Coordination	
Overall Cabinet Rating	
Cabinet Notes	
Cabinet Photos
