# Glen St. Intersections Pedestrian Study

Memo To: Mr. Aaron Frankenfeld, Director  
Adirondack/Glens Falls Transportation Council (A/GFTC)  
11 South Street, Suite 203  
Glens Falls, NY 12801

Date: 8/27/2021

From: Barton & Loguidice, D.P.C.

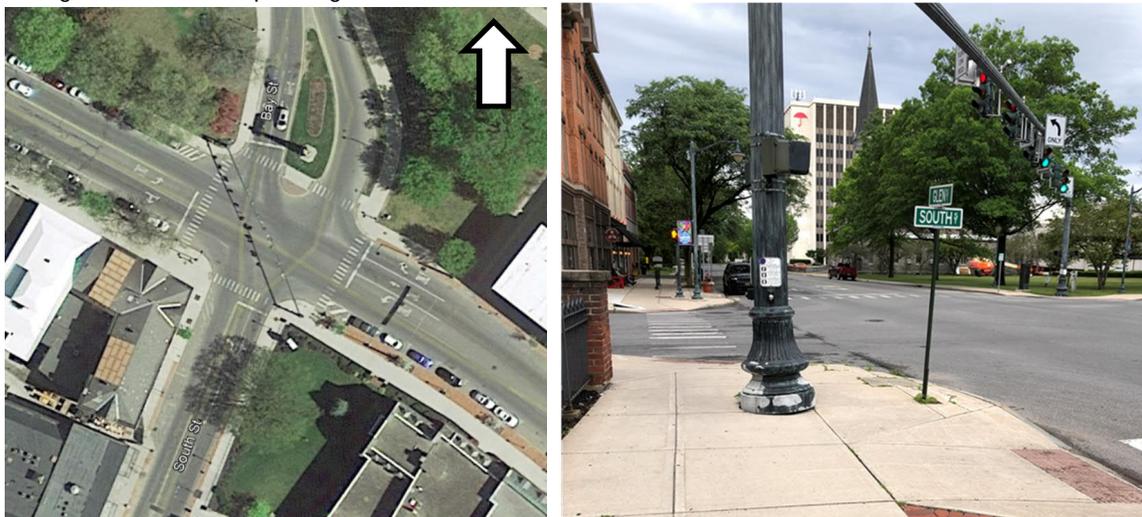
Figure 2.1 – Glen St. at South St./Bay St. Intersection

The intersection is four way signalized with two mast arm signal poles located at the northwest and southeast corners. There are ADA pedestrian signals/push buttons at all approaches with the button for each direction mounted on the same signal pole with the heads above. Curb ramps were previously installed to ADA standards at each corner of the intersection.

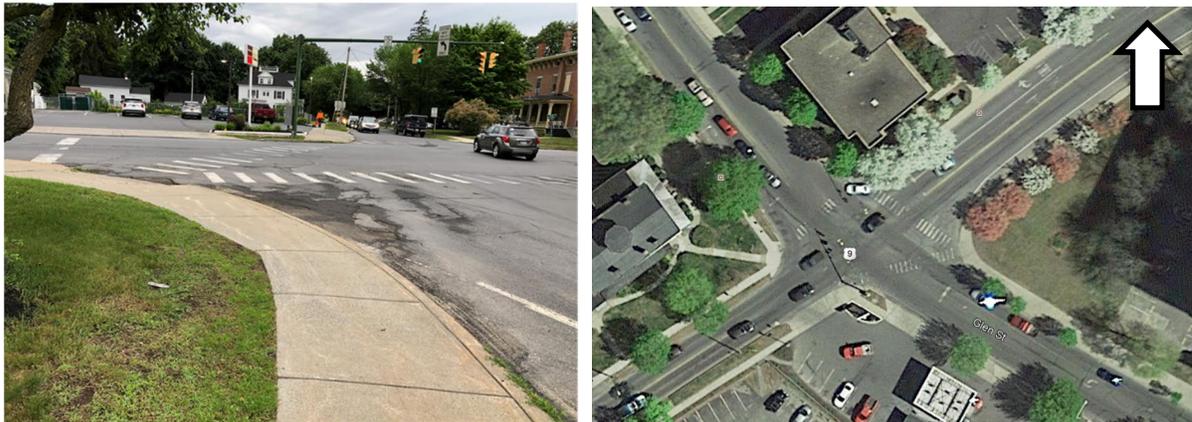
Figure 2.2 – Glen St. at Sherman Ave./Washington St.

Glen St. at Sherman Ave./Washington St.: This intersection is located west of the South St./Bay St. intersection. It is four way signalized for vehicles and does not include pedestrian signal equipment. This intersection is also centrally located in the City of Glens Falls, surrounded by local businesses. There are sidewalks on each corner of the intersection with curb ramps that do not meet current ADA requirements.
