Final Glen St. Intersections Pedestrian Study

Memo To: Mr. Aaron Frankenfeld, Director
Adirondack/Glens Falls Transportation Council (A/GFTC)
11 South Street, Suite 203
Glens Falls, NY 12801

Date: 12/23/2021

From: Barton & Loguidice, D.P.C.

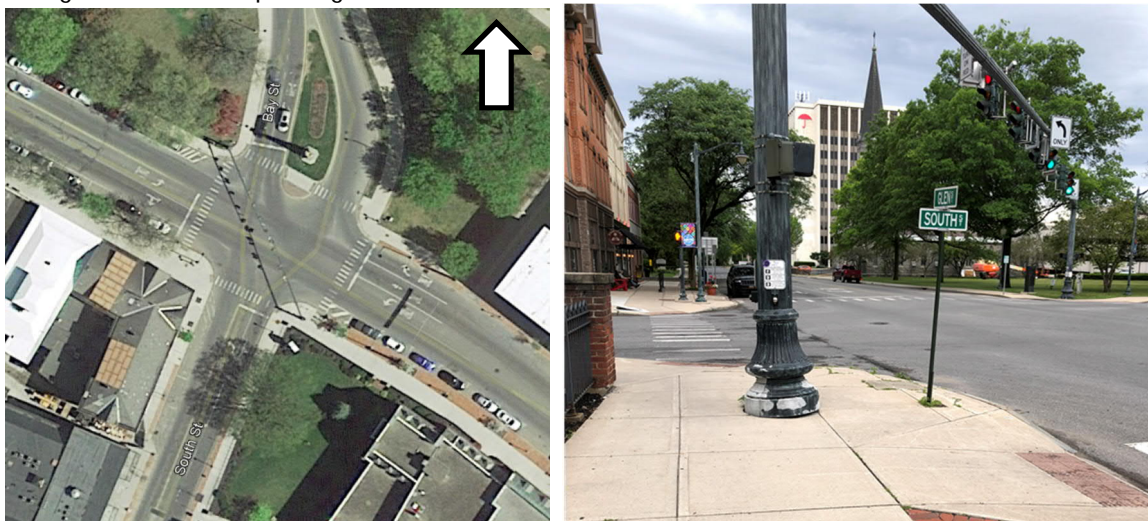
Figure 2.1 – Glen St. at South St./Bay St. Intersection

The intersection is four way signalized with two mast arm signal poles located at the northwest and southeast corners. There are ADA pedestrian signals/push buttons at all approaches with the button for each direction mounted on the same signal pole with the heads above. Curb ramps were previously installed to ADA standards at each corner of the intersection.

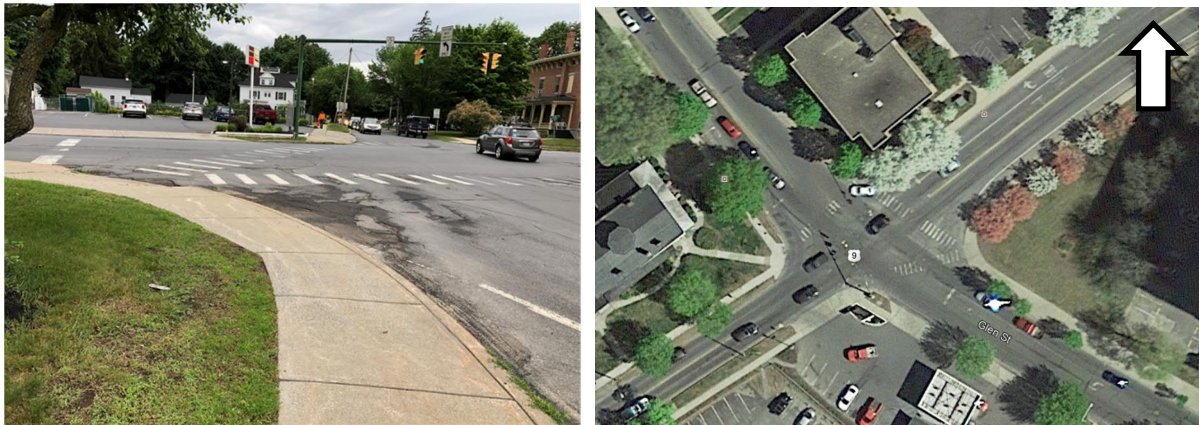
Figure 2.2 – Glen St. at Sherman Ave./Washington St.

Glen St. at Sherman Ave./Washington St.: This intersection is located west of the South St./Bay St. intersection. It is four way signalized for vehicles and does not include pedestrian signal equipment. This intersection is also centrally located in the City of Glens Falls, surrounded by local businesses. There are sidewalks on each corner of the intersection with curb ramps that do not meet current ADA requirements.
