### Bay Street & Sanford Street Glens Falls, NY

### INTERSECTION SAFETY STUDY

December 2013

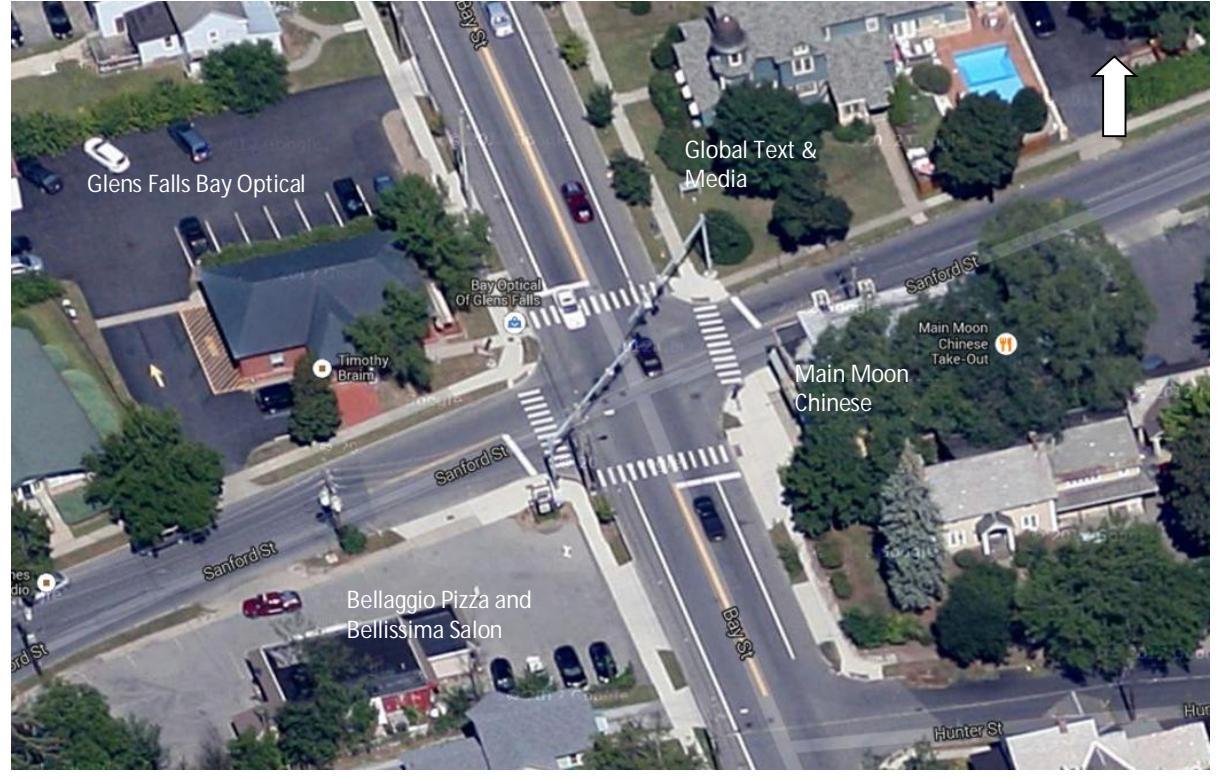
Figure 1: Bay Street and Sanford Street

Bay Street and Sanford Street are essentially straight and level. The two streets are nearly perpendicular but there is a slight horizontal curve on Sanford Street just west of the intersection.

Bay Street and Sanford Street intersect at a four-way intersection operating under traffic signal control. Each approach consists of a shared left/ through/right turn lane with parking permitted on both sides of all approaches. Parking areas on Bay Street are highlighted with a single white edge line but individual spaces are not designated within these areas. On street parking is also permitted on both sides of Sanford Street although no parking areas are defined with pavement markings. Pedestrians are accommodated through a sidewalk on the both sides of Bay Street and Sanford Street with a utility strip separating the concrete curb from the sidewalk. There are no separate bicyclist accommodations.

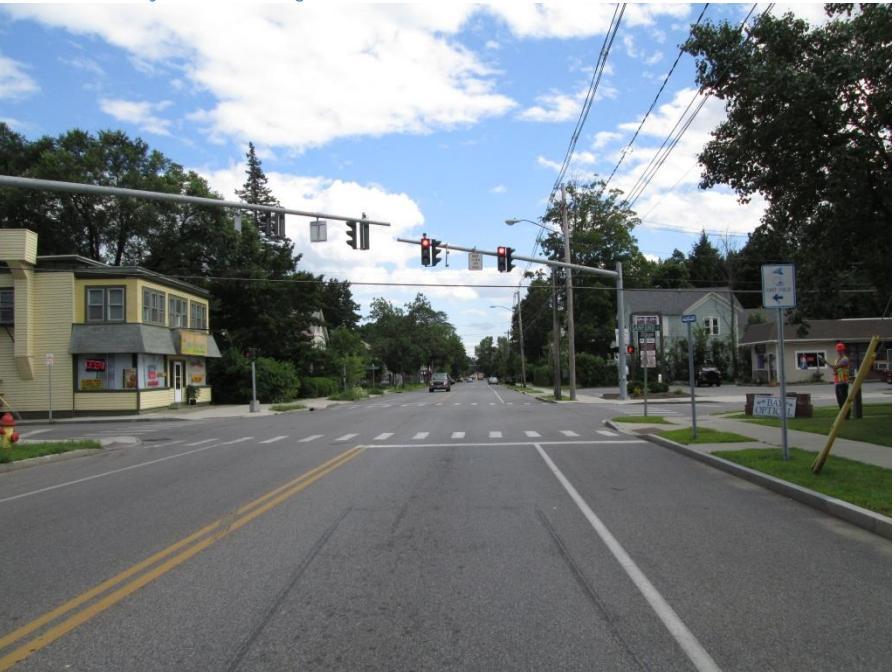
Photo 1: On Bay Street looking south at Sanford Street

Each approach is controlled by a pair of standard 3-section vehicular signal heads vertically mounted on mast arms. The mast arm poles are located on the northeast and southwest corners of the intersection and are angled diagonally through the intersection. The existing operation of the signals consists of two phases (Bay Street north/south and Sanford Street east/west). The north/south phase was observed to be approximately 35 seconds with the east/west phase observed to be approximately 18 seconds for a total cycle length of 65 seconds. Each phase included approximately 4 seconds yellow and 2 seconds all red. The signal is not part of a coordinated system. No Turn on Red signs are mounted on the mast arms for each of the approaches to the intersection. See Photo 1.

The height of the signals, from the top of pavement to the bottom of the signal head housing was measured in the field. The signals that control the northbound and westbound approaches were at 20.5 ft. and 20.9 ft. The signals that control the southbound and eastbound approaches were approximately 19.5 ft. and 20 ft.

The traffic signals that control the Sanford Street eastbound and westbound approaches exceed the maximum standard for mounting heights of signal faces, as noted in Section 4D.15 of the MUTCD and NYS Supplement. In accordance with these documents, vehicular signal faces located over any portion

of a highway that can be used by motor vehicles shall be at least 15 feet above the pavement and not more than 19 feet. All of the existing vehicular signal faces exceed this maximum mounting height with the signals ranging in height from 19.5 feet to 20.9 feet (from top of pavement to bottom of signal housing). Since all of the signals exceed the maximum height to the bottom of the signal housing, several of the signals also exceed the maximum top of signal head mounting height.

### Adjust Signal Head Positions

The signals controlling the westbound approach should be lowered at least 2.5 to 3 feet. The signals controlling the eastbound approach should be lowered at least 1.5 to 2 feet. Determination of the appropriate method to lower the signal heads, including the use of new signal brackets, lowering the mast arm, or installing new signals should be assessed. A detailed engineering evaluation, including an assessment of the structural capacity of the supports, impact on utilities, and visibility of the signal heads will be necessary prior to implementing this measure. This evaluation could be approached by having a structural engineer review and evaluate the design shop drawings of the mast arm poles that were installed and/or work with the pole manufacturer to determine the ability of the poles to accept loading revisions based on their design load.

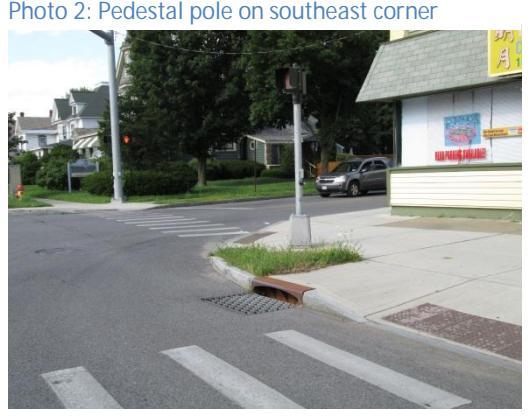
the upraised hand and walking person symbol overlaid Photo 2: Pedestal pole on southeast corner upon each other. No countdown timers exist at this intersection. The pedestrian signal heads, buttons and signs are mounted on the mast arm at the northeast and southwest corners. At the southeast corner, the pedestrian signals, pushbuttons and signs for crossing the south leg of Bay Street and the east leg of Sanford Street are both mounted on the same pedestal pole. At the time of this study, the pedestrian signal at the northwest corner, which would have consisted of the pedestrian signals, pushbuttons and signs for crossing the north leg of Bay Street and the west leg of Sanford Street, both mounted on

the same pedestal pole, was missing due to a recent accident that occurred which demolished the Bay Optical sign and the pedestrian signals.

In addition, some of the existing pedestrian push buttons were not operating the intended approach as noted below:

### Southwest corner pedestrian signal

- Pushbutton to cross the Bay Street south leg operates the Sanford Street west leg crossing.
- Pushbutton to cross the Sanford Street west leg operates the Bay Street south leg crossing.

### Southeast corner pedestrian signal

Pushbutton to cross the Bay Street south leg operates the Sanford Street west leg crossing. Hence, there is no accommodation for pedestrians to cross the Bay Street south leg from the southeast corner of the intersection.

The pushbuttons, signs and pedestrian signals at the southeast and southwest corners should be corrected so that the buttons activate the correct signals, and the damaged/missing signals at the northwest corner should be re-installed to accommodate pedestrian crossings through the intersection.

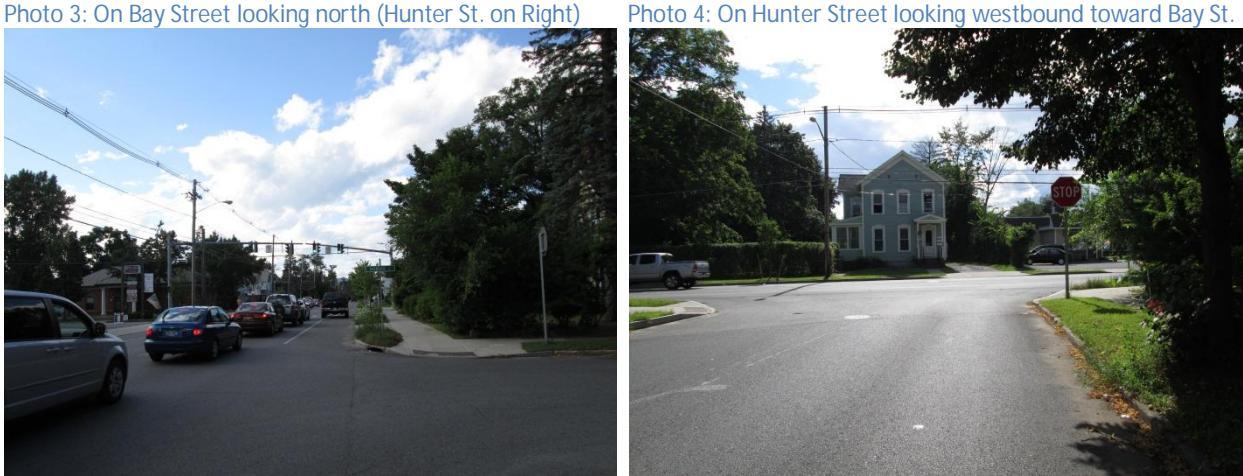
Photo 3: On Bay Street looking north (Hunter St. on Right)

Hunter Street intersects Bay Street approximately 145 feet south of the Bay Street and Sanford Street intersection. See Photo 3. Hunter Street is a two-lane east-west roadway that is Stop controlled and intersects Bay Street forming an unsignalized "T" intersection. See Photo 4. The Hunter Street westbound approach consists of a shared left/ right turn lane. Pedestrians are accommodated through a sidewalk on both sides of Hunter Street with a grassed utility strip separating the concrete curb from the sidewalk. There are no separate bicyclist accommodations. There are no pavement markings on Hunter Street. Overgrown brush and vegetation on the northeast corner of the intersection limit the intersection sight distance.

While most of the intersection and surrounding area is open (Photo 1), there are a few locations where trees and vegetation have become overgrown impairing visibility. At the northeast corner of the Bay Street and Hunter Street intersection, there is a bush and some overgrown vegetation that limits visibility (Photo 6) to pedestrians and bicyclists riding on the sidewalk.

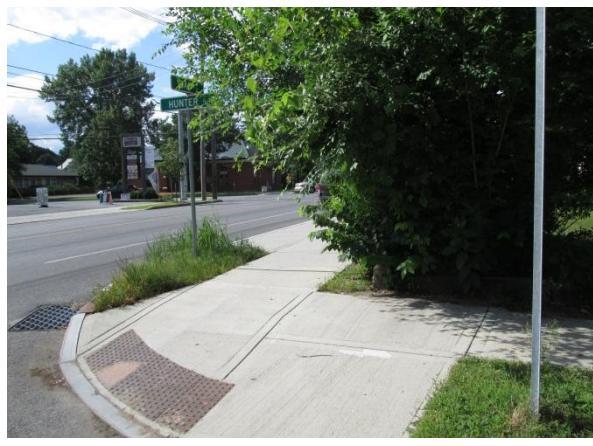
Photo 6: On Hunter St. at stop bar and sign looking north

- Pedestrian pushbuttons are not operating as intended. The pedestrian signal at the northwest corner is missing, the pushbuttons at the southwest corner operate the opposite approach than designated by placement and signage (e.g. button to cross Bay Street south leg operates Sanford Street west leg), and there is no accommodation to cross the Bay Street south leg from the southeast corner, since the pedestrian button at the southeast corner controls the Sanford Street west leg crossing. See Section 2.0A.
- Visibility of the signals and signage for vehicles at the Sanford Street eastbound and westbound approach stop lines is limited due to the height and longitudinal placement of the signals.

and overgrown bushes at the northwest corner of the Hunter Street and Bay Street intersection. See Photos 2 and 6.

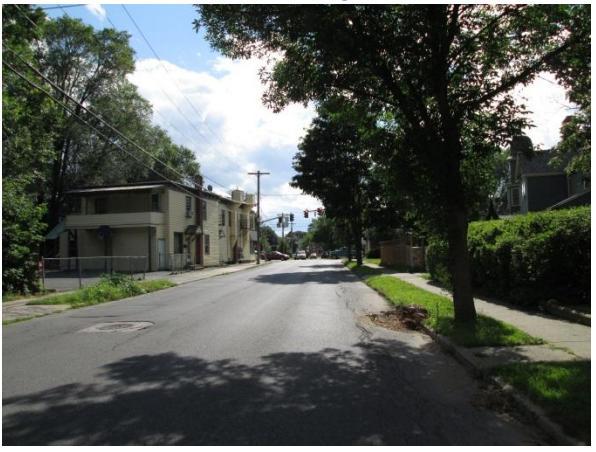
Photo 7: On Sanford Street looking westbound

- Visibility of the signal and overhead signage is impeded for Sanford Street westbound vehicles due to the tree canopy overhanging the Sanford Street westbound approach. See Photo 7.
- Visibility of southbound vehicles, pedestrians and bicyclists on Bay Street is impeded for the Hunter Street vehicles due to the northbound queue at Sanford Street, on-street parking

Likewise, the trees along the north side of the Sanford Street westbound approach have canopies that are overhanging the roadway and impacting the view of the traffic signal. The overhead No Right Turn on Red sign is not visible due to the canopy from these trees (Photo 7). Trees and brush should be trimmed and removed as necessary to maintain adequate lines of sight.

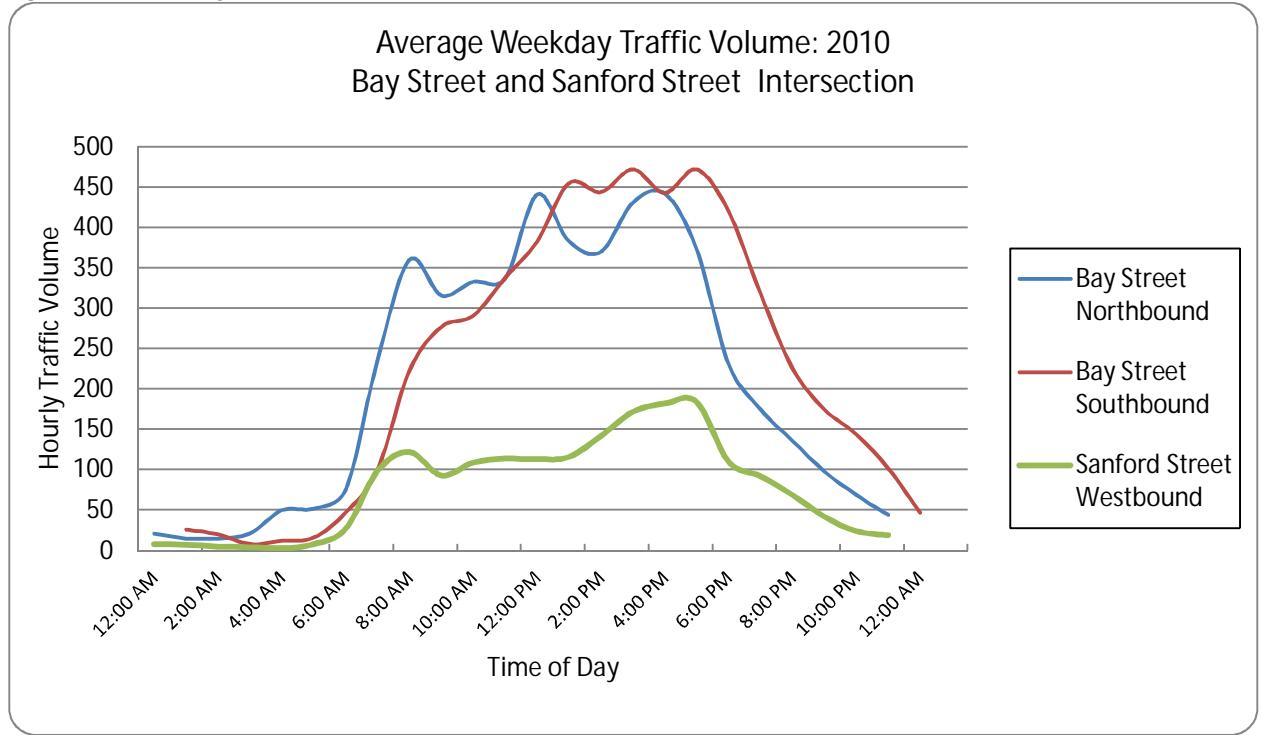
Figure 2: AADT Hourly Traffic Volumes

The New York State Department of Transportation (NYSDOT) Traffic Volume Data Viewer was used to obtain the Average Annual Daily Traffic Volume (AADT) data for Bay Street and Sanford Street. Table 2 below summarizes the 2010 AADT. Figure 2 below shows hourly volumes approaching the intersection. See Appendix B for the Traffic Hourly Data Report.

Three signalized intersections exist on Bay Street between Washington Street and Sanford Street (at Washington Street, Grand Street, Sanford Street). No signalized intersections exist on Bay Street north of Sanford Street to the City line. North of the City line, there is one midblock crossing, to accommodate the Warren County Bikeway, and a signalized intersection at NYS Route 254. The data indicates that motorists travel at a slightly higher 85<sup>th</sup> percentile speed in the southbound direction than the northbound direction. This suggests that the motorists are traveling at a slightly higher speed in the roadway segment where there is uninterrupted flow and a slightly lower speed in the roadway segment where there is interrupted flow due to the signals. Bay Street is posted 30 mph so the results of the speed study are consistent with expected 50<sup>th</sup> and 85<sup>th</sup> percentile speeds for this posted speed limit and the character of this area of Bay Street.

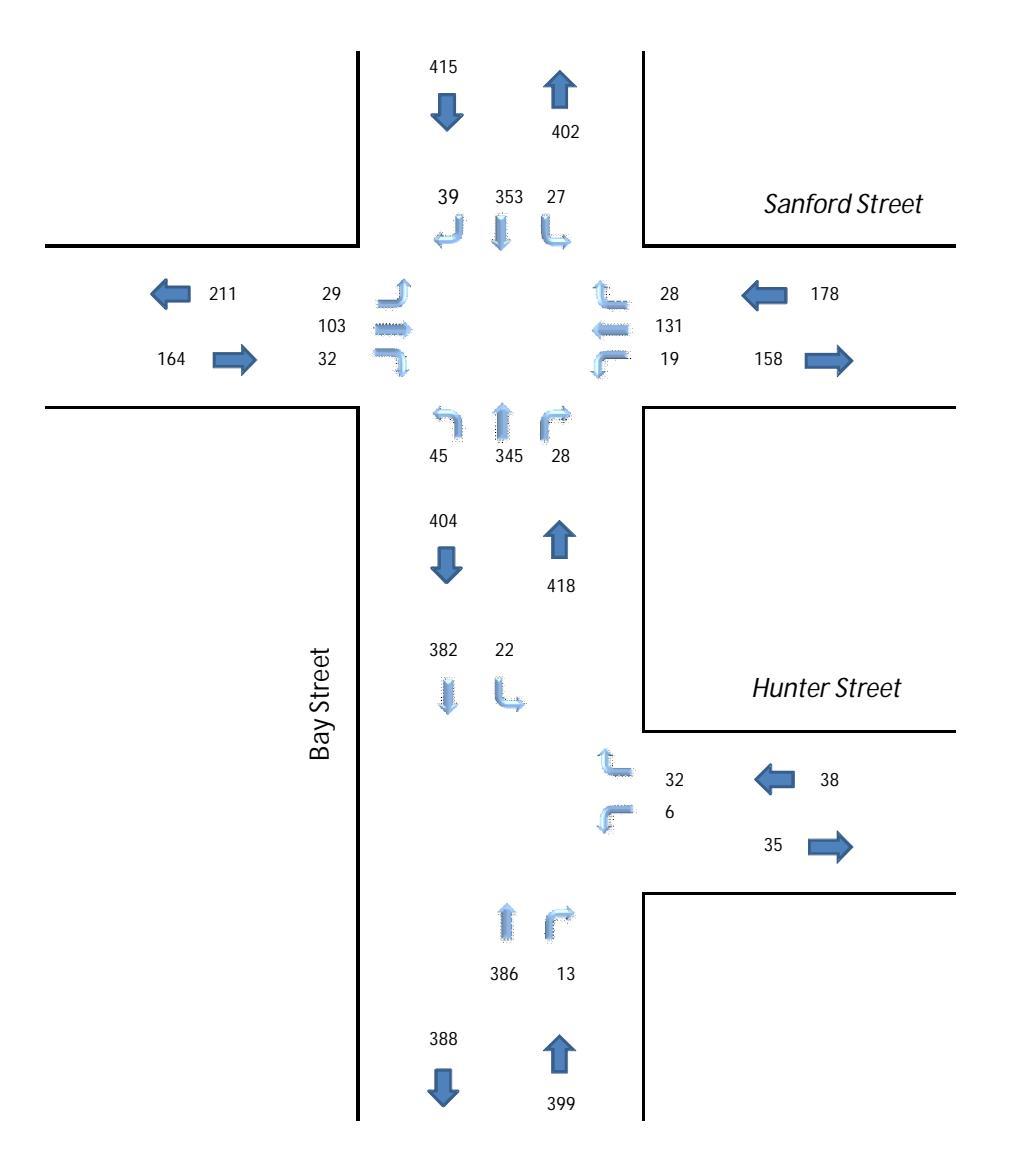
### Figure 3: PM Peak Hour Volumes

Intersection turning movement traffic counts were conducted at the Bay Street and Sanford Street and Hunter Street intersections on July 30, 2013 during the weekday PM peak period from 4:00 pm to 6:00 pm. Traffic counts were recorded at 15-minute increments. Pedestrian counts were also recorded at the intersections concurrently with the vehicle counts. The PM peak hour occurred from 4:30 pm to 5:30 pm. See Figure 3 below for the PM peak period volumes. The traffic volumes are included in Appendix B.

- The two-way PM peak period volume on Bay Street is approximately 820 vehicles, which is more than twice the two-way PM peak period volume on Sanford Street (375 vehicles).
- Approximately 60% of the traffic entering Hunter Street is from the north (turning left).
- Approximately 85% of the traffic exiting Hunter Street is to the north (turning right).
- The primary pedestrian movement during the PM peak period was from the south (17 pedestrians).

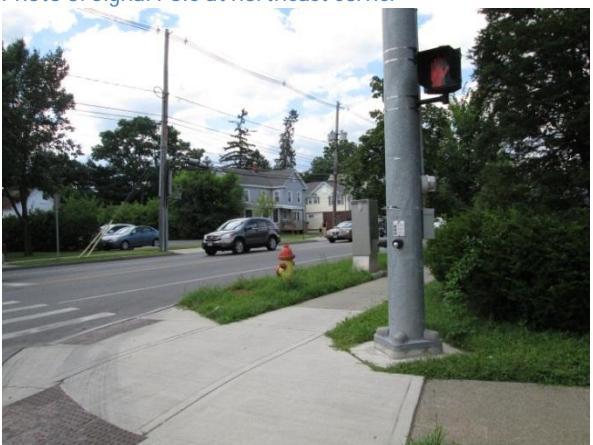
Photo 8: Signal Pole at northeast corner

While the accident data did not indicate a pedestrian/bicycle safety issue, the pedestrian signals are not functioning according to the intended operation. In addition, the pedestrian signal at the northwest corner of the intersection is missing due to an accident that occurred in April 2013. As discussed in Section 2.0B, the pedestrian signals at the southwest and the southeast are not functioning correctly. The pushbuttons, signs and pedestrian signals at the northeast corner (Photo 8) are functioning correctly.
